FINAL
Hazardous Building
Materials Assessment

Oxford on Rideau Public School
50 Water Street, Oxford Mills,
Ontario

**Upper Canada District School
Board**

March 28, 2023

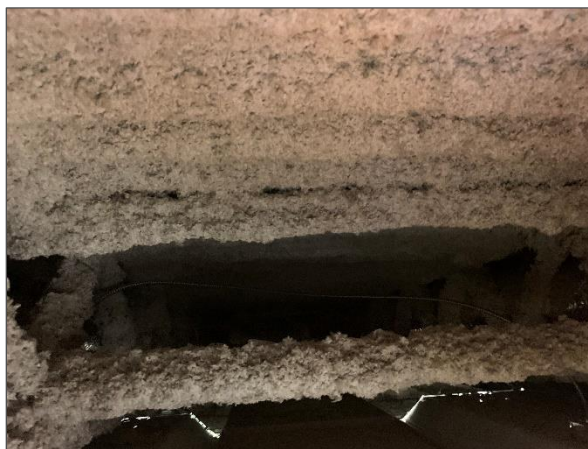
Spray-applied fireproofing and overspray present on the structure in isolated locations does not contain asbestos (previous Pinchin samples 0013A-C). Fireproofing present in the 1994 addition is presumed to be non-asbestos based on the construction date of the addition.

Non-asbestos spray-applied fireproofing.

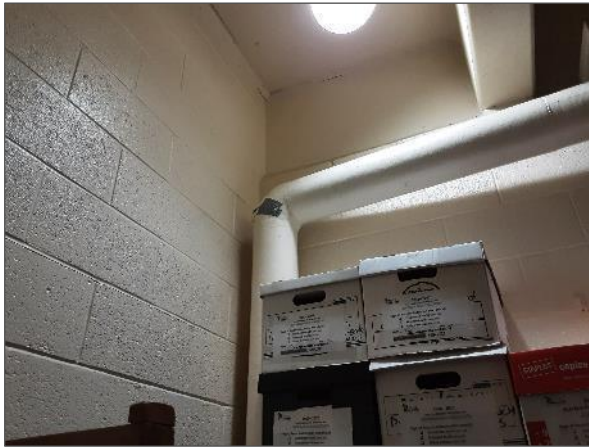
Asbestos-containing parging cement elbows and non-asbestos sweatwrap insulation.

Material, Quantity & Condition	Location	Recommended Procedure
Parging cement insulation, 6 elbows, fair condition	Location 1	Remove or repair in accordance with Type 2 or Glove Bag asbestos abatement procedures

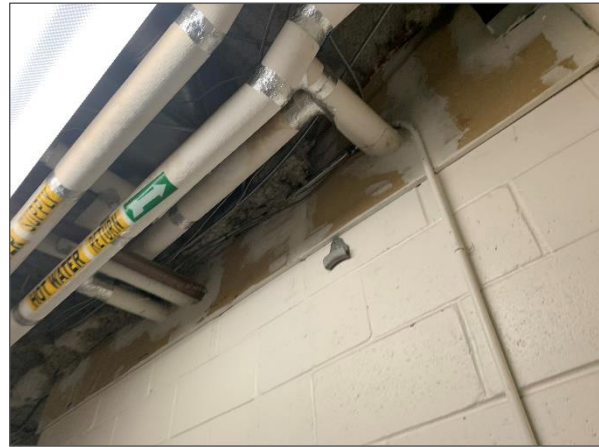
Non-asbestos fibreglass insulation.

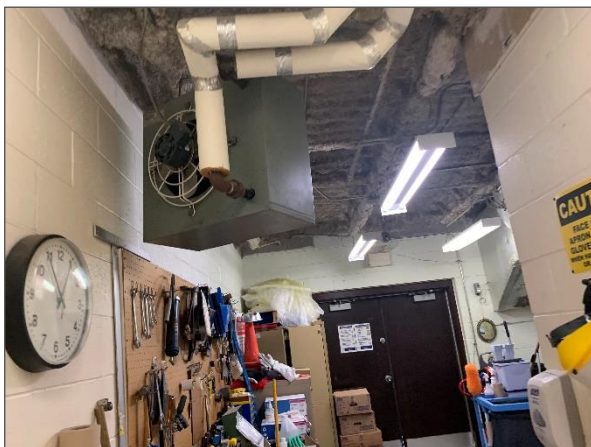
Uninsulated suspended unit heater.

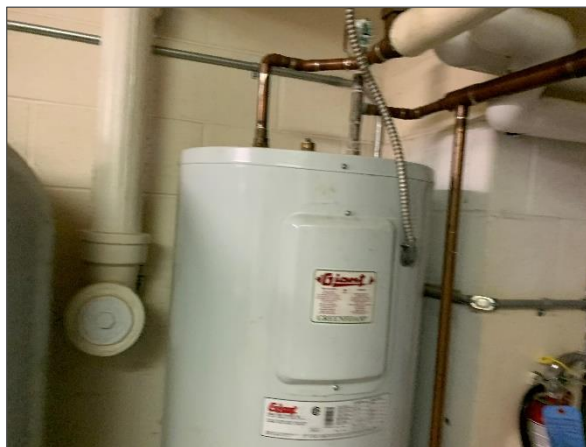
Non-asbestos fibreglass insulated hot water tank with metal jacketing.

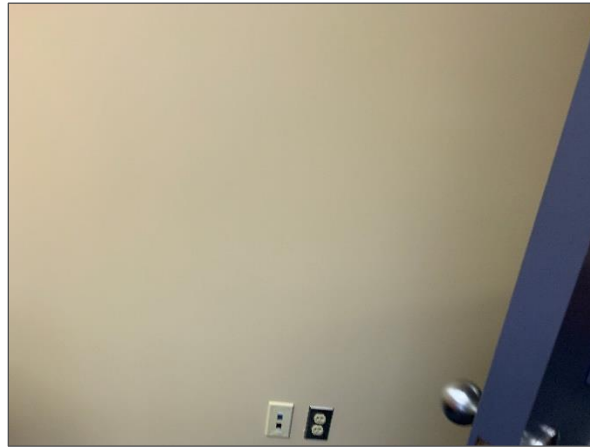
Drywall joint compound present on wall and ceiling finishes throughout the 1964 original building does not contain asbestos (previous Pinchin samples 0003A-C and samples S0019A-E).

Non-asbestos drywall joint compound.
