FINAL **Hazardous Building** **Materials Assessment**

South Grenville District High
School
1000 Edward Street, Prescott,
Ontario

Pinchin File: 302783.041

South Grenville District High School, 1000 Edward Street, Prescott, Ontario
Upper Canada District High School

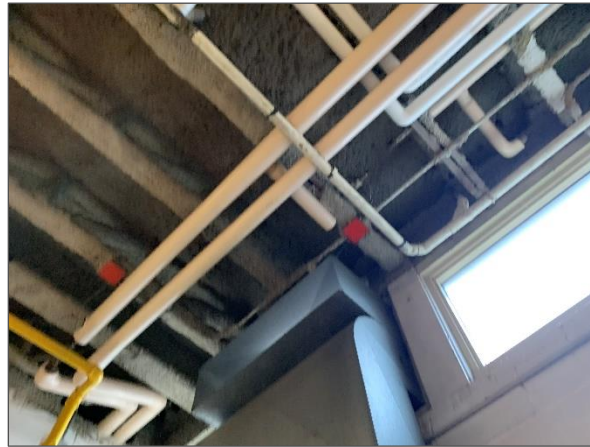
Spray-applied fireproofing and overspray present on the structure in Locations 1590, 1591, 1770 and 2350 does not contain asbestos (previous Pinchin samples 01A-C and 30A-C).

Non-asbestos sprayed fireproofing.

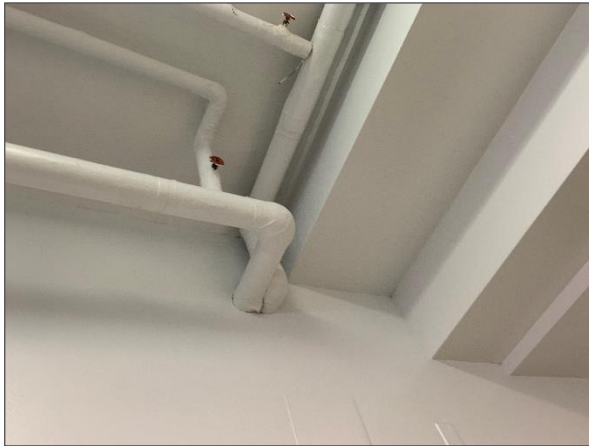
Asbestos-containing parging cement insulation present on pipe elbows.

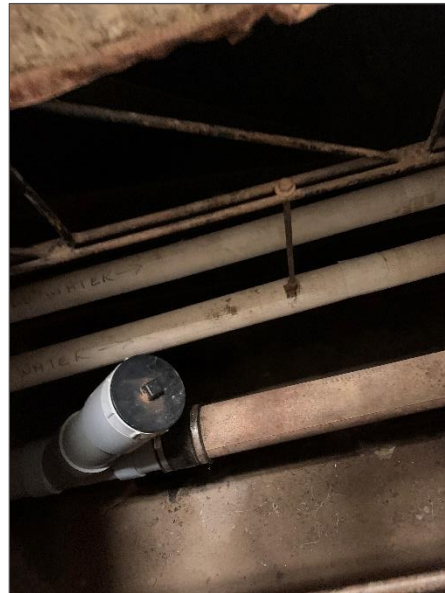
Asbestos-containing Aircell pipe insulation.

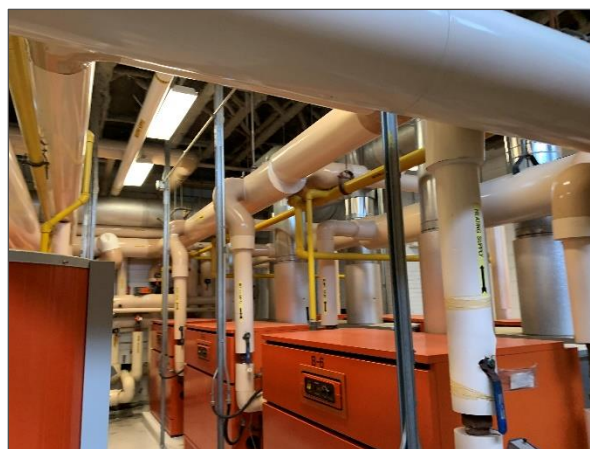
Mechanical equipment (e.g., air handling units, suspended unit heaters, hot water tanks, boilers) is either uninsulated or insulated with non-asbestos fibreglass.

Non-asbestos insulated boilers.
