**FINAL**  
**Hazardous Building**  
**Materials Assessment**  
**(Management)**

Thousand Islands Secondary  
School  
2510 Parkedale Avenue,  
Brockville, Ontario

**Upper Canada District School  
Board**

September 15, 2023

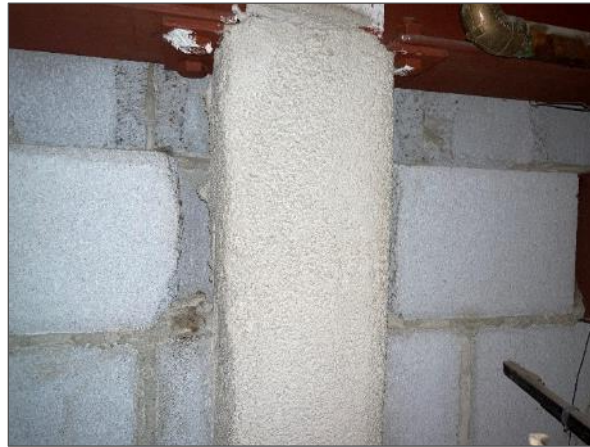
Spray-applied fireproofing and overspray present on a steel column in the second floor corridor of Building Phase E (Location 2979) does not contain asbestos (samples S0073A-C).

Non-asbestos sprayed fireproofing present on the steel column.

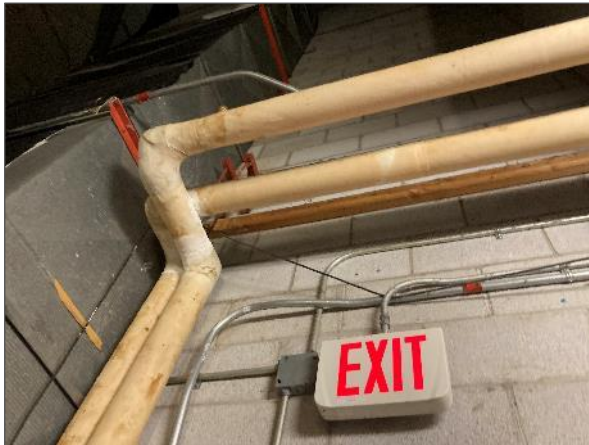
Asbestos-containing paring cement insulation on pipe elbows.

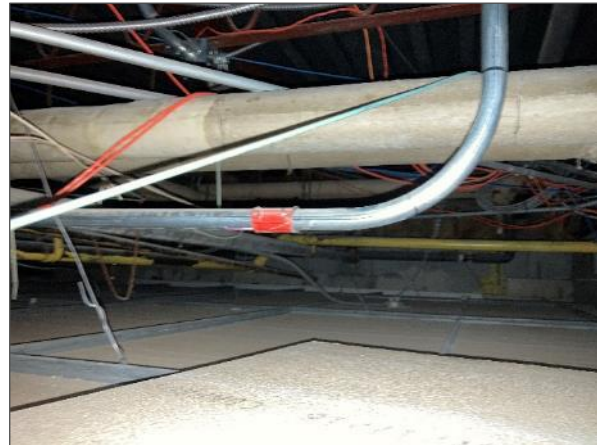
Asbestos-containing Caposite insulation.

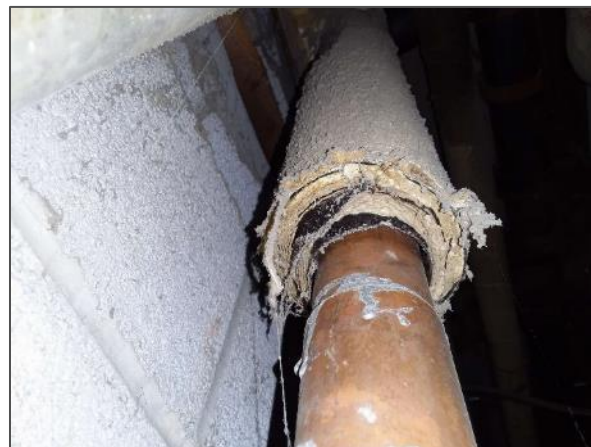
Non-asbestos sweatwrap insulation.

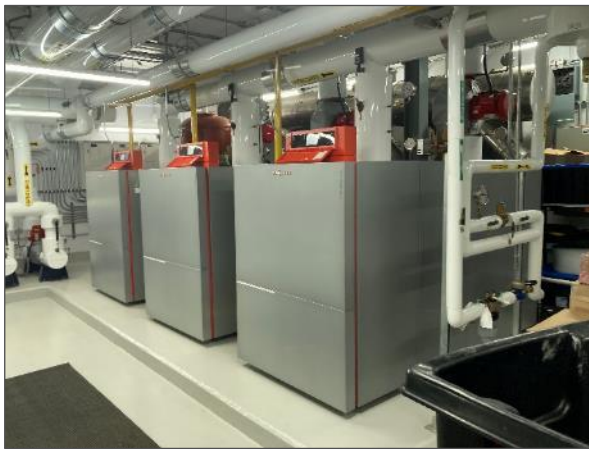
Non-asbestos insulated boilers.

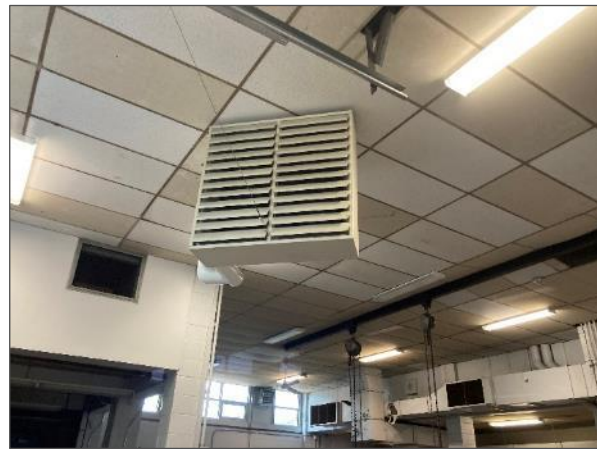
Non-asbestos fibreglass insulated suspended unit heater.

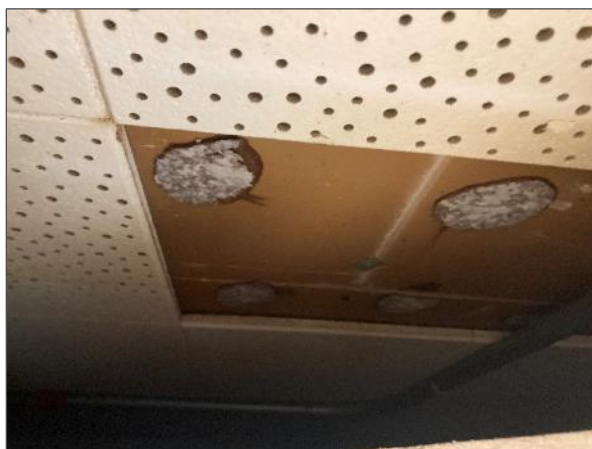
Adhesive associated with 1'x1' acoustic ceiling tiles throughout the building does not contain asbestos (previous Pinchin samples 0010A-C).

Non-asbestos acoustic ceiling tile mastic.

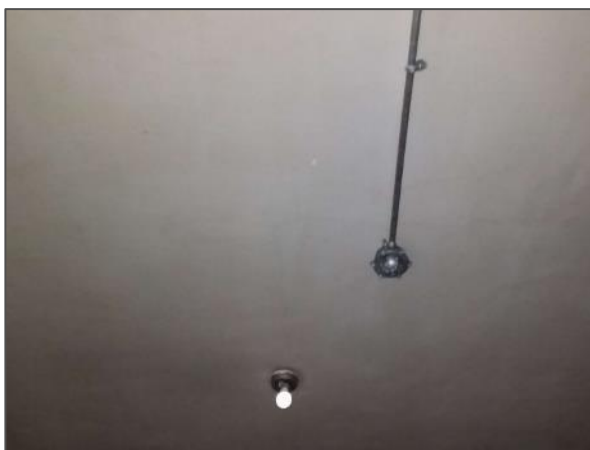
Asbestos-containing plaster base coat in Building Phase D.

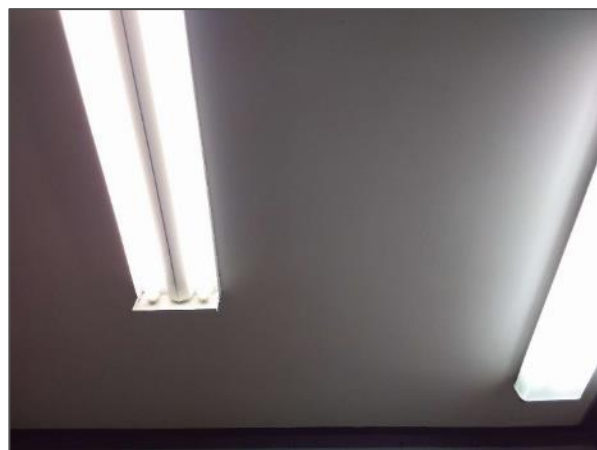
Smooth plaster, containing asbestos in the finish layer, is present on walls and ceilings throughout Building Phase E (previous Pinchin samples 0001D and G and samples S0062A-G). A total of nine samples of plaster were collected and it was found that one sample contains asbestos. The asbestos-positive result indicates that at a minimum, a portion of the plaster application contains asbestos, and all smooth plaster present throughout the 1967 addition is presumed to contain asbestos. Further sampling may be considered to delineate asbestos-containing plaster from newer, non-asbestos plaster. The plaster is applied to metal lath.

Asbestos-containing smooth plaster in Building Phase E.

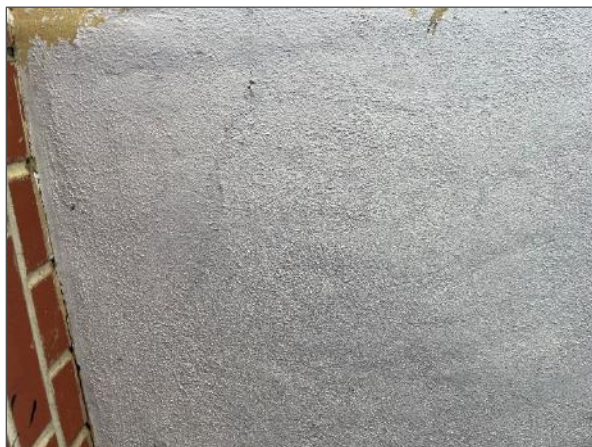
Textured plaster, containing asbestos, is present on the exterior canopies of Building Phase D (samples S0081A-C). The plaster is applied to metal lath.

Asbestos-containing textured plaster on exterior canopy of Building Phase D.

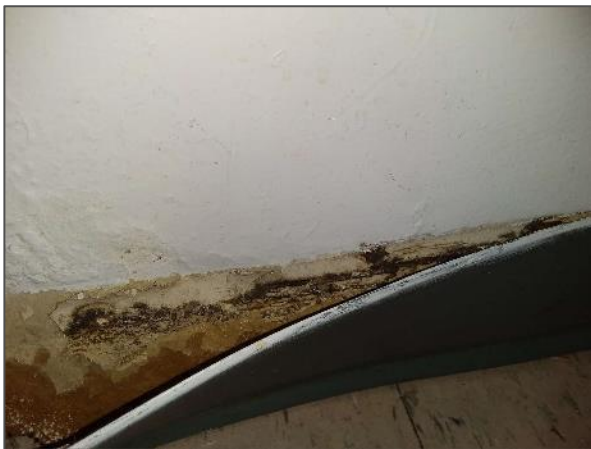
Visible mould growth and water staining is present on the drywall wall in the Washroom (Location 1012).

Mould growth and water staining present on the drywall wall in the Washroom (Location 1012).

Conduct an intrusive mould investigation to determine the extent of mould growth. The investigation should identify the source of the water intrusion that contributed to the mould growth and water damage observed during this assessment.

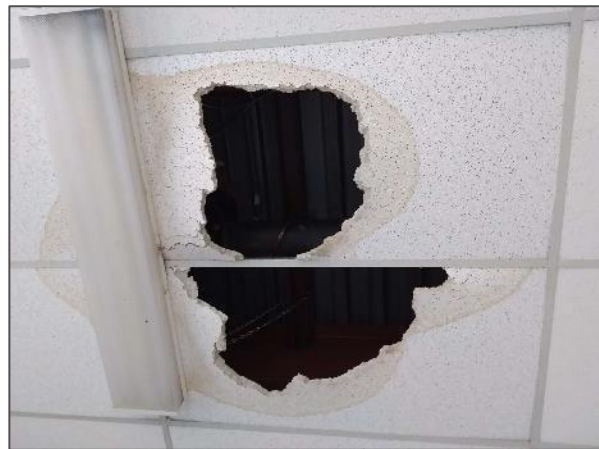
Visible water staining is present on acoustic ceiling tiles in the Classroom (Location 2160).

Water staining present on acoustic ceiling tiles in the Classroom (Location 2160).

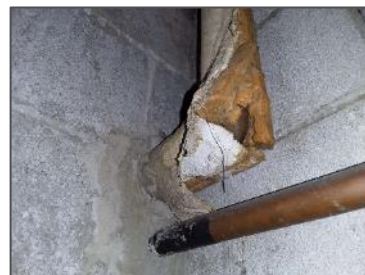
Material, Quantity & Condition	Location	Recommended Procedure	Photo
Parging cement insulation, 5 elbows, poor condition	Location 1022	Remove or repair in accordance with O.Reg.278/05 Type 2 or Glove Bag asbestos abatement procedures

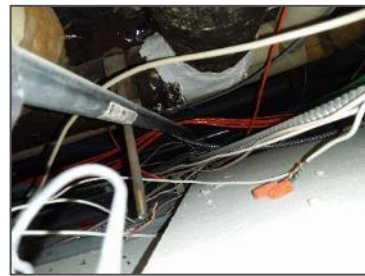
Parging cement insulation, 1 elbow, poor condition	Location 1091

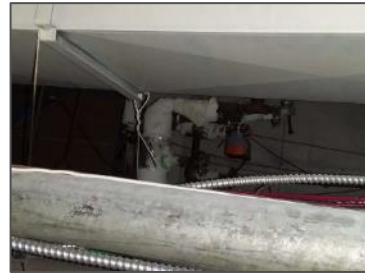
Parging cement insulation, 2 square feet, debris			
Parging cement insulation, 1 elbow, poor condition	Location 1097

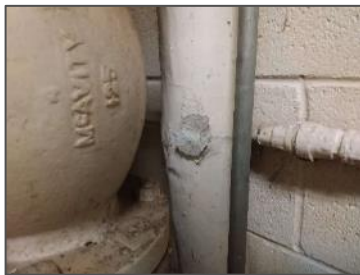
Material, Quantity & Condition	Location	Recommended Procedure	Photo
Parging cement insulation, 1 joint, poor condition	Location 1115

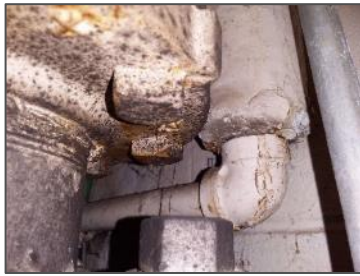
Parging cement insulation, 1 end, poor condition

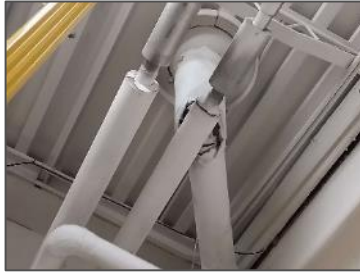
Parging cement insulation, 1 elbow, poor condition	Location 1885

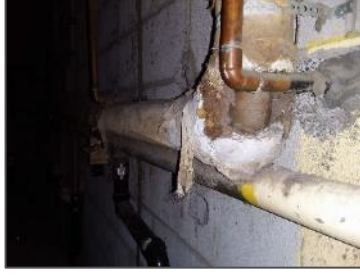
Parging cement insulation, 3 elbows, poor condition	Location 1978

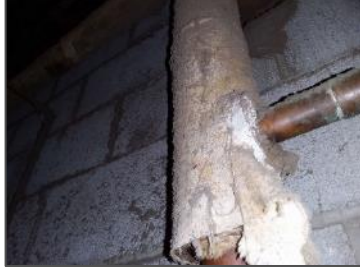
Parging cement insulation, 1 tee, poor condition

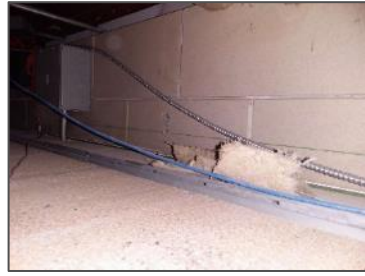
Material, Quantity & Condition	Location	Recommended Procedure	Photo
Caposite insulation, 2 linear feet, poor condition	Location 1983		 
Caposite insulation, 2 square feet, debris

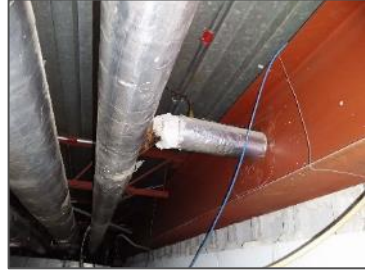
Parging cement insulation, 2 elbows, poor condition

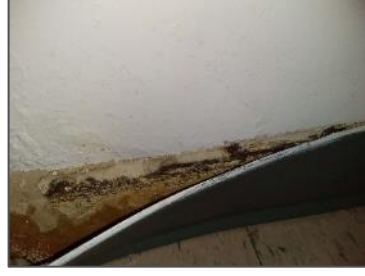
Drywall wall, 6 square feet, mould growth	Location 1012	Remove following EACC Level 2 Mould Abatement Procedures
