## **FINAL** **Hazardous Building** **Materials Assessment**

Lombardy Public School  
596 Highway 15, Lombardy,  
Ontario

**Upper Canada District School  
Board**

April 11, 2023

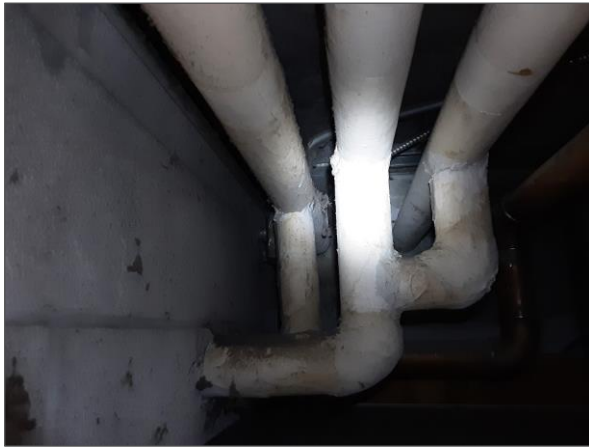
Asbestos-containing parging cement insulation on pipe elbows and tees.

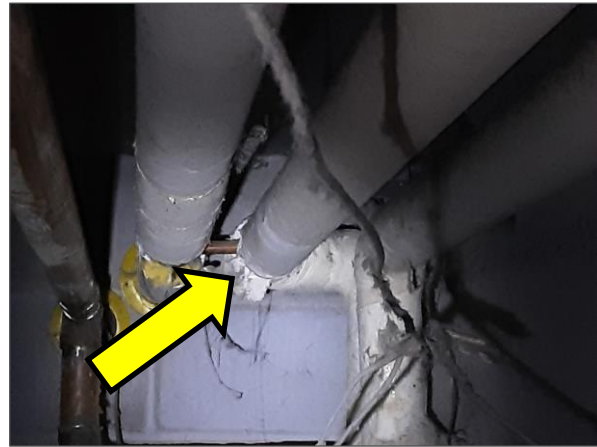
- Parging cement pipe insulation.
- Vinyl sheet flooring.
- Butyl sealant.
- Paint on concrete block.
- Paint on concrete deck.
- All asbestos-containing materials were observed to be in good condition, with the exception of the following:
  - Parging cement insulation in poor condition on one pipe elbow in the Kitchen (Loc.20).

Asbestos-containing parging cement insulation on a pipe elbow in poor condition in location 20.

Material, Quantity & Condition	Location	Recommended Procedure	Photo
Parging cement insulation, 1 pipe elbow, poor condition	Kitchen (Loc.20)	Remove/repair in accordance with O. Reg. 278/05 Type 2 or Type 2 Glove Bag Asbestos Abatement Procedures

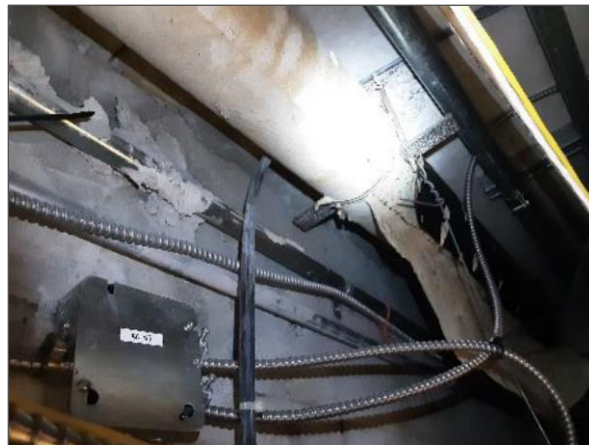
Non-asbestos Sweatwrap insulation.

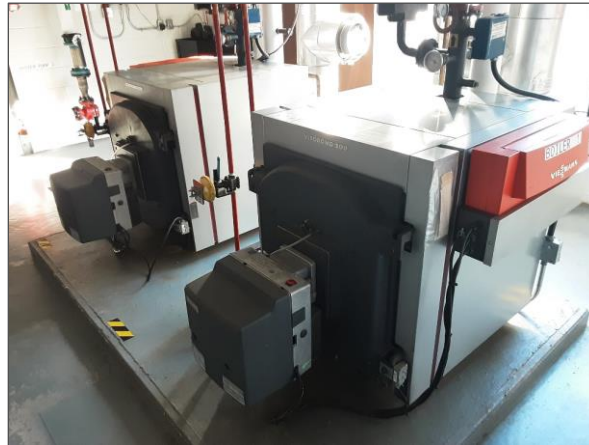
Boilers insulated with non-asbestos fibreglass.

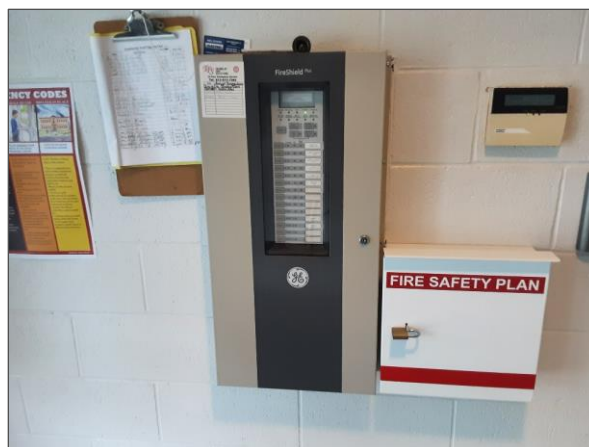
Lead-containing batteries in fire alarm control panel.

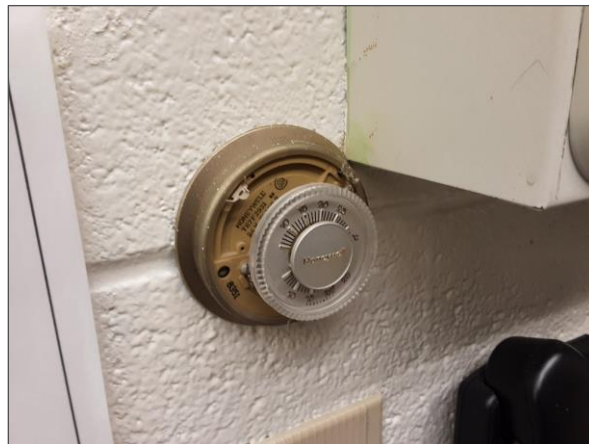
Thermostat containing liquid mercury ampules.

Do not break lamps or separate liquid mercury from components. Recycle and reclaim mercury from fluorescent lamps and thermostats when taken out of service. Mercury is classified as a hazardous waste and must be disposed of in accordance with applicable regulations.
