FINAL **Hazardous Building** **Materials Assessment**

Cambridge Public School
2123 Route 500 West, Embrun,
Ontario

March 28, 2023

Pinchin File: 302783.062

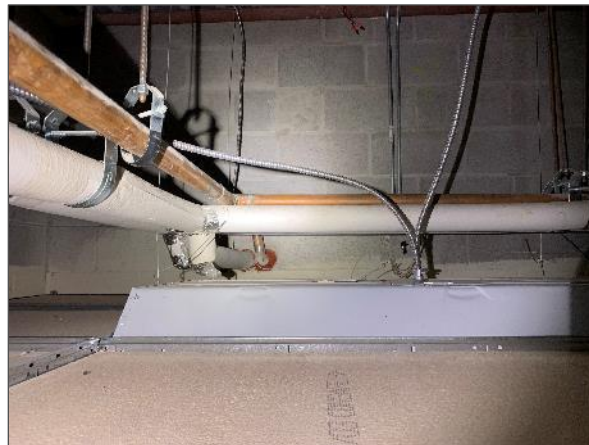
Pipes are either uninsulated or insulated with non-asbestos fibreglass.

Pipes insulated with non-asbestos fibreglass.

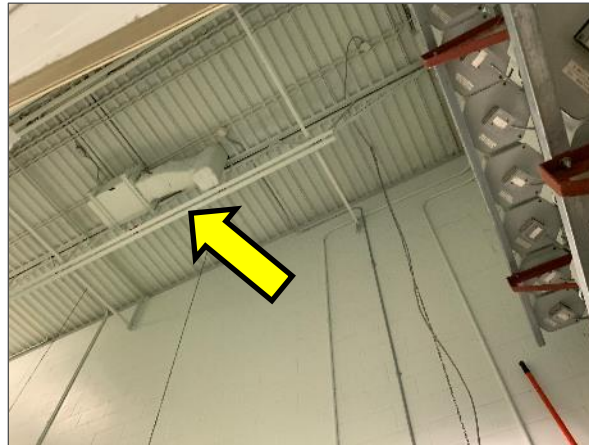
Ducts are either uninsulated or insulated with non-asbestos fibreglass.

Duct insulated with non-asbestos fibreglass.

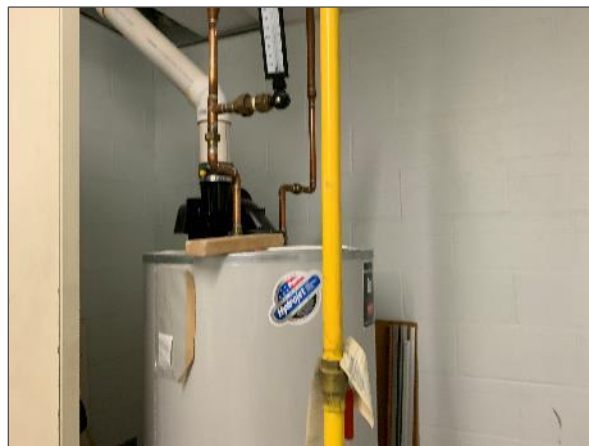
Mechanical equipment (hot water tank) is insulated with non-asbestos fibreglass.

Hot water heating tank insulated with non-asbestos fibreglass.

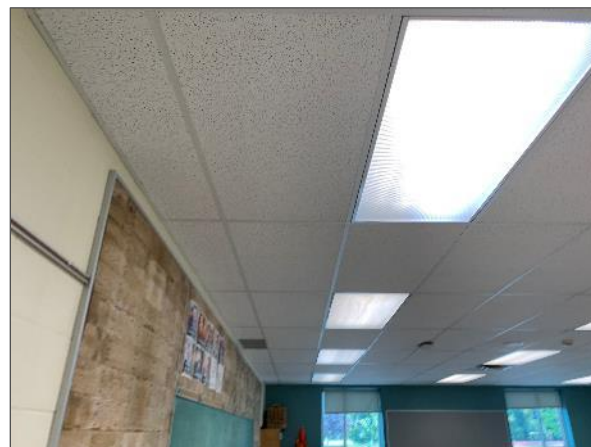
All ceiling tiles are presumed to be non-asbestos based on the age of the materials determined from the age of the building construction (on or after 1990). The tiles were manufactured after asbestos stopped being used in acoustic ceiling tiles.

Non-asbestos lay-in acoustic ceiling tiles.

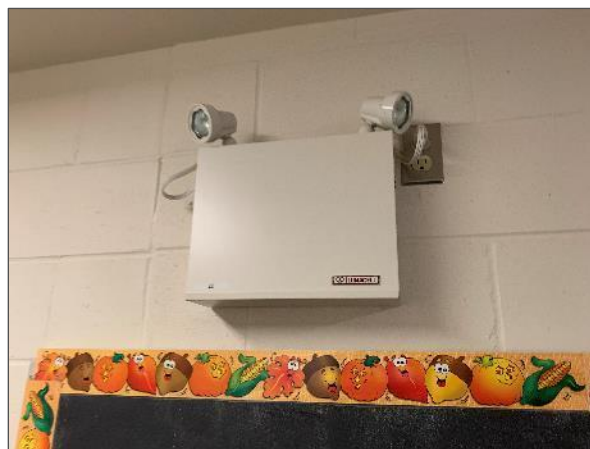
Lead-containing batteries are present in emergency lighting.

Lead-containing batteries in emergency lighting.

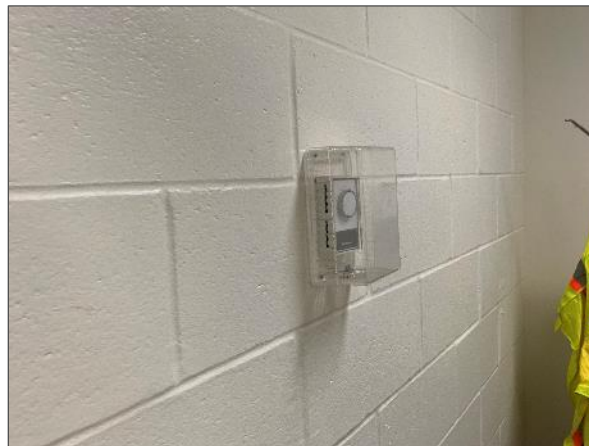
Mercury is present as a liquid in thermostats ampules.

Thermostat containing liquid mercury ampules.

Do not break lamps or separate liquid mercury from components. Recycle and reclaim mercury from fluorescent lamps and thermostats when taken out of service. Mercury is classified as a hazardous waste and must be disposed of in accordance with applicable regulations.
