**Re: Hazardous Building Materials Assessment (Pre-Construction)**

Garage Building, 240 County Road 4, Millhaven, Ontario  
Pinchin File: 337875.001

## Hazardous Building Materials Assessment (Pre-Construction)

Garage Building, 240 County Road 4, Millhaven, Ontario  
Loyalist Township

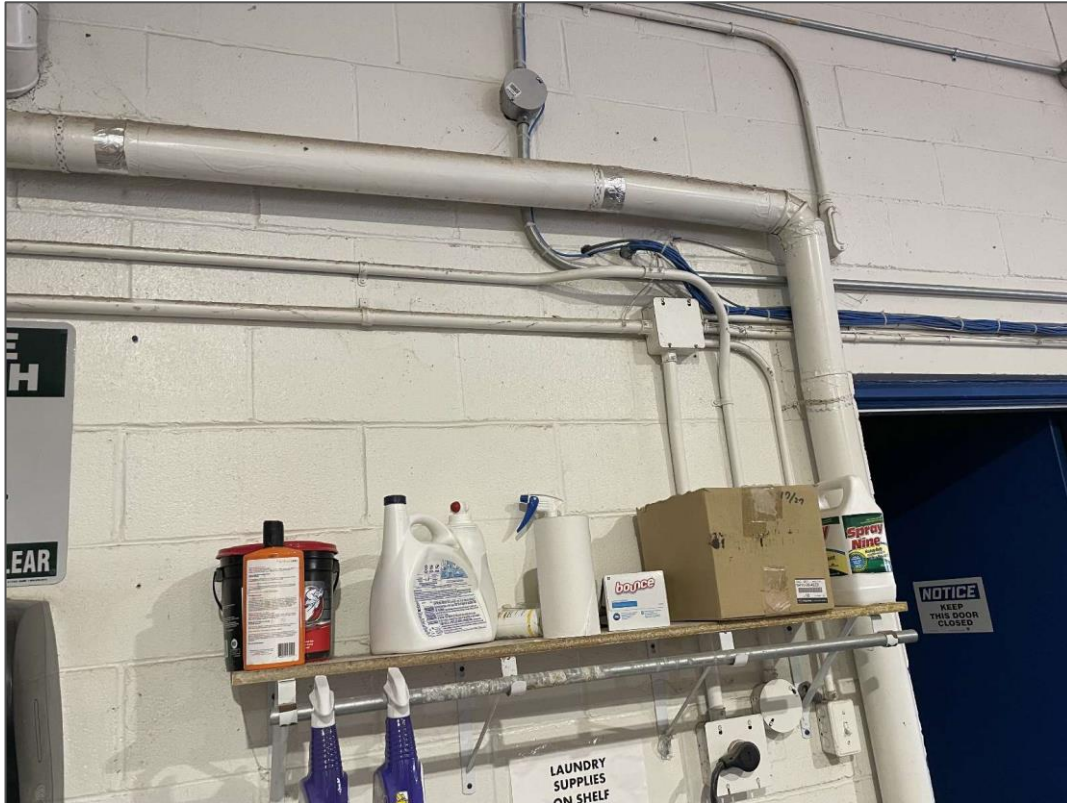
| Sample Number | Material Description | Concentration | Confirmed Hazard | Total Quantity Present | Notes |
|---|---|---|---|---|---|
| L0002 | Wall Concrete (precast) White/blue/green | 0.0878% | Yes | 2,680 SF | Note 2 |

S0001A and L0002 – Non-asbestos white paint on concrete block containing low levels of lead.

For paints identified as having low levels of lead (i.e., equal to or above 0.009% (90 mg/kg) but less than or equal to the EACC guideline of 0.1% (1,000 mg/kg) for lead-containing paints) special precautions are not recommended unless aggressive disturbance (grinding, blasting, torching) is planned. Exposure from

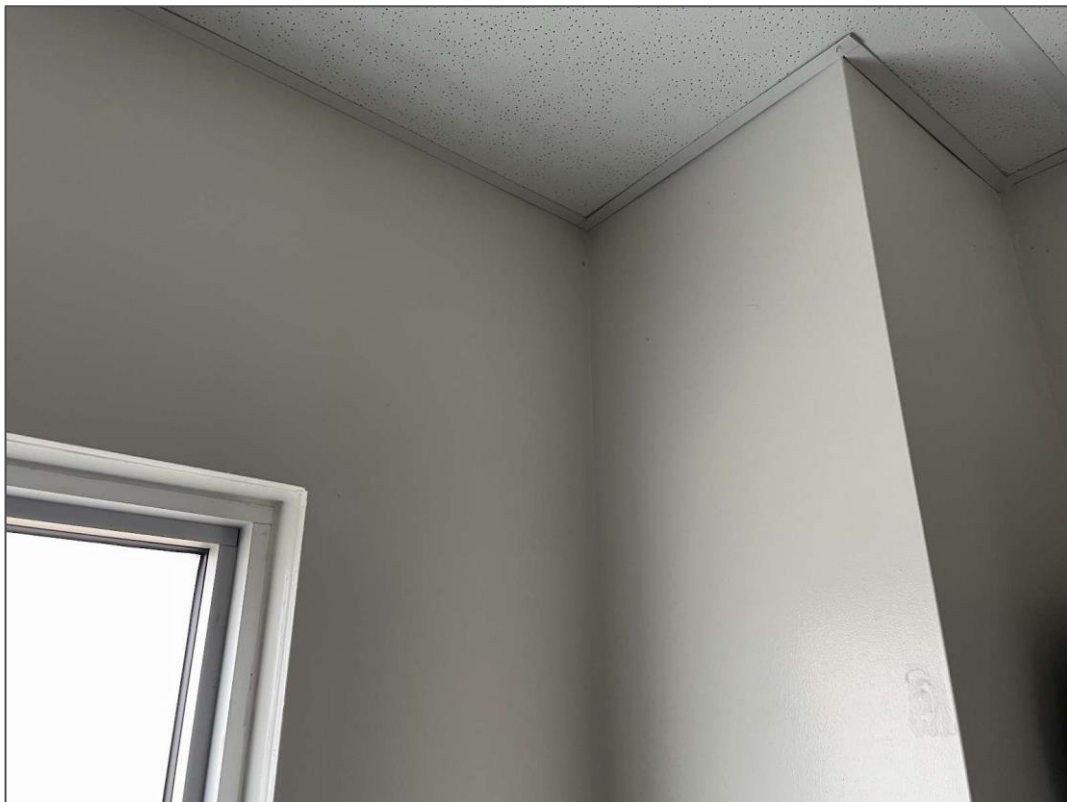
| Sample Number | Material Description | Type of Asbestos | Confirmed Hazard | Total Quantity Present | Notes |
|---|---|---|---|---|---|
| S0002<br>ABC | Wall, Ceiling Drywall joint compound | None Detected | No | 410 SF | |

| Sample Number | Material Description | Concentration | Confirmed Hazard | Total Quantity Present | Notes |
|---|---|---|---|---|---|
| L0004 | Wall Drywall and joint compound Off-white | 0.0008% | No | 410 SF | Note 3 |

S0002A and L0004 – Non-lead containing off-white paint on drywall wall with non-asbestos joint compound.

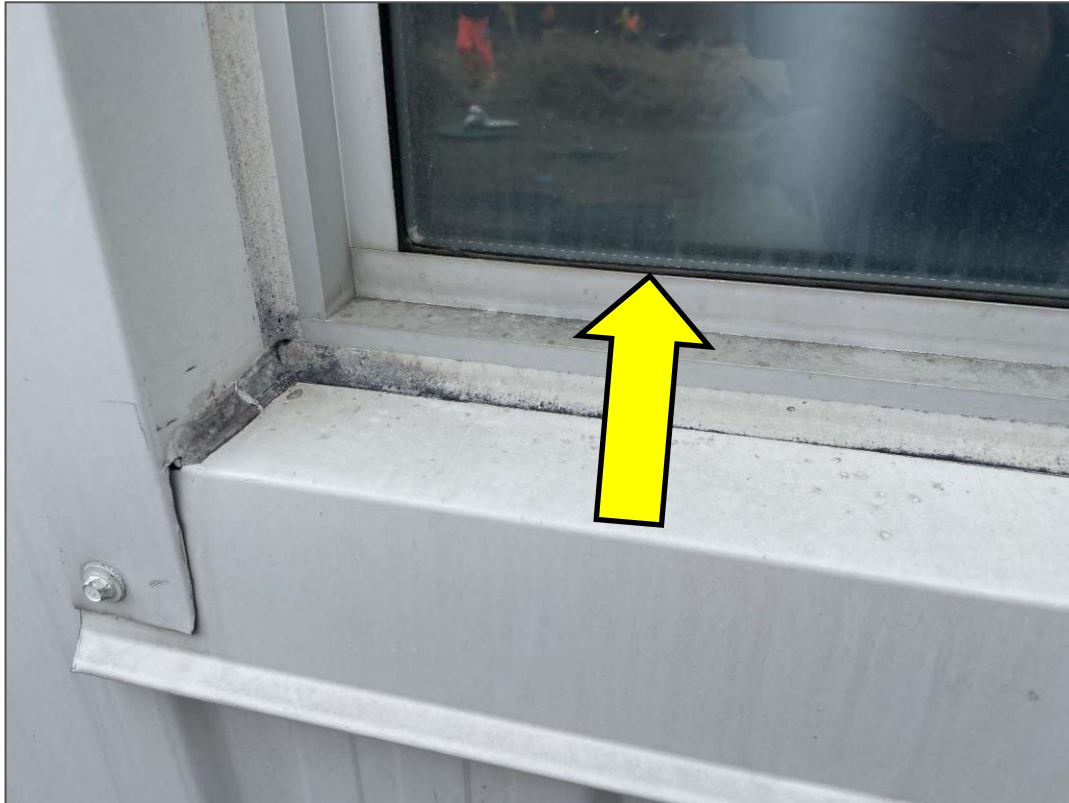
| Sample Number | Material Description | Type of Asbestos | Confirmed Hazard | Total Quantity Present | Notes |
|---|---|---|---|---|---|
| S0003<br>ABC | Window Liner Caulking Black Butyl Sealant | None Detected | No | 200 LF | |

S0003A – Non-asbestos black butyl sealant on window liner.

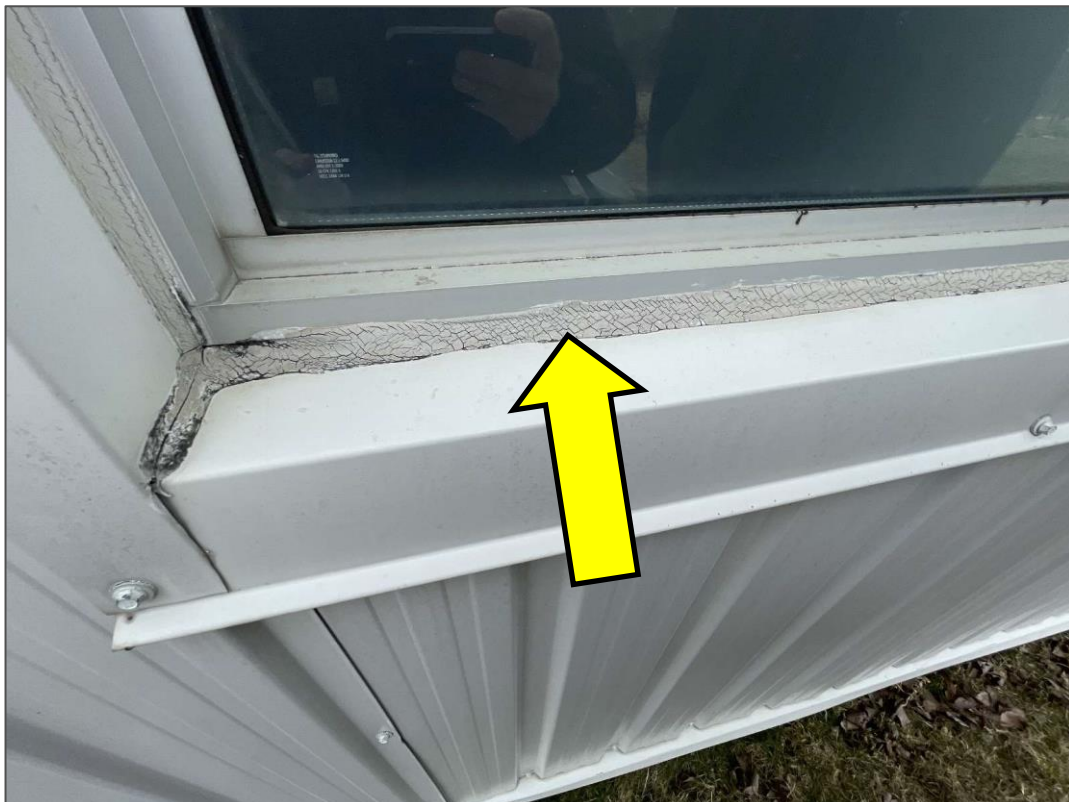
| Sample Number | Material Description | Type of Asbestos | Confirmed Hazard | Total Quantity Present | Notes |
|---|---|---|---|---|---|
| S0004<br>ABC | Window Caulking Grey | None Detected | No | 200 LF | |

S0004A – Non-asbestos grey caulking on window.

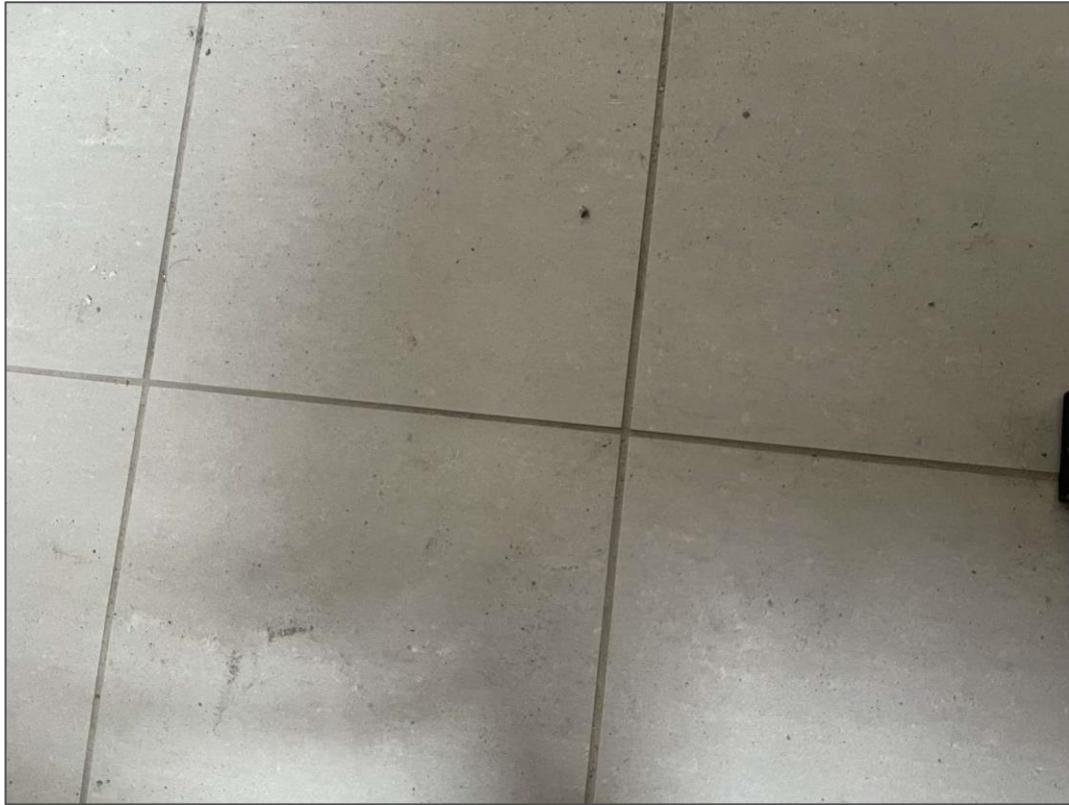
| Sample Number | Material Description | Type of Asbestos | Confirmed Hazard | Total Quantity Present | Notes |
|---|---|---|---|---|---|
| V9500 | Floor, Wall Mortar Thinset Under Ceramic Tiles | Presumed Asbestos | Yes | 425 SF | Note 1 |

1. Materials identified as Sample Number V9500 were either observed to be present or based on the construction of the building/equipment are likely present in concealed locations. These materials have not been sampled and are presumed to contain asbestos

based on historical known use of asbestos. Sampling of these materials may be completed prior to disturbance.

V9500 – Presumed asbestos-containing thinset under ceramic tiles on floor.

- Sample presumed thinset under ceramic tiles prior to disturbance if impacted by the planned renovations.
- Any items listed as exclusions in this report, prior to disturbance.

Remove asbestos-containing materials (ACM) prior to renovation, alteration, or maintenance if ACM may be disturbed by the work.

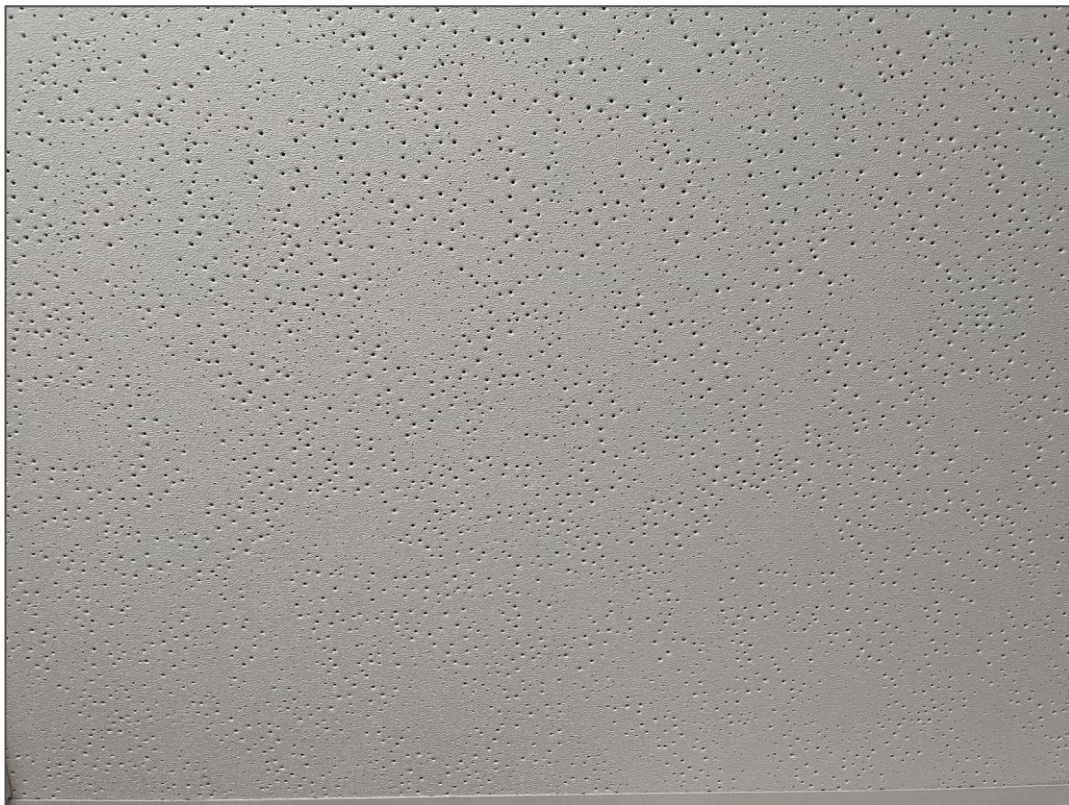
| Sample Number | Material Description | Type of Asbestos | Confirmed Hazard | Total Quantity Present | Notes |
|---|---|---|---|---|---|
| V0000 | Ceiling Ceiling Tiles (lay-in) 2'x4', Pinholes, Date Stamp: 2013 | None | No | 295 SF | Note 2 |

2. Materials identified as Sample Number V0000 were determined to be non-asbestos based on the manufacture date and known end of use of asbestos in these products.
3. Destructive testing was conducted of a representative selection of concrete block walls, including creating penetrations at three locations. The location of destructive testing has been indicated on the drawing in Appendix I. Loose fill vermiculite was not observed within the cavities.

V0000 – Non-asbestos lay-in ceiling tiles with pinholes, date stamp: 2013.

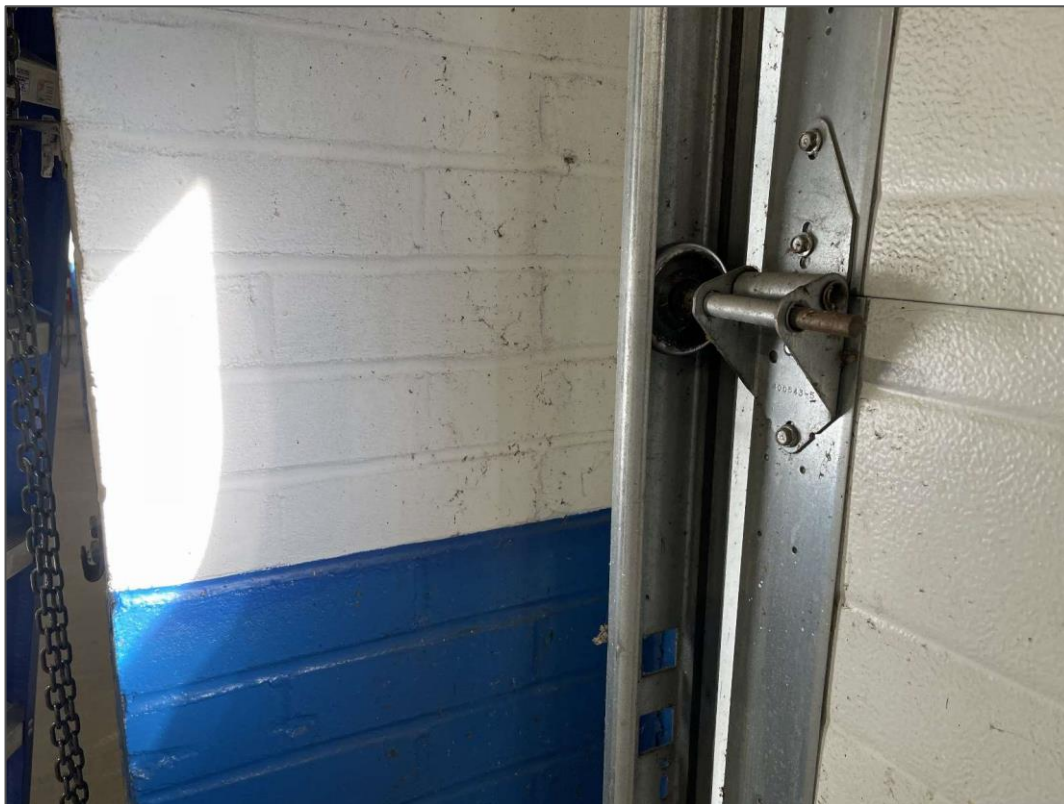
| Sample Number | Material Description | Concentration | Confirmed Hazard | Total Quantity Present | Notes |
|---|---|---|---|---|---|
| L0001 | Wall Masonry White/blue | 0.0124% | Yes | 200 SF | Note 2 |

L0001 – White/blue paint on masonry wall containing low levels of lead.

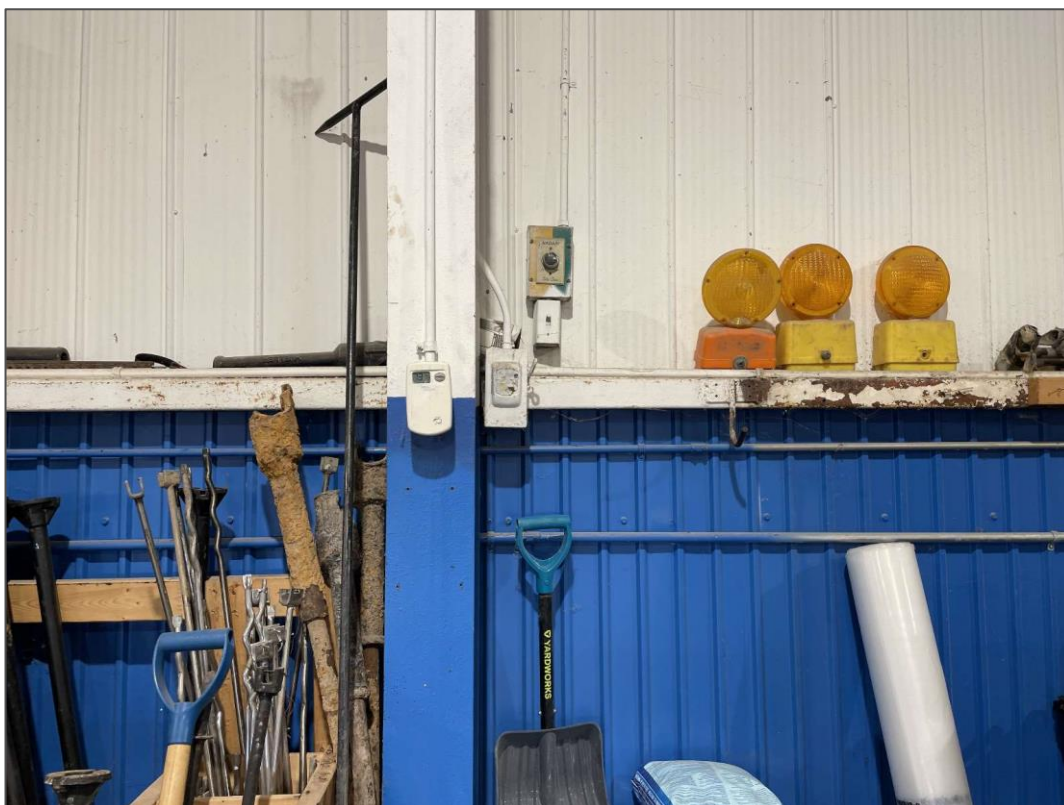
| Sample Number | Material Description | Concentration | Confirmed Hazard | Total Quantity Present | Notes |
|---|---|---|---|---|---|
| L0003 | Structure Metal White/blue | 0.0836% | Yes | 4,000 SF | Note 2 |

L0003 – White/blue paint on metal structure containing low levels of lead.

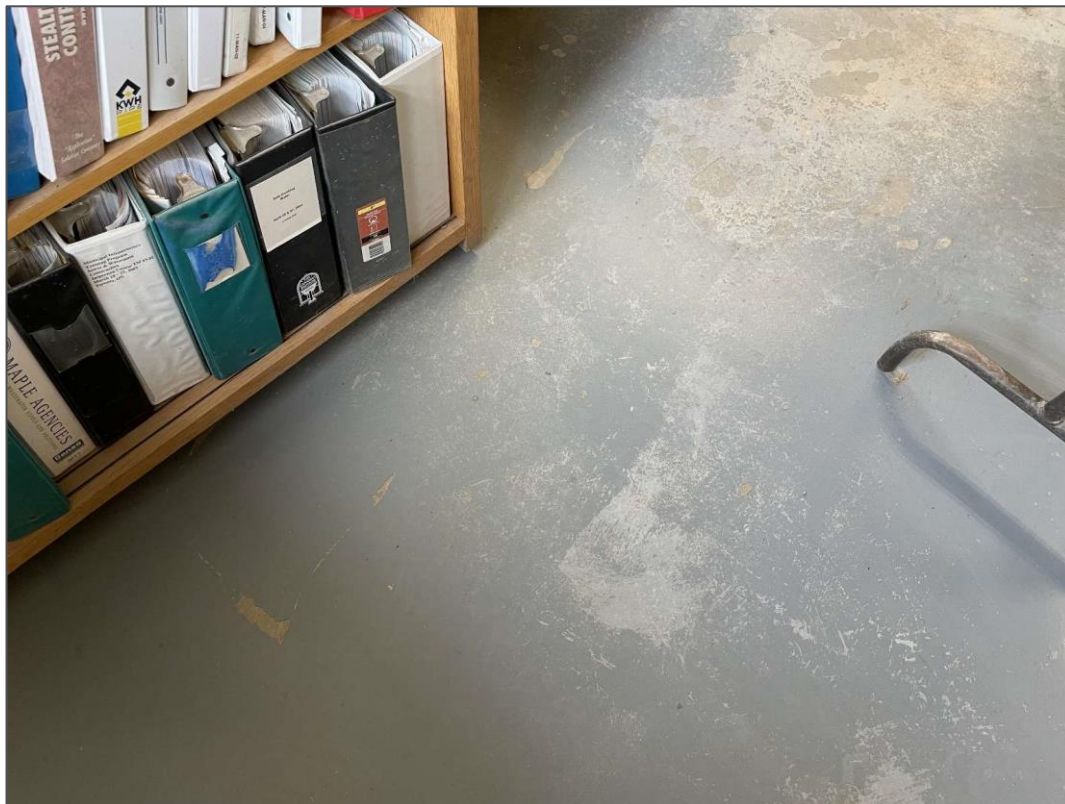
L0005 – Grey paint on concrete floor containing high levels of lead.

For lead-containing or lead-based paints (i.e., greater than the EACC guideline of 0.1% (1,000 mg/kg) for lead-containing paints, and 0.5% (5,000 mg/kg) for lead-based), construction disturbance may result in over-exposure to lead dust or fumes. The need for work procedures, engineering controls and personal protective equipment should be assessed on a site-specific basis to comply with Ministry of Labour, Training and Skills Development regulations and guidelines.

Items painted with paints containing elevated levels of lead may be a hazardous waste. Test lead-painted materials for leachable lead and other metals prior to disposal. Metallic components coated with lead paint do not require leachate testing and can be disposed of as non-hazardous construction and demolition (C&D) waste.
