June 22, 2026

**Re: Hazardous Building Materials Assessment (Pre-construction)**  
Dishwasher Room Renovation  
Kingston General Hospital, Kidd-Davies Wing, 76 Stuart Street, Kingston, ON  
Pinchin File: 287280.118

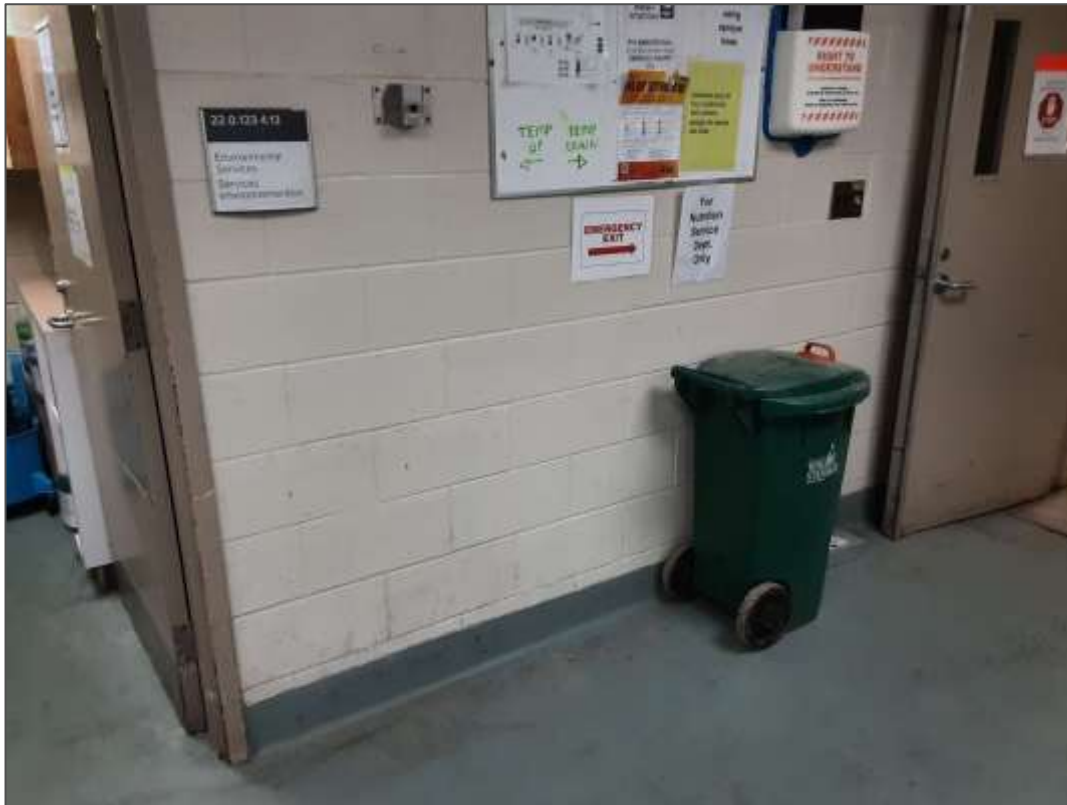
S0001H (None), On concrete block, Wall, Paint, Warewashing (Location #: 127)

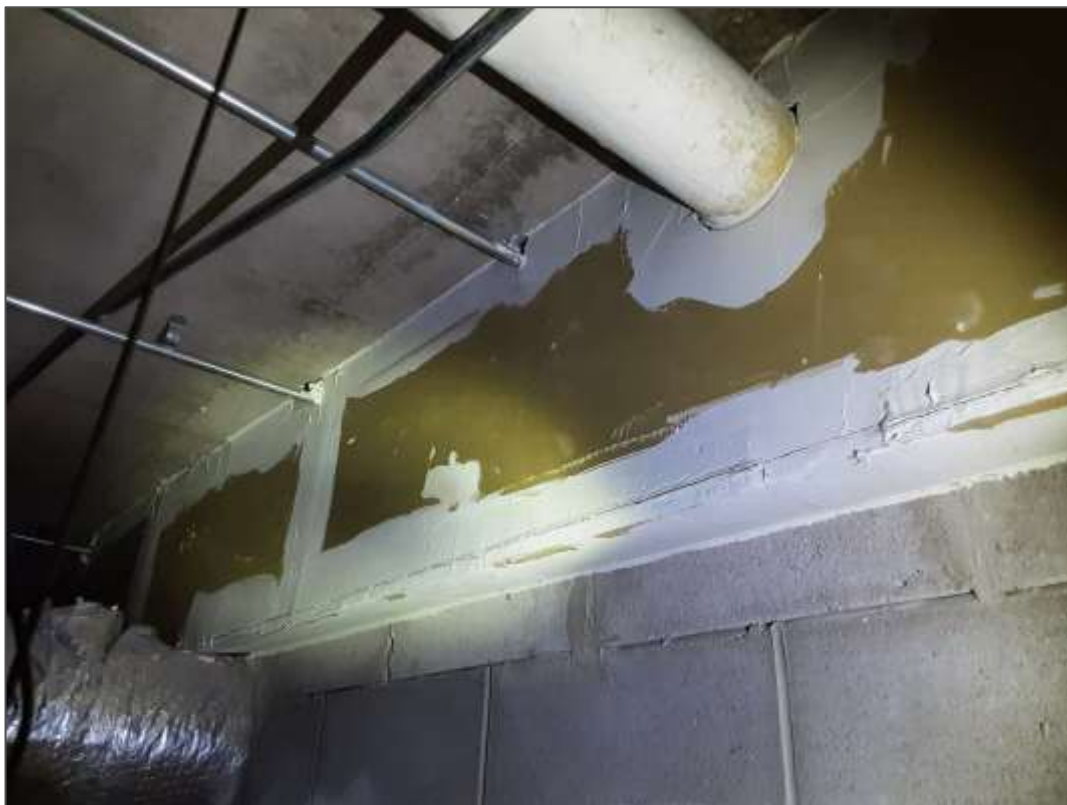
S2015D (None), Wall, Bulkhead, Drywall and joint compound, Warewashing (Location #: 127)

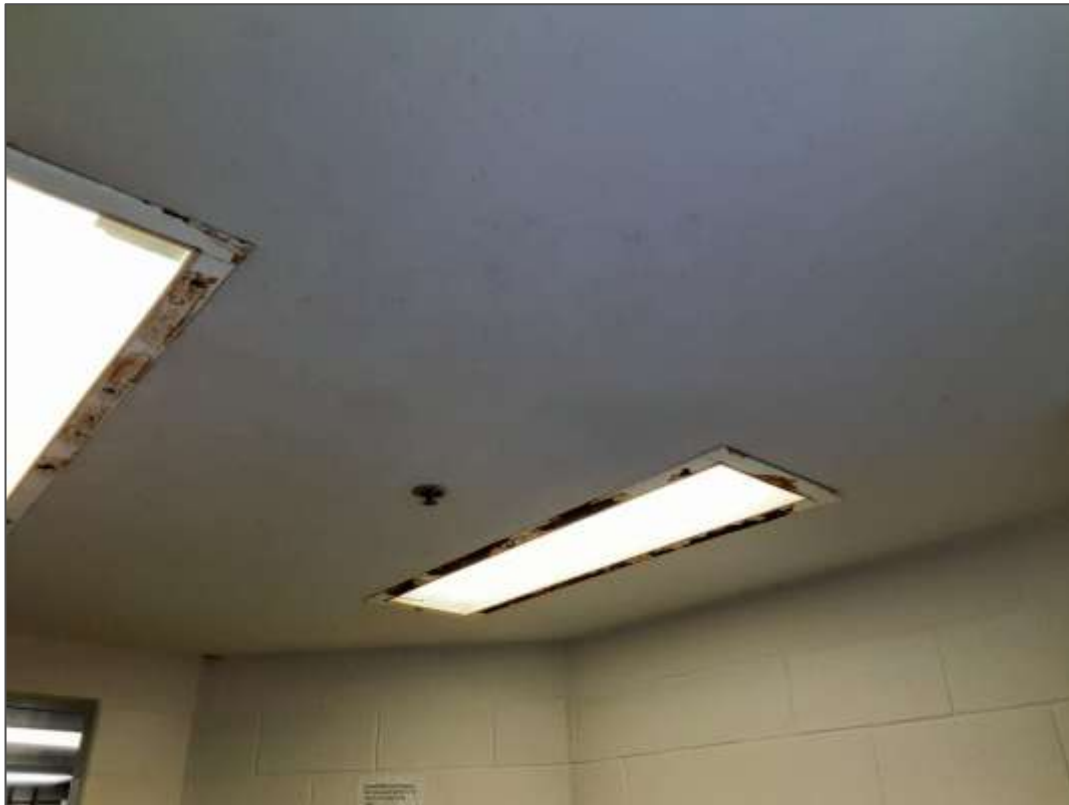
S2026C (None), Textured plaster in cart wash room, Ceiling, Plaster, Warewashing (Location #: 127)

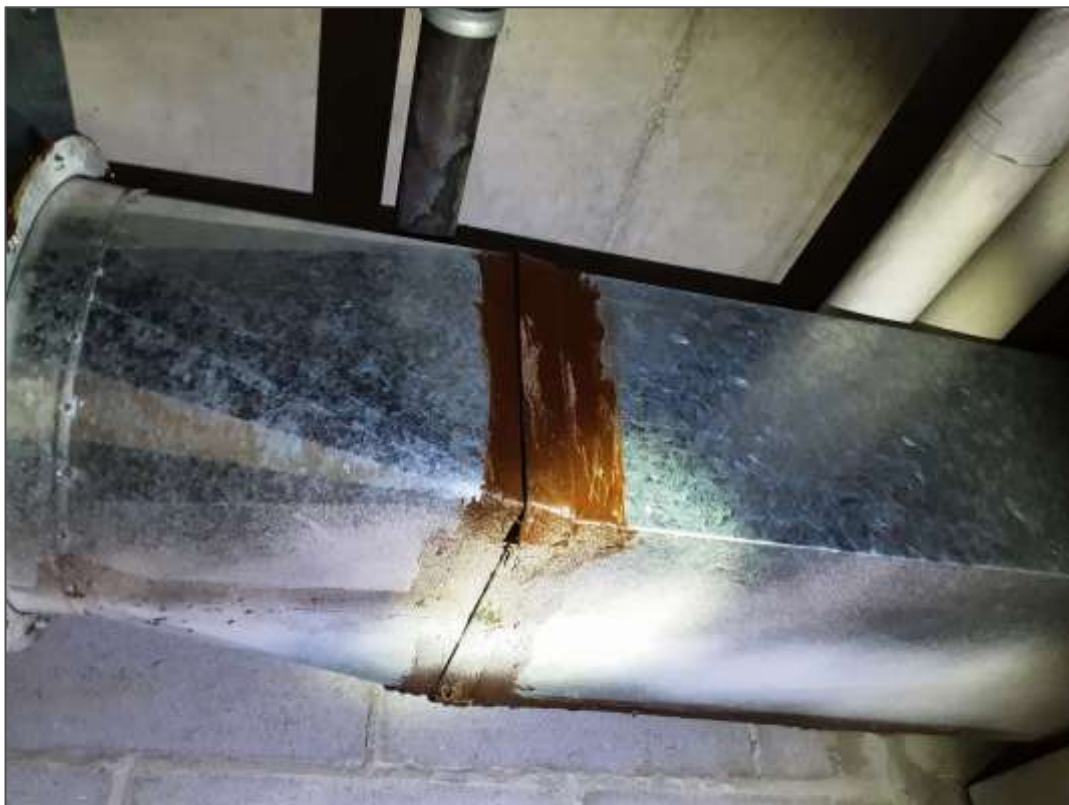
S2027C (None), Brown duct mastic, Duct, Mastic, Warewashing (Location #: 127)

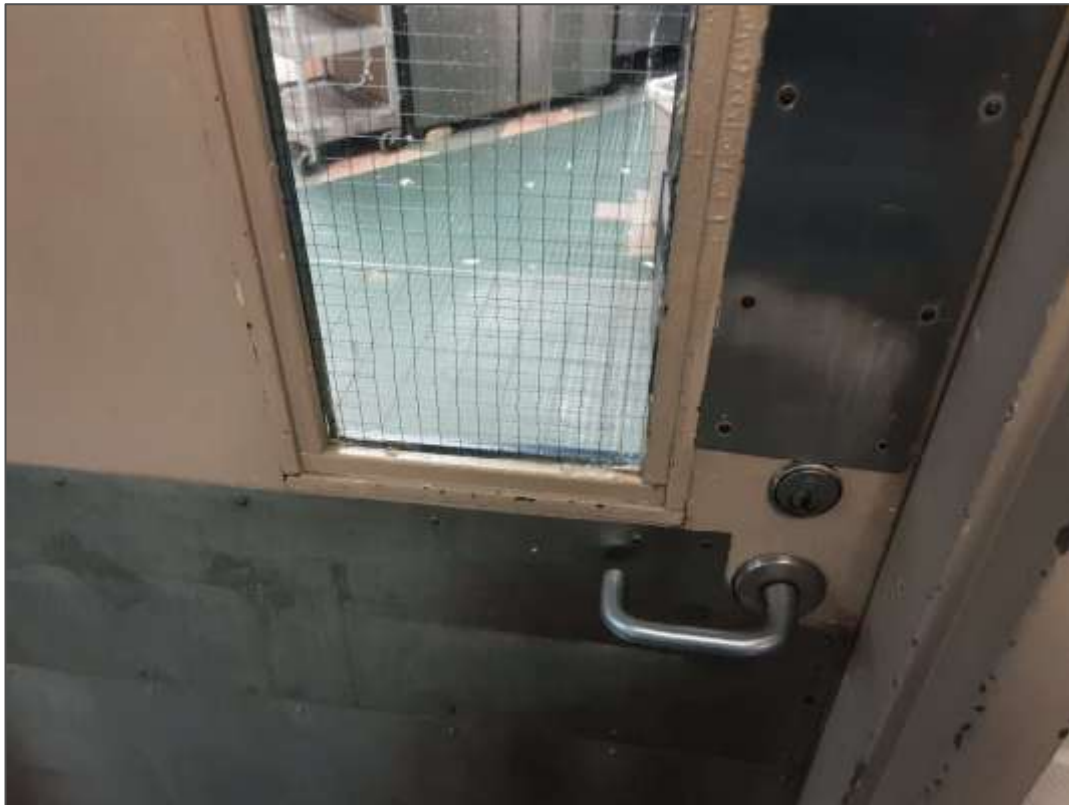
V9500 (Presumed Asbestos), Butyl sealant on windows and doors, not anticipated to be impacted by renovations, Wall, Window Liner, Sealant, Warewashing (Location #: 127)

Remove asbestos-containing materials (ACM) prior to renovation, alteration, or maintenance if ACM may be disturbed by the work.

If the identified ACM will not be removed prior to commencement of the work, any potential disturbance of ACM must follow asbestos precautions appropriate for the type of work being performed.

Asbestos-containing materials must be disposed of at a landfill approved to accept asbestos waste.

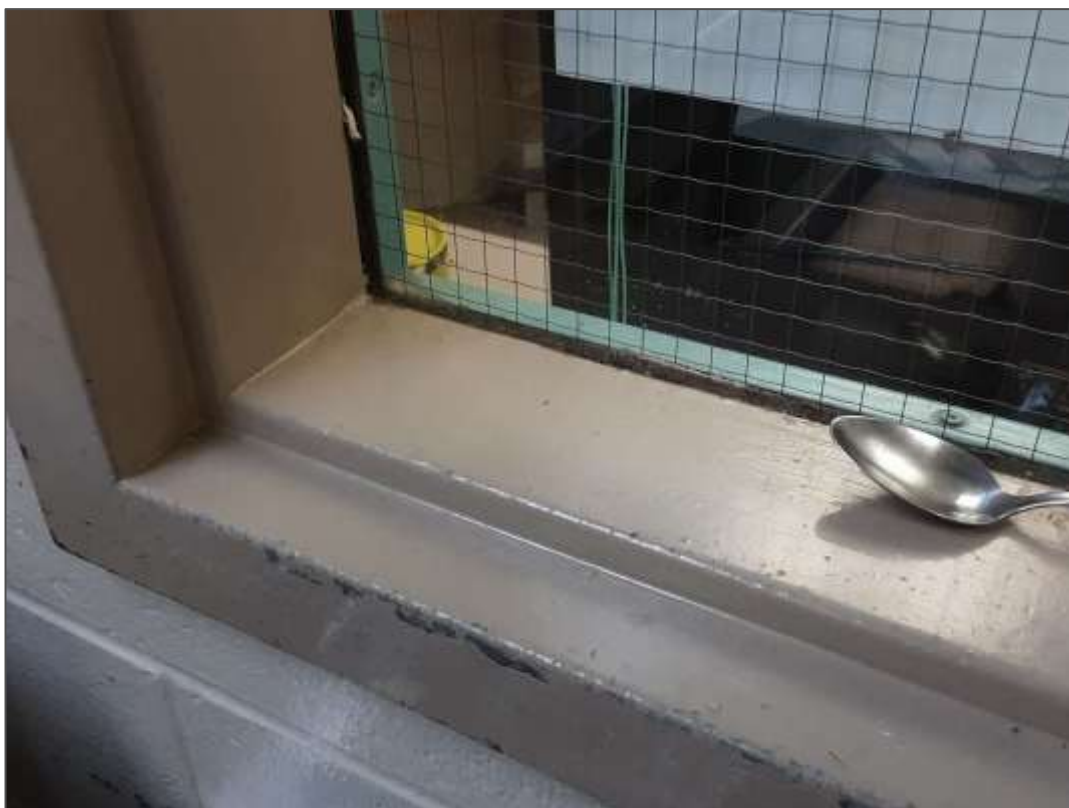
V9500 (Presumed Asbestos), Butyl sealant on windows and doors, not anticipated to be impacted by renovations, Wall, Window Liner, Sealant, Warewashing (Location #: 127)

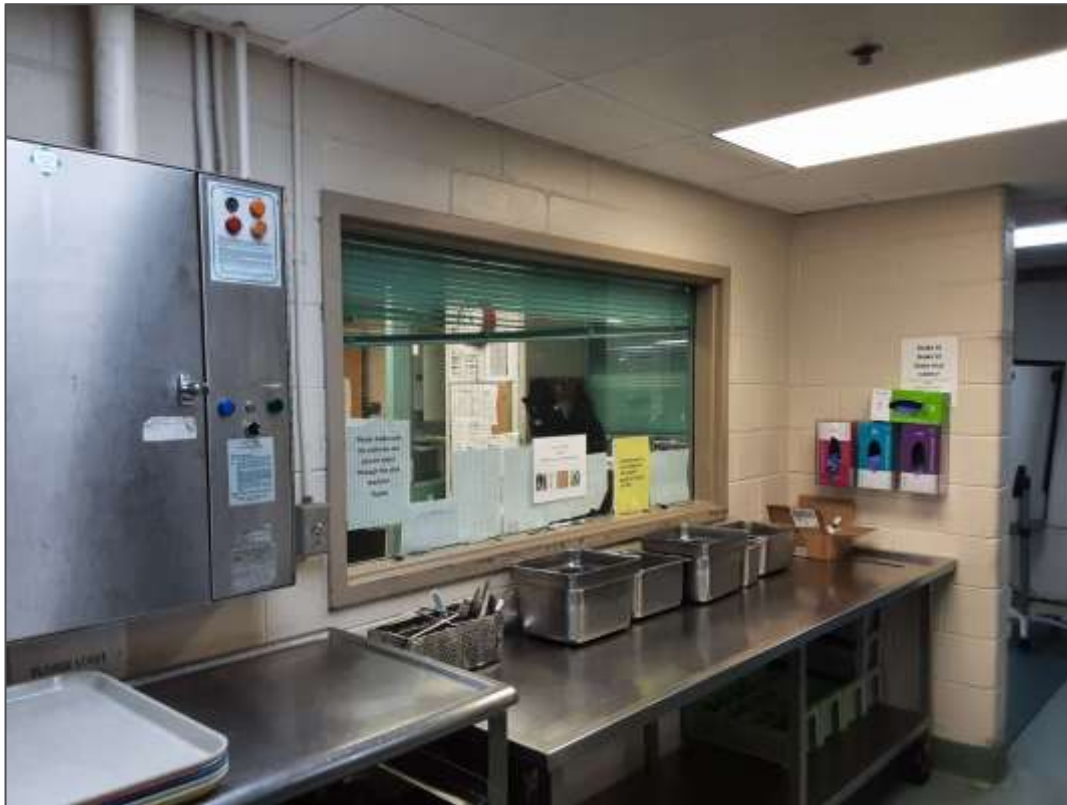
V9500 (Presumed Asbestos), Butyl sealant on windows and doors, not anticipated to be impacted by renovations, Wall, Window Liner, Sealant, Warewashing (Location #: 127)

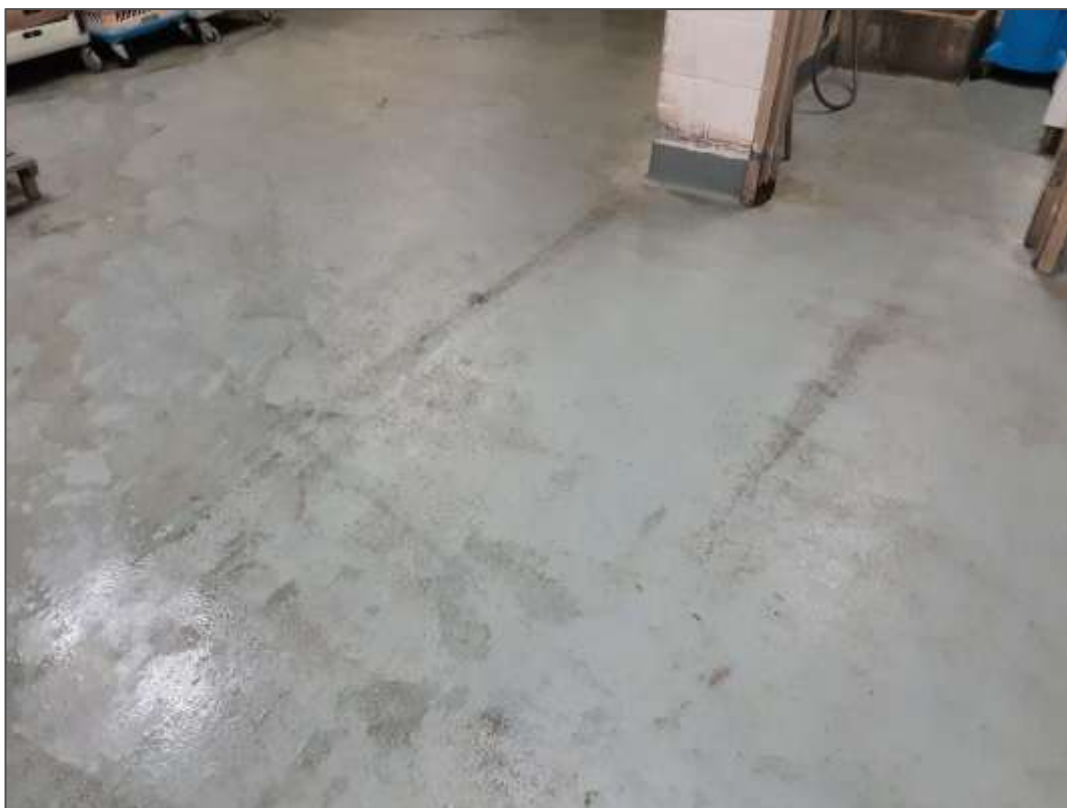
V0000 (None), Installed post 2010, Floor, Epoxy, Warewashing (Location #: 127)

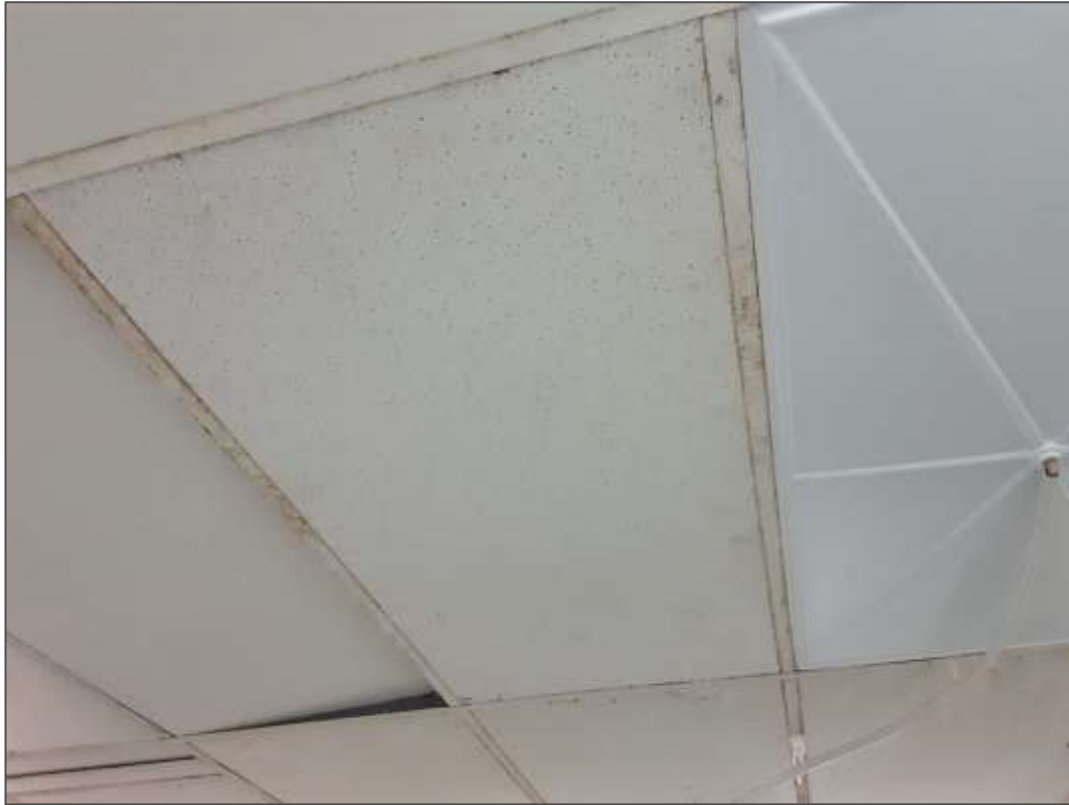
V0000 (None), 2'x4' white with painted dark flecks, dated 04/2015, Ceiling, Ceiling Tiles (lay-in), Warewashing (Location #: 127)

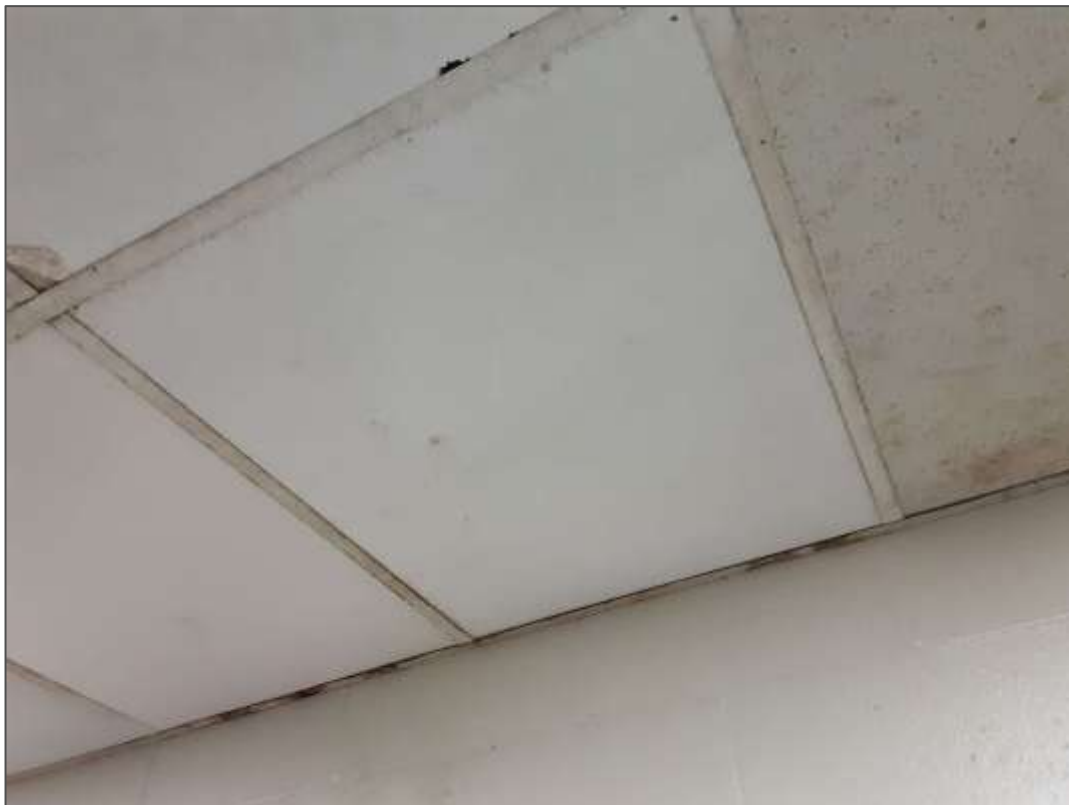
V0000 (None), 2'x4' white smooth, dated 06/17/20, Ceiling, Ceiling Tiles (lay-in), Warewashing (Location #: 127)

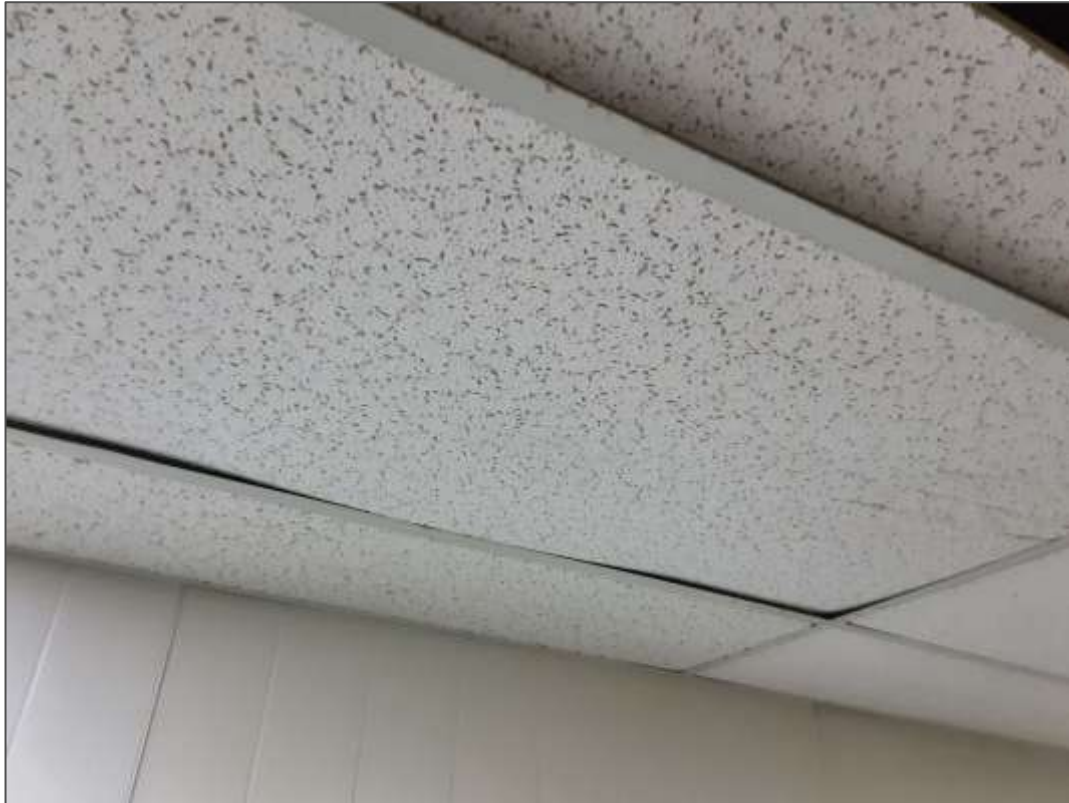
V0000 (None), 2'x4' deep fissures and pinholes, dated 01/20/06, Ceiling, Ceiling Tiles (lay-in), Warewashing (Location #: 127)

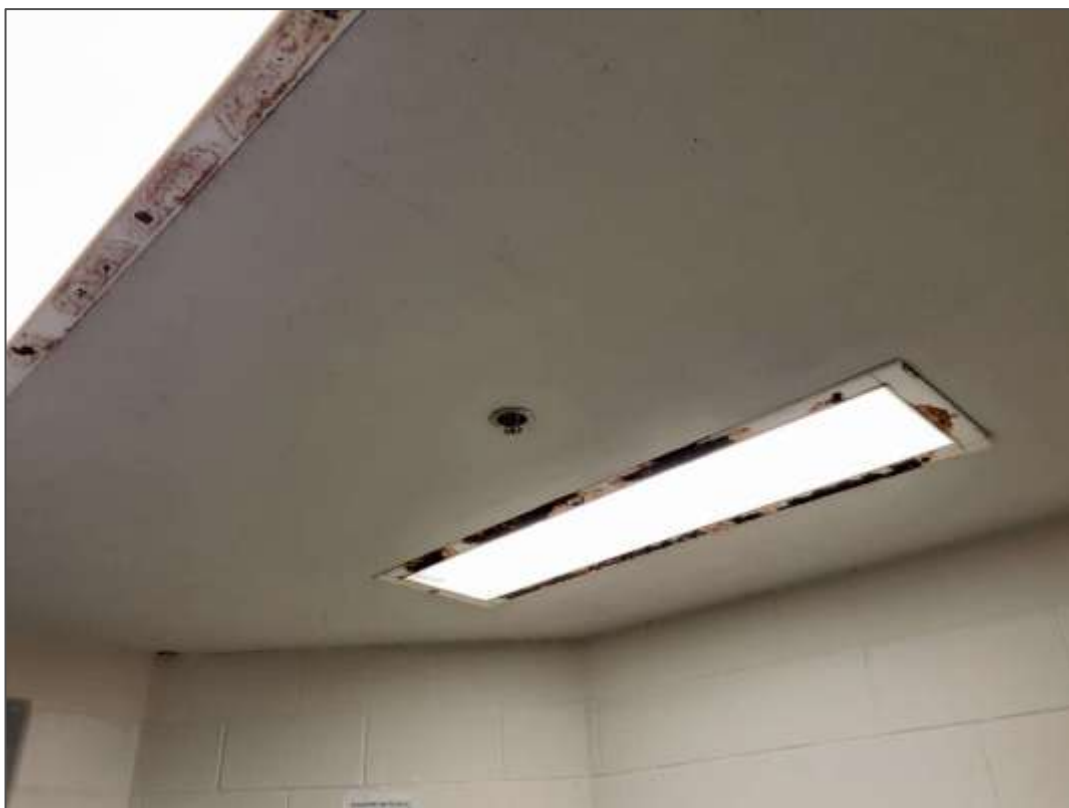
L0017(Lead, None), White on textured plaster ceilings, Ceiling, Warewashing (Location #: 127)

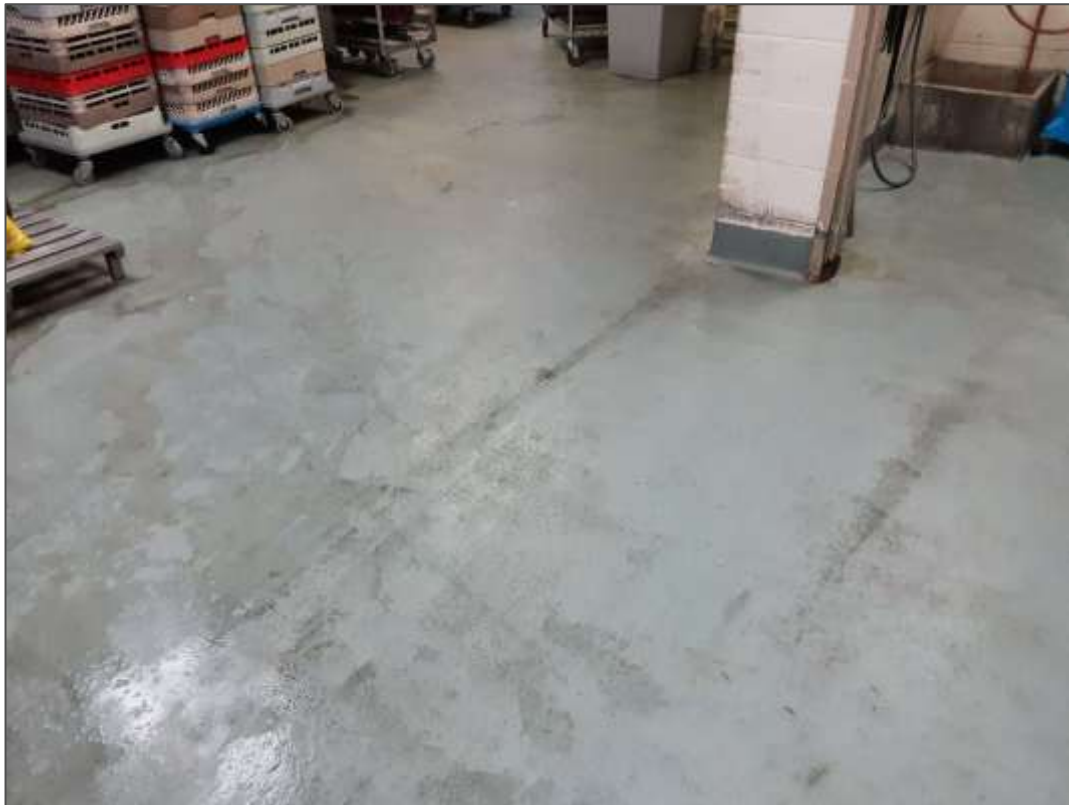
L0018(Lead, None), Green on epoxy flooring, Floor, Warewashing (Location #: 127)

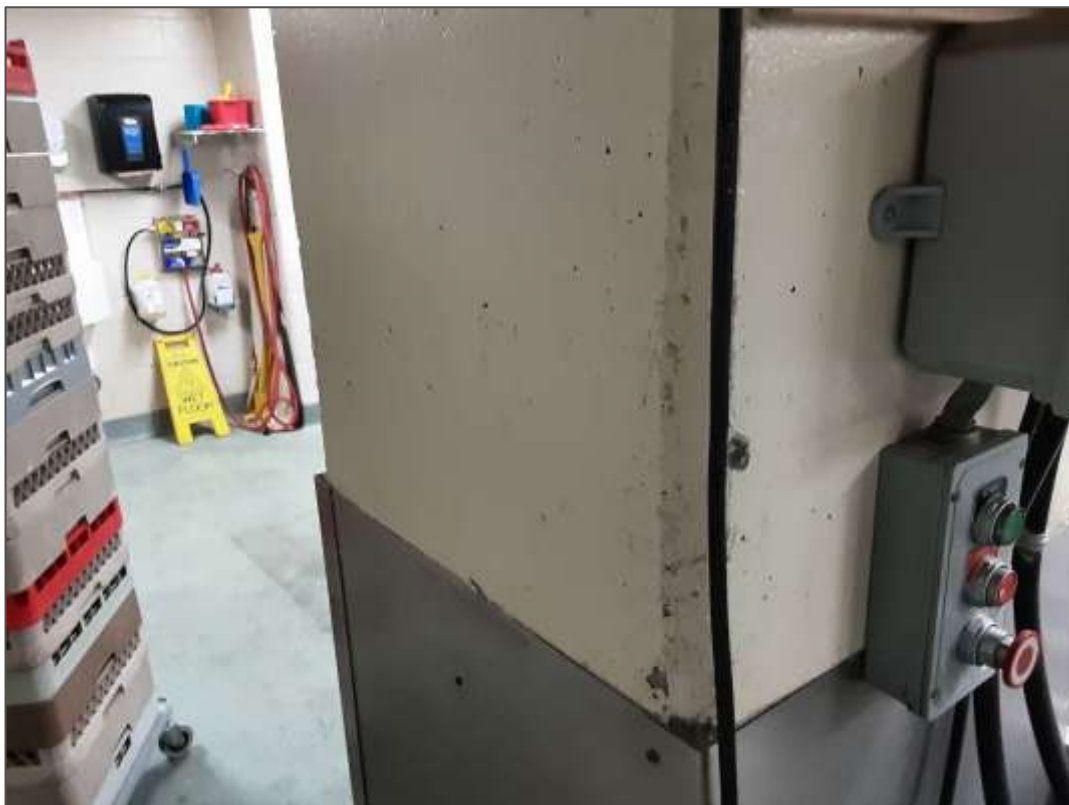
L0019(Lead, None), White on poured concrete columns, Structure, Warewashing (Location #: 127)

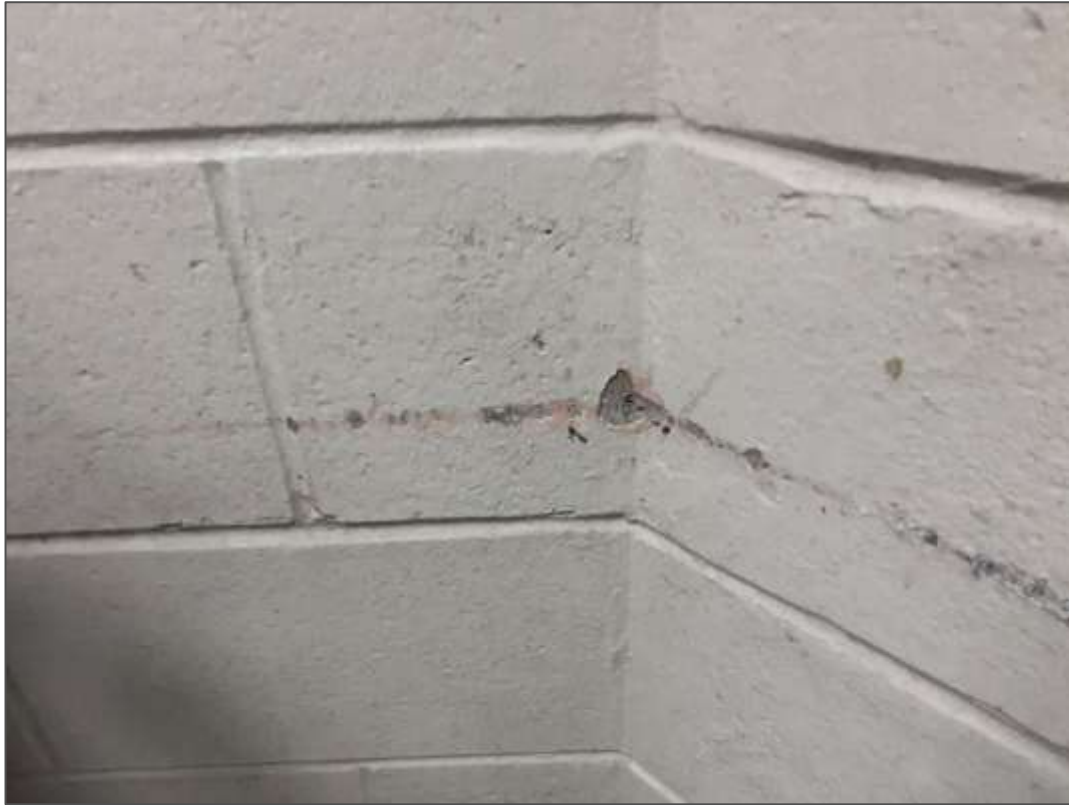
L0020(Lead, None), White and pink on concrete block, Wall, Warewashing (Location #: 127)

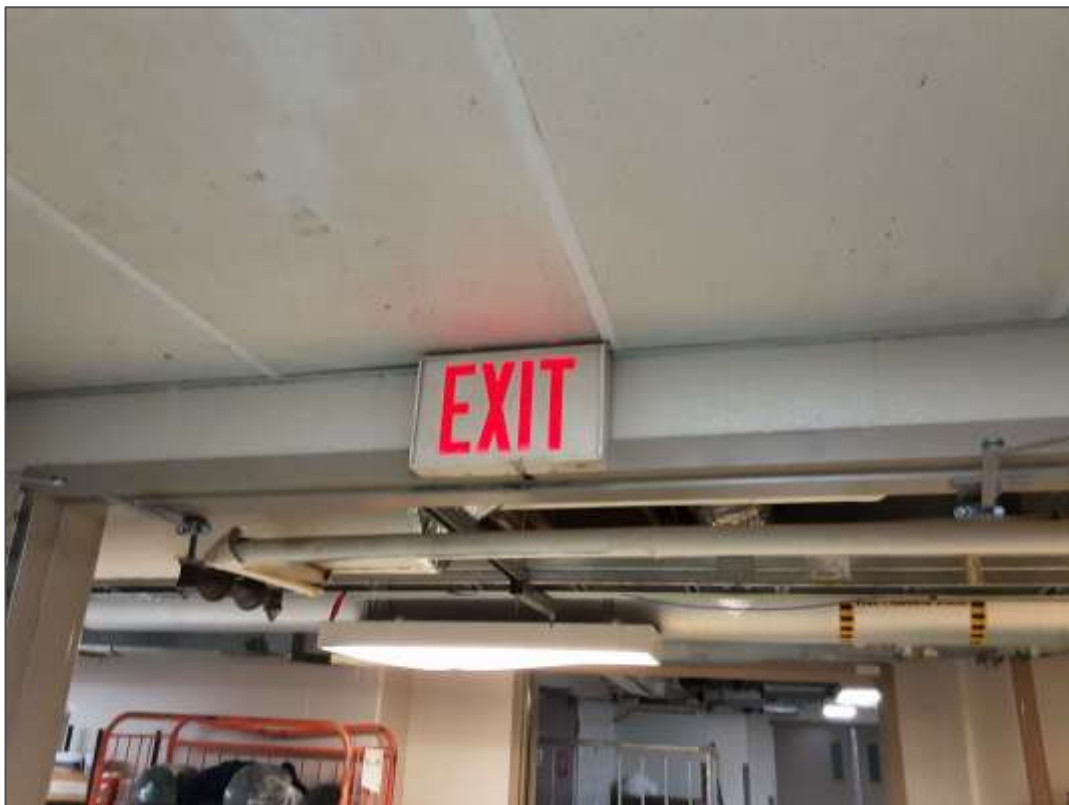
Pb Products, V9500(Presumed), BATTERIES IN EMER. LIGHTS, Warewashing (Location #: 127)

Lead-containing items should be recycled when taken out of service.

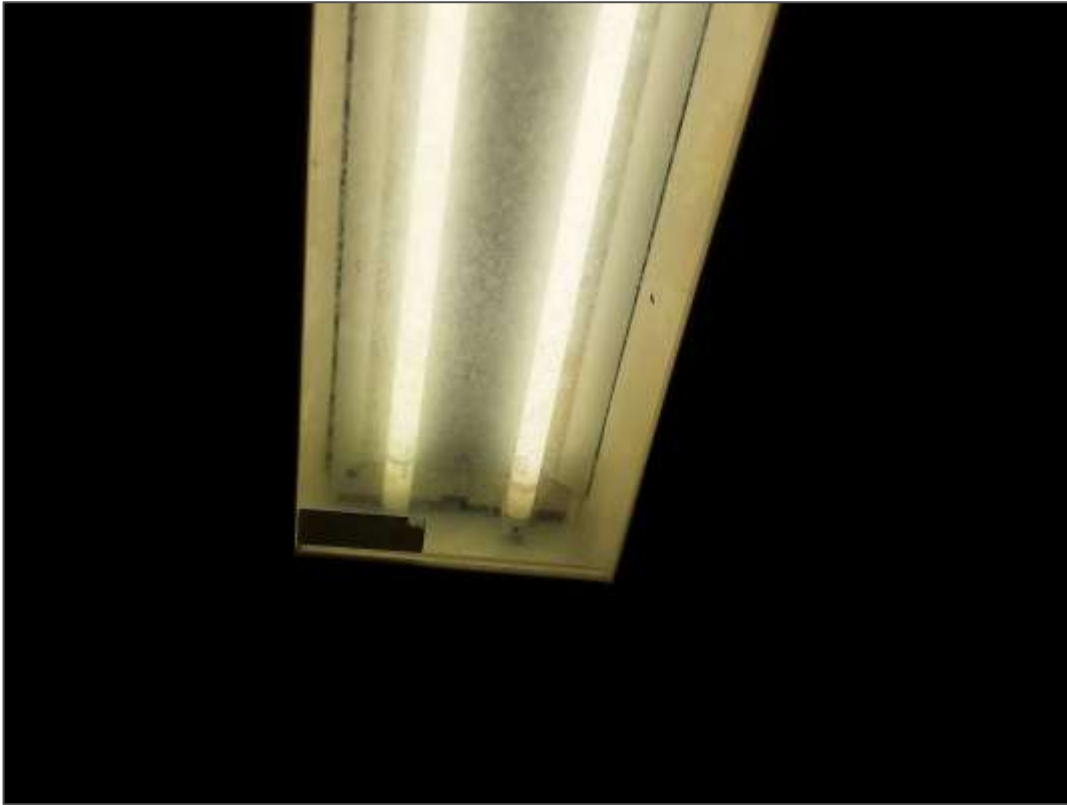
Mercury, V9000(Yes), LIGHT FIXTURE, T8, Warewashing (Location #: 127)

Do not break lamps. Recycle and reclaim mercury from fluorescent lamps when taken out of service. Mercury is classified as a hazardous waste and must be disposed of in accordance with applicable regulations.

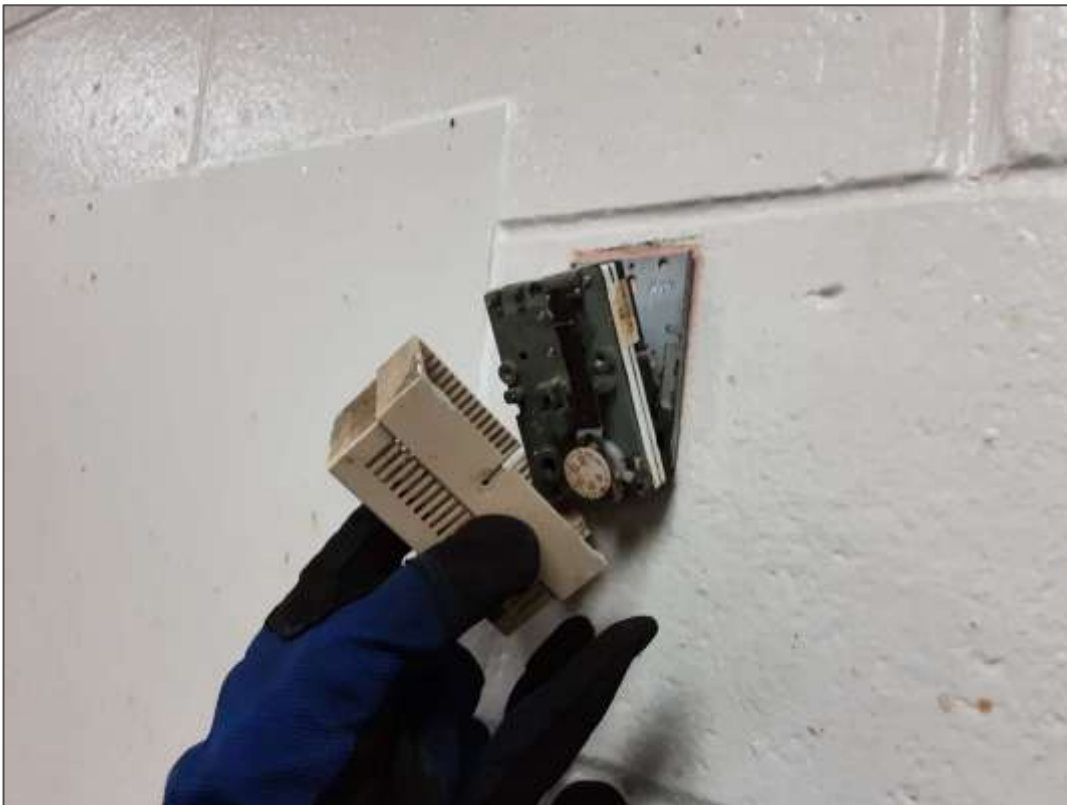
Mercury, V0000(No), THERMOSTAT, Electric Type, Warewashing (Location #: 127)
