# FINAL **Asbestos Reassessment**

Ernestown Secondary School  
50 Main Street, Odessa, Ontario

December 16, 2025

Pinchin File: 201262.363

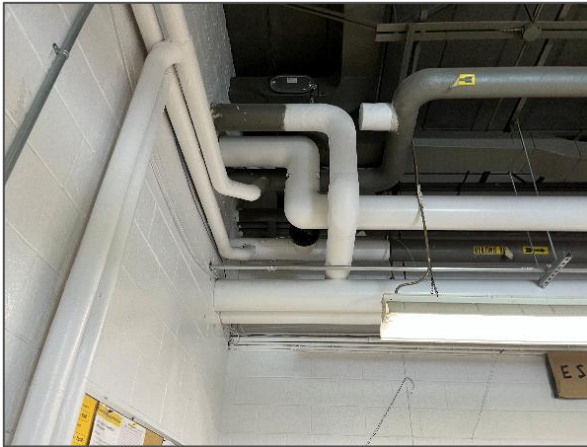
Asbestos-containing parging cement insulation on pipe elbows.

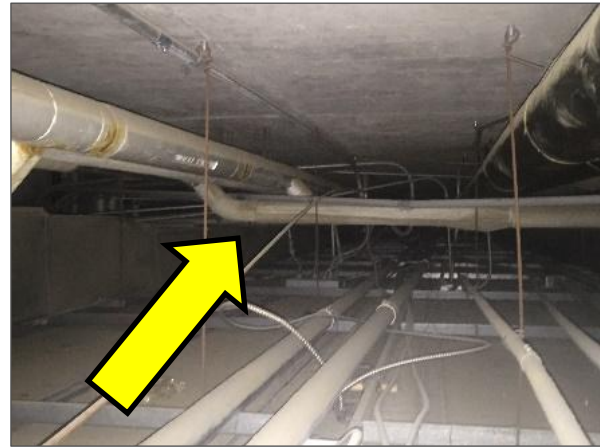
| Material, Quantity & Condition | Location Name | Recommended Procedure |
|---|---|---|
| Aircell insulation, 3 linear feet damaged | COR109 | Remove or repair in accordance with O.Reg. 278/05 Type 2 or Glove-bag asbestos abatement procedures |

Damaged asbestos-containing parging cement insulation on pipe fitting and damaged Aircell pipe insulation in COR109.

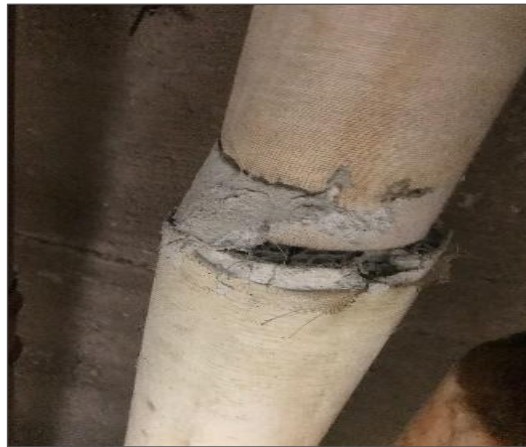
| Material, Quantity & Condition | Location Name | Recommended Procedure |
|---|---|---|
| Parging cement insulation, 1 pipe fitting damaged | COR102 | Remove or repair in accordance with O.Reg. 278/05 Type 2 or Glove-bag asbestos abatement procedures |

Damaged asbestos-containing parging cement insulation on pipe fitting that is unjacketed in COR102.

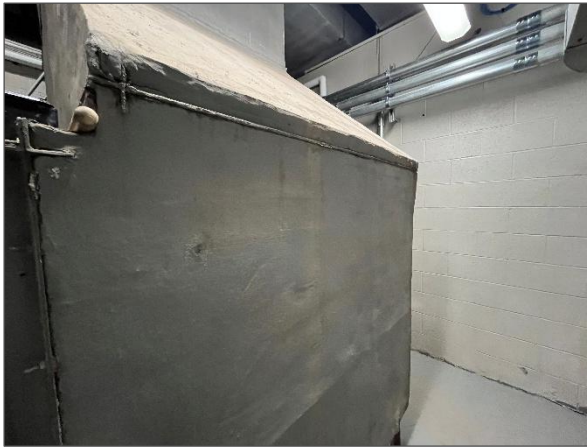
Asbestos-containing parging cement present on ducts.

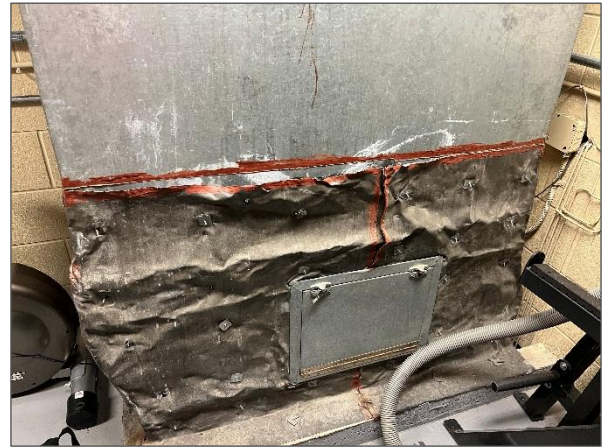
Asbestos-containing brown duct mastic on lead sheeting.

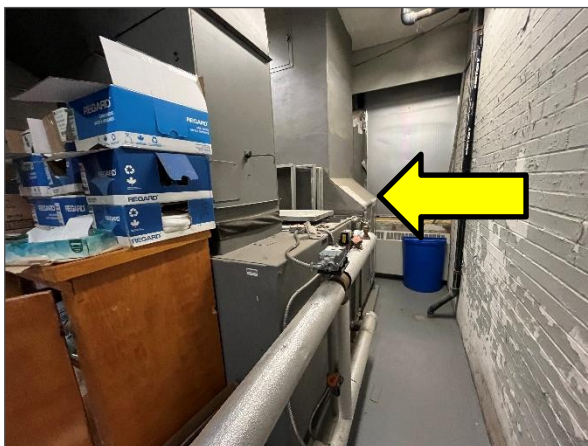
Asbestos-containing parging cement present on air handling unit.

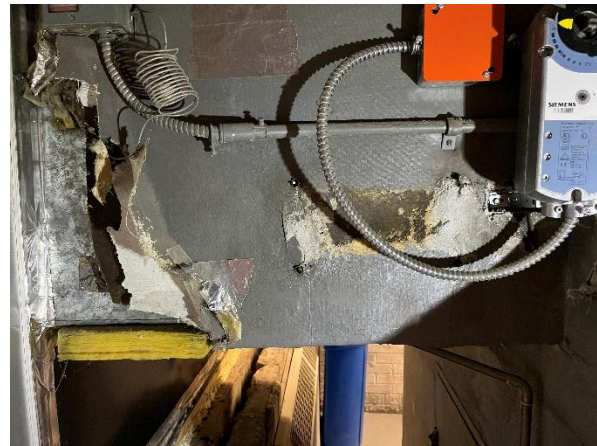
| Material, Quantity & Condition | Location Name | Recommended Procedure |
|---|---|---|
| Parging cement insulation on air handling unit, 6 square feet damaged and 1 square foot of debris | MECH201 | Remove or repair in accordance with O.Reg. 278/05 Type 2 and Type 2 Clean Up asbestos abatement procedures |

Damaged asbestos-containing parging cement insulation on air handling unit in MECH201.

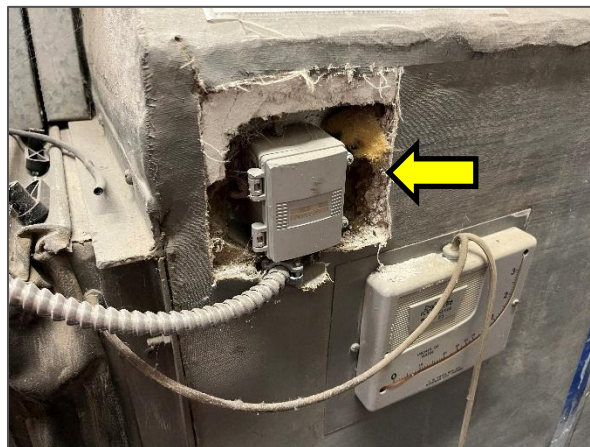
Damaged asbestos-containing parging cement insulation and debris in MECH201.

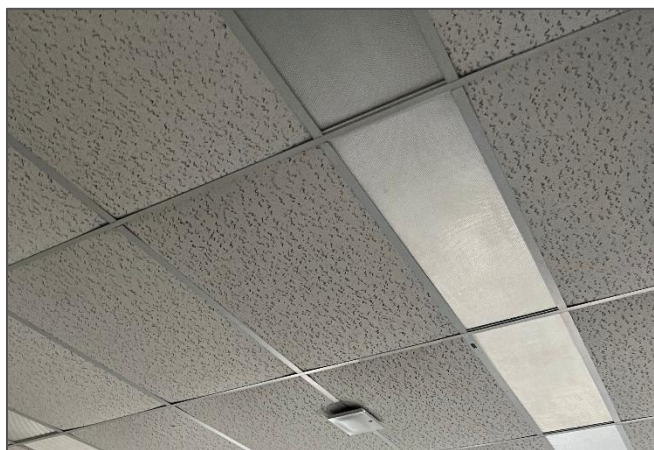
Asbestos-containing 2'x4' acoustic ceiling tiles with waves and pinholes.

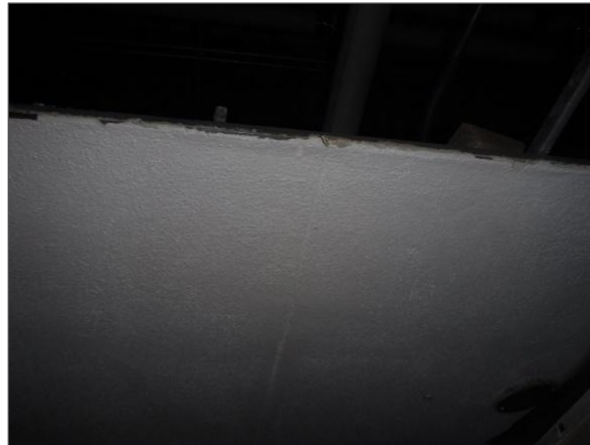
Asbestos-containing textured plaster in OFF106.

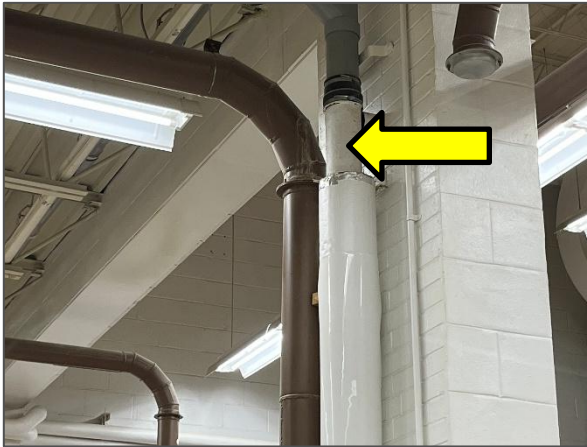
Presumed asbestos-containing Transite pipe.

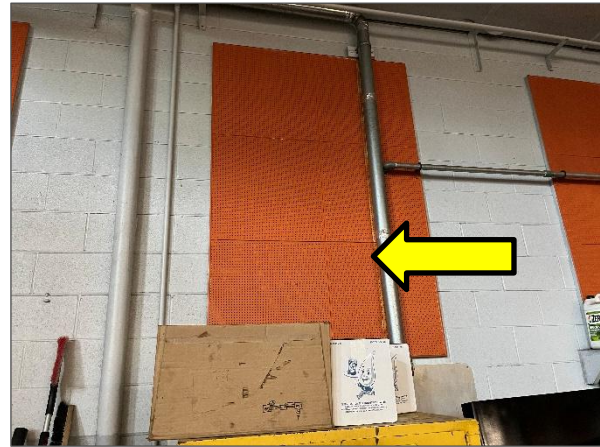
Asbestos-containing Transite boards as a wall finish.

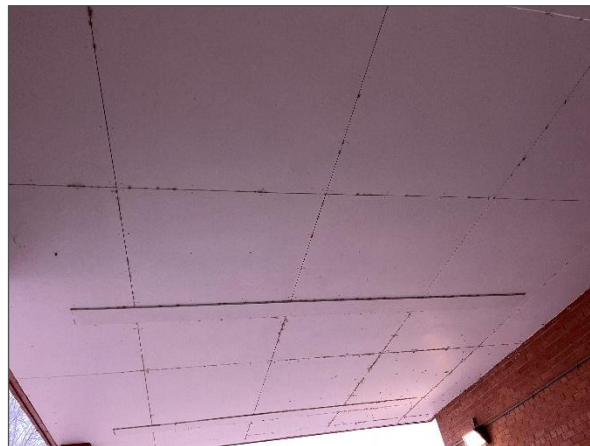
Presumed asbestos-containing transite board as soffit above the main entrance doors.

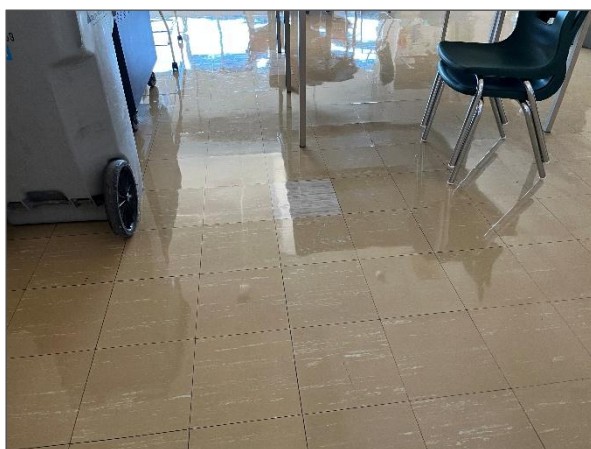
Asbestos-containing 12"x12" tan vinyl floor tiles with white streaks.

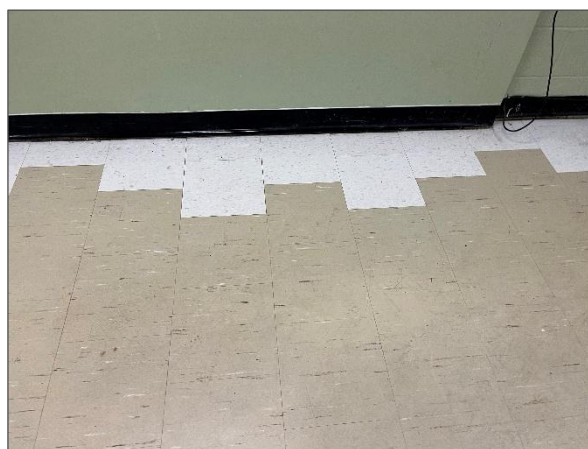
Asbestos-containing 12"x12" beige vinyl floor tiles with maroon and white streaks.

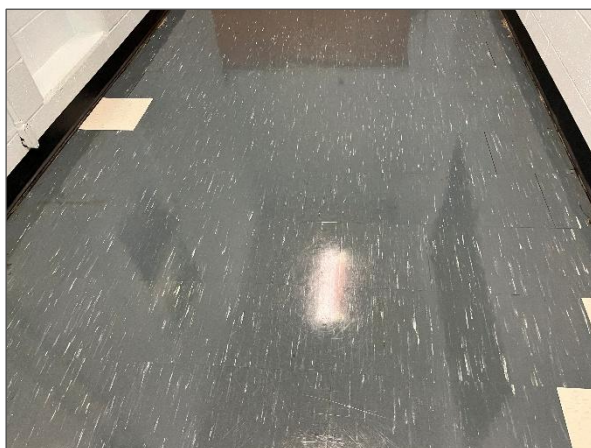
Asbestos-containing 12"x12" blue vinyl floor tiles with white streaks.

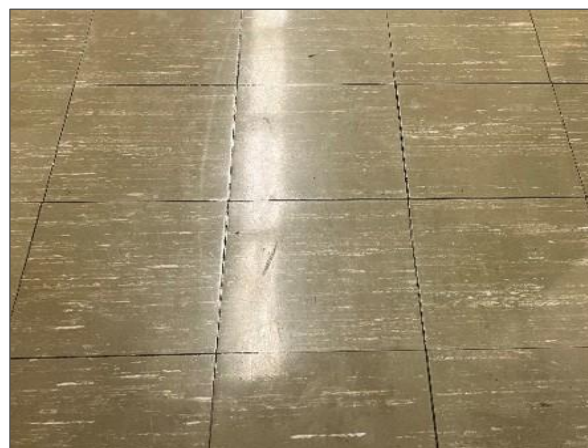
Asbestos-containing 12"x12" olive green vinyl floor tiles with beige streaks.

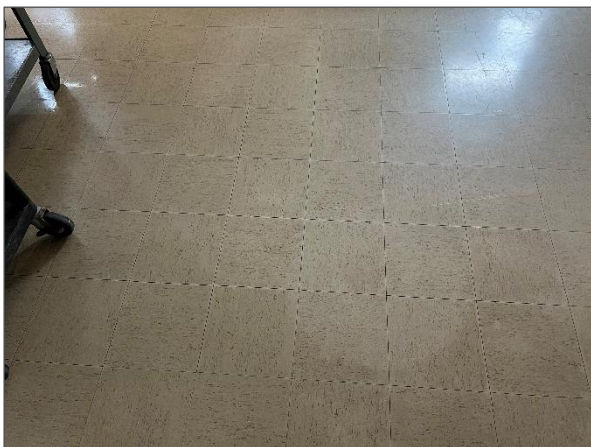
Asbestos-containing 9"x9" beige vinyl floor tiles with brown streaks.

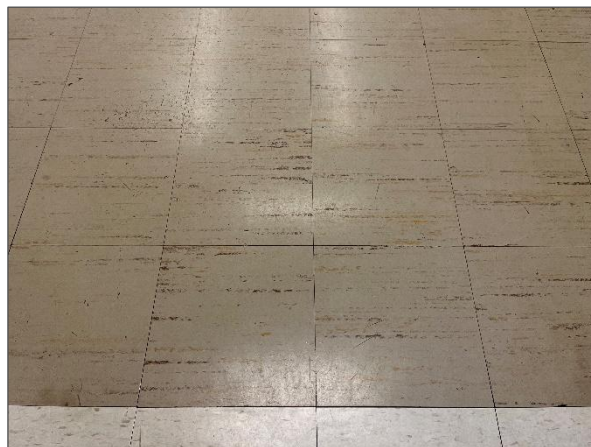
Asbestos-containing 12"x12" off-white vinyl floor tiles with yellow and brown streaks.

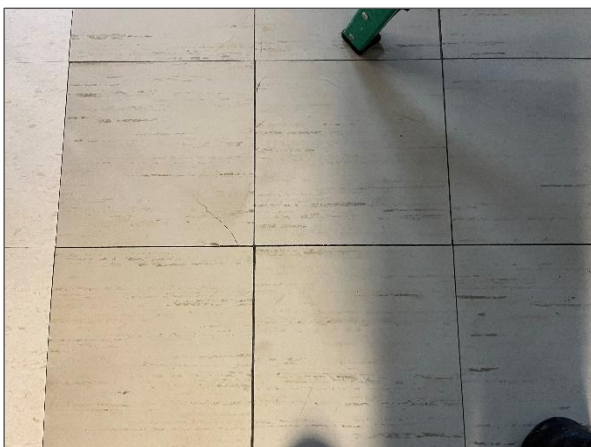
Asbestos-containing 12"x12" off-white vinyl floor tiles with yellow and green streaks.

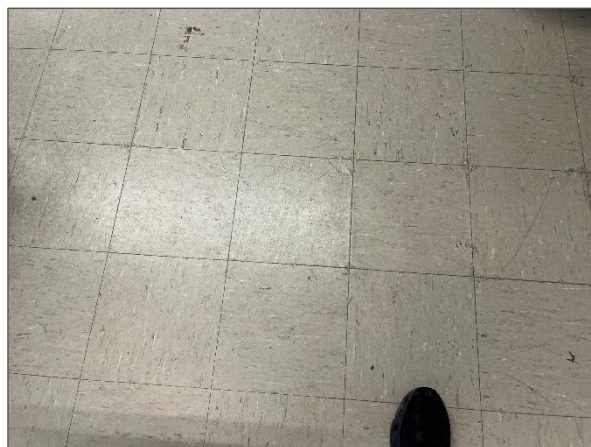
Asbestos-containing 12"x12" beige vinyl floor tiles with brown streaks.

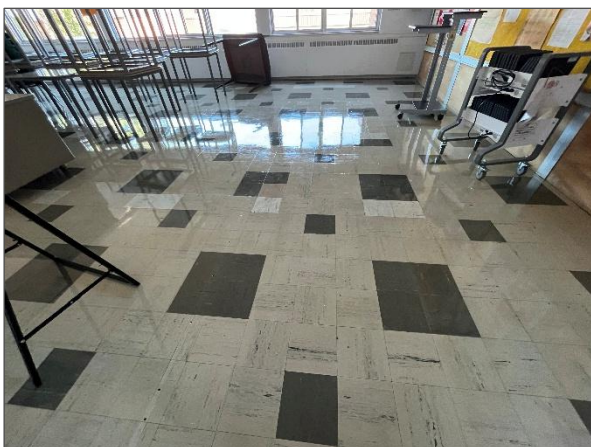
Asbestos-containing 9"x9" grey vinyl floor tiles with white and black streaks.

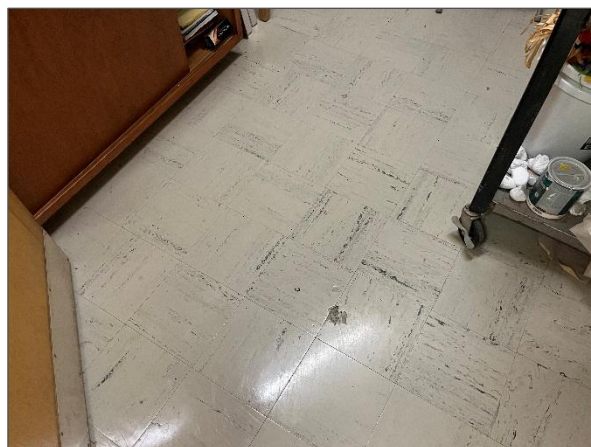
Asbestos-containing 9"x9" beige vinyl floor tiles with grey streaks.

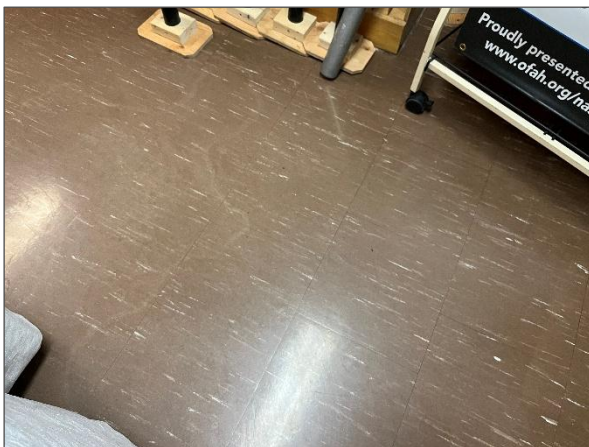
Asbestos-containing brown vinyl floor tiles with white streaks.

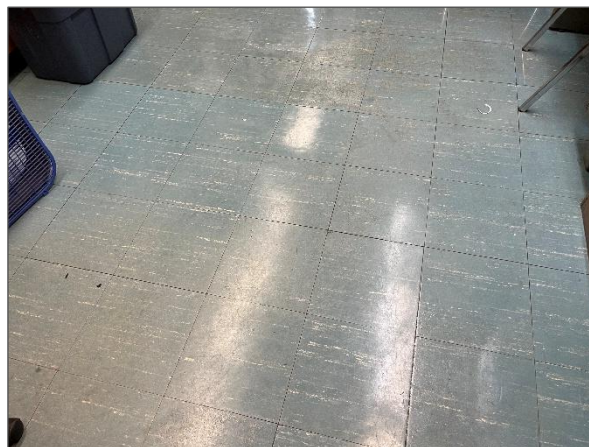
Asbestos-containing 12"x12" light blue vinyl floor tiles with white streaks.

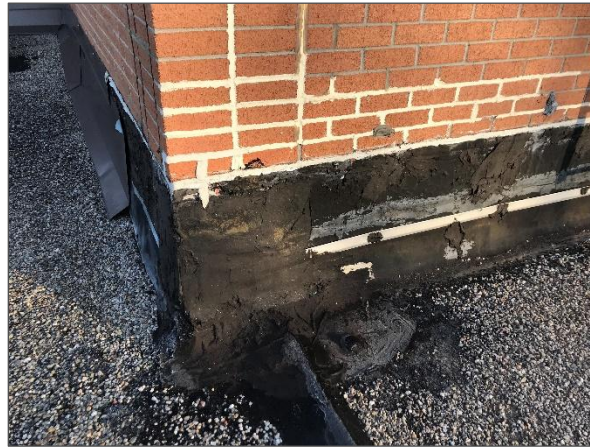
Asbestos-containing black mastic formerly concealed by metal roof flashing on brick wall.
