**TARGETED PRE-RENOVATION
DESIGNATED SUBSTANCE & HAZARDOUS MATERIALS SURVEY
R32 (YEO HALL) MASONRY REPAIRS PHASE 2, PHASE 3 AND PHASE 4
ROYAL MILITARY COLLEGE
CFB KINGSTON, ONTARIO**

**Submitted to:
Department of National Defence c/o Defence Construction Canada
5 Artisan Road, Rm 101
CFB Kingston, ON
K7K 7B4**

24 April 2017

Project No. SWC179086

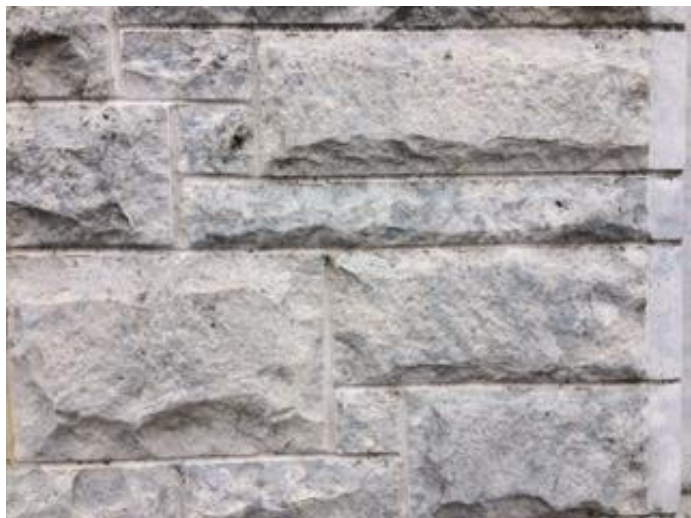
- Phase 2
 - Mortar (Sample 3A-G) was sampled from the west exterior wall of the bridge to R31 and was found to be non-asbestos-containing as per O. Reg. 278/05
 - Mortar (Sample 5A-G) was sampled from the north exterior wall and was found to be non-asbestos-containing as per O. Reg. 278/05

Photo 1: Phase 2 – Mortar from the west exterior wall was found to be non-asbestos-containing

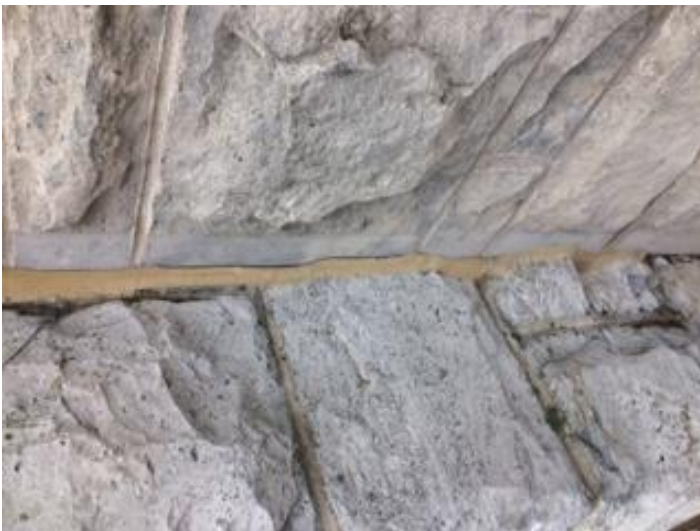
- Light grey caulking (Sample 2A-C) was sampled from the south exterior wall and was found to be non-asbestos-containing as per O. Reg. 278/05
 - White expansion joint compound (Sample 4A-C) was sampled from the north exterior wall and was found to be non-asbestos-containing as per O. Reg. 278/05

Photo 2: Phase 2 – White Expansion Joint Compound from the north exterior wall was found to be non-asbestos-containing

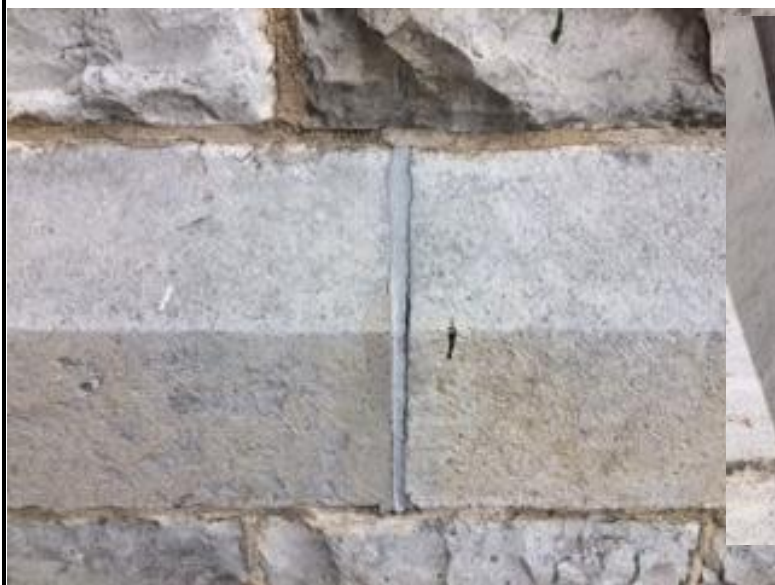
- Black caulking (Sample 6A-C) was sampled from the north exterior wall and was found to be non-asbestos-containing as per O. Reg. 278/05
- Phase 3
 - Light grey caulking (Sample 2A-C) was sampled from the north exterior wall and was found to be non-asbestos-containing as per O. Reg. 278/05

Photo 3: Phase 3 – Light Grey Caulking from the north exterior wall was found to be non-asbestos-containing

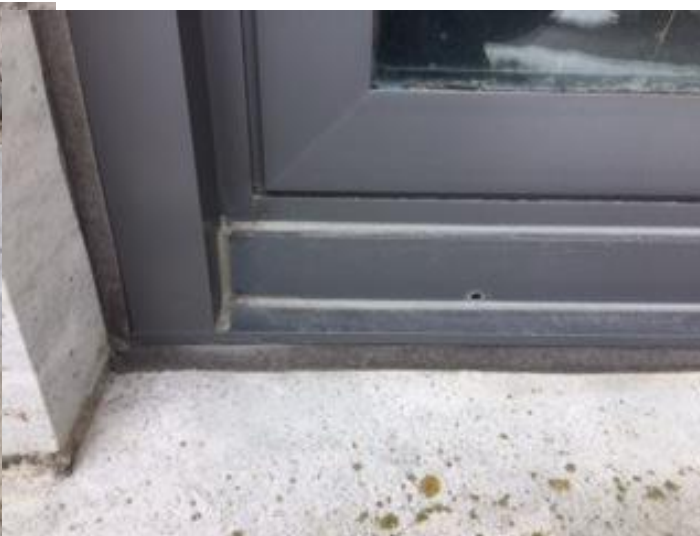
- White expansion joint compound (Sample 2A-C) was sampled from west exterior wall and was found to be non-asbestos-containing as per O. Reg. 278/05
 - Dark grey caulking (Sample 3A-C) was sampled from the west exterior window and was found to be non-asbestos-containing as per O. Reg. 278/05

Photo 4: Phase 4 – Dark Grey Window Caulking from the west exterior wall was found to be non-asbestos-containing
