**Hazardous Building Materials Assessment  
Front of Yonge Public School  
1504 County Road 2  
Mallorytown, Ontario**

Prepared for:  
Upper Canada District School Board  
225 Central Avenue West  
Brockville, Ontario, K6V 5X1

February 1, 2011

Pinchin File 63221

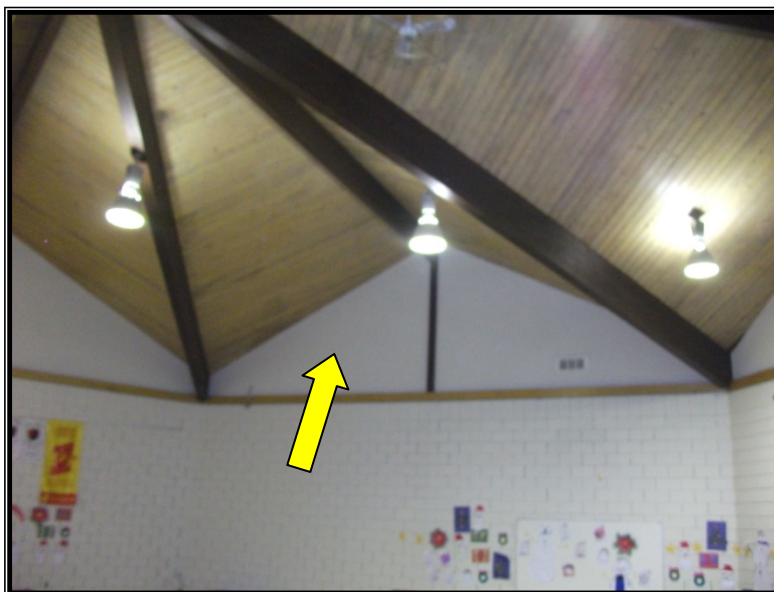
Texture finishes, containing 5-10% chrysotile asbestos (Samples 0003A-G), are present on the upper portions of the walls in the gymnasium and stage (Locations 11 and 13). Texture finish is a friable material, was painted and was noted in good condition. Refer to Photo 1 in Appendix V.

Friable asbestos-containing texture finish present on the upper portions of the walls in the gymnasium and stage (Locations 11 and 13).

All asbestos-containing materials were noted in good condition at the time of the assessment and as such, no remedial work is required at this time.

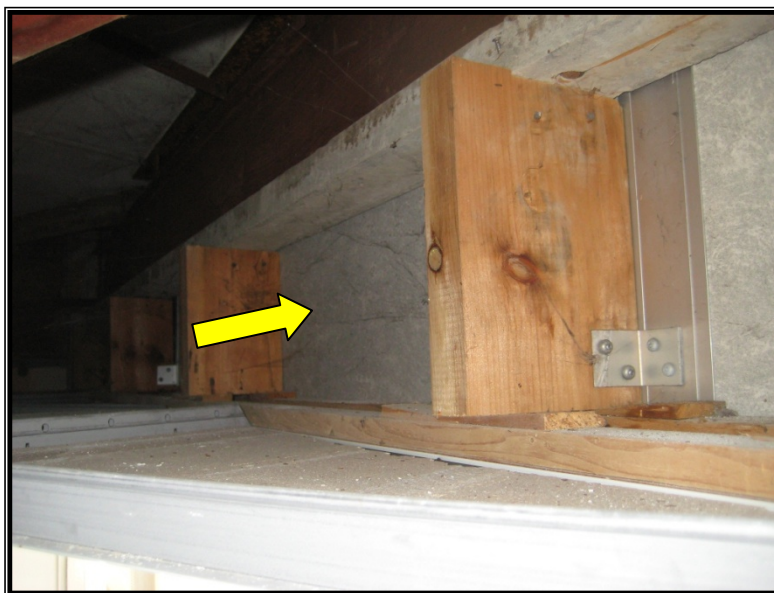
Transite board is present as window panels and behind radiators around the interior perimeter of the building. The transite panels are concealed behind millwork, wall coverings, and above ceiling tiles. Transite is a non-friable material that was visually determined to contain asbestos. All transite is in good condition. There is approximately 1500 square feet of transite throughout the building. Refer to Photo 2 in Appendix V.

Non-friable asbestos-containing transite board is present as window panels and behind radiators around the interior perimeter of the building. The transite panels are concealed behind millwork, wall coverings, and above ceiling tiles.
