FINAL **Hazardous Building** **Materials Assessment**

Pineview Public School
8 George Street, Athens,
Ontario

**Upper Canada District School
Board**

April 20, 2023

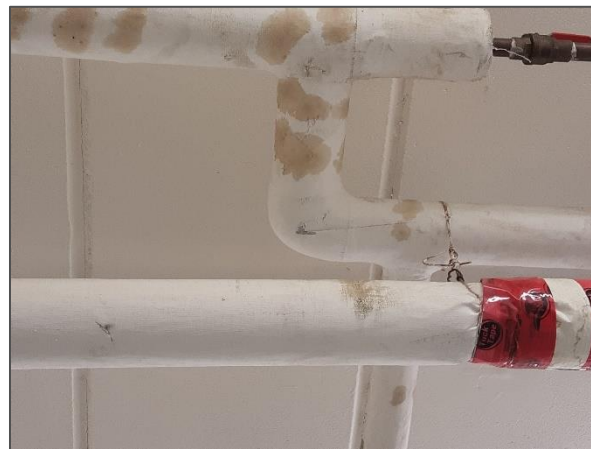
Asbestos-containing parging cement pipe insulation.

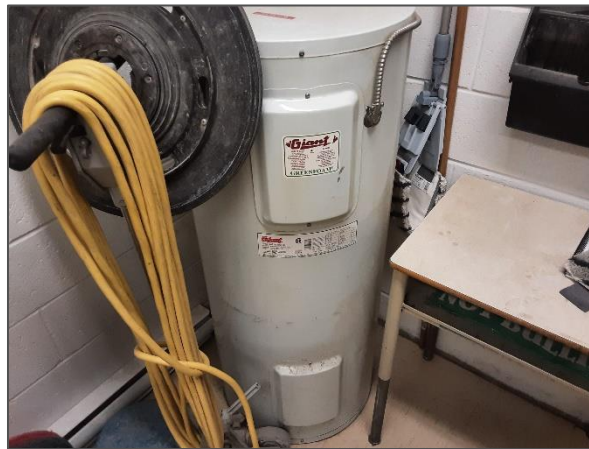
Non-asbestos fibreglass insulated hot water tank with metal jacketing.

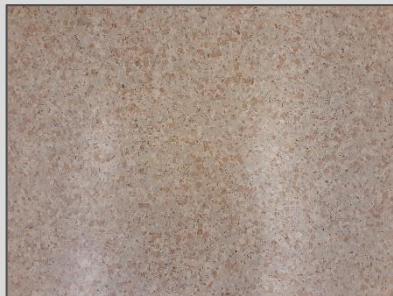
| Description | Sample Location (Loc #) | Sample Number | Asbestos (Backing / Adhesive) | Photo |
|---|---|---|---|---|
| Large beige cubes | Locations 7, 9 and 47 | Previous Pinchin Samples 0004A-C | None Detected Chrysotile* | |

*Due to contamination from the asbestos-containing mastic, the vinyl sheet flooring must be treated as asbestos-containing for handling and disposal purposes.

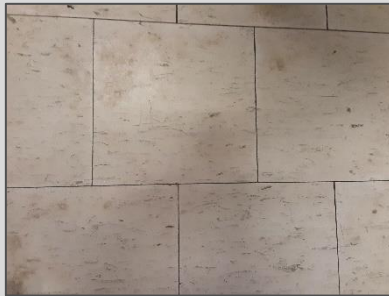
| Description | Sample Location (Location #) | Sample Number | Asbestos (Tile / Adhesive) | Photo |
|--|---|---|---|---|
| 12"x12", white with black streaks | Location 46 | Previous Pinchin Samples 0005A-C | Chrysotile None Detected | |

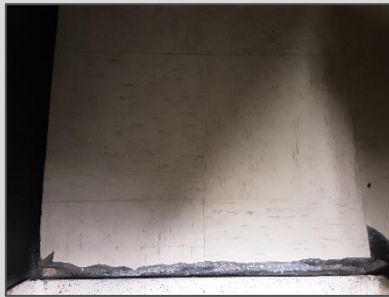
| Description | Sample Location (Location #) | Sample Number | Asbestos (Tile / Adhesive) | Photo |
|--|---|---|---|---|
| 12"x12", beige with fine brown streaks | Locations 15, 38 and 45 | Previous Pinchin Samples 0006A-C | Chrysotile None Detected | |

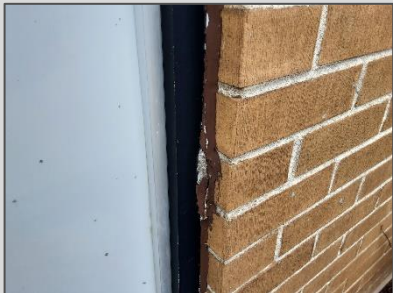
| Material, Description and Application | Sample Location (Location #) | Sample Number | Asbestos | Photo |
|---|---|---|---|---|
| Caulking, brown/grey, window frames | Exterior, 1968 Original Building (Location 100) | S0012A-C | Chrysotile | |

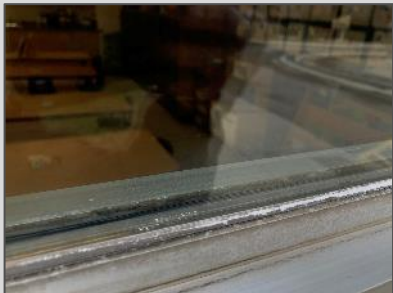
| Material, Description and Application | Sample Location (Location #) | Sample Number | Asbestos | Photo |
|---|---|---|---|---|
| Caulking, soft grey, window frames | Exterior, 1968 Original Building (Location 100) | S0013A-C | Chrysotile | |

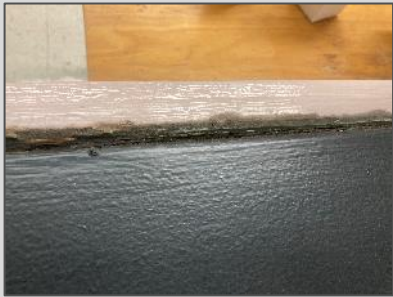
| Material, Description and Application | Sample Location (Location #) | Sample Number | Asbestos | Photo |
|---|---|---|---|---|
| Putty, grey, window liners | Locations 31, 32 and 62 | S0029A-C | Chrysotile | |

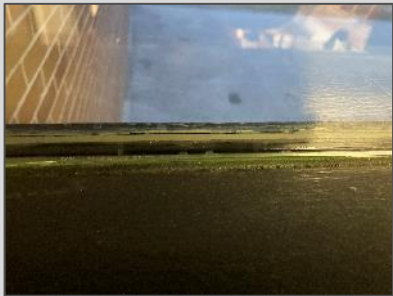
| Material, Description and Application | Sample Location (Location #) | Sample Number | Asbestos | Photo |
|---|---|---|---|---|
| Putty, black, window liners | Locations 31 and 67 | S0030A-C | Chrysotile | |

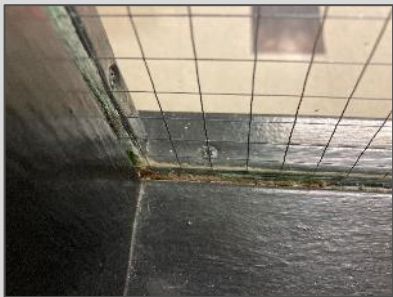
| Material, Description and Application | Sample Location (Location #) | Sample Number | Asbestos | Photo |
|---|---|---|---|---|
| Putty, grey, window liners | Location 22 | S0031A-C | Chrysotile | |

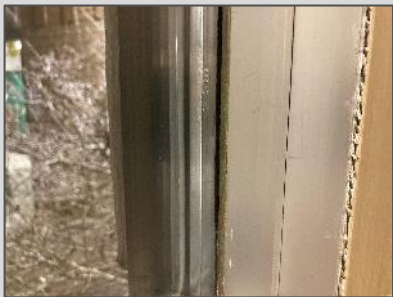
| Material, Description and Application | Sample Location (Location #) | Sample Number | Asbestos | Photo |
|---|---|---|---|---|
| Glazing putty, grey, window liners | Locations 1 and 60 | S0032A-C | Chrysotile | |

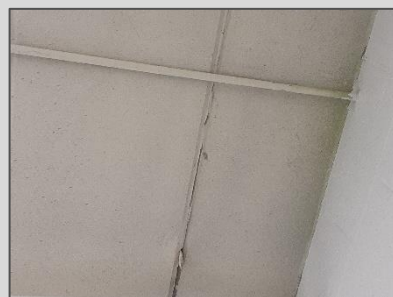
| Material, Description and Application | Sample Location (Location #) | Sample Number | Asbestos | Photo |
|---|---|---|---|---|
| Caulking, white, Siporex panelling | Location 27 | S0034A-C | Chrysotile | |

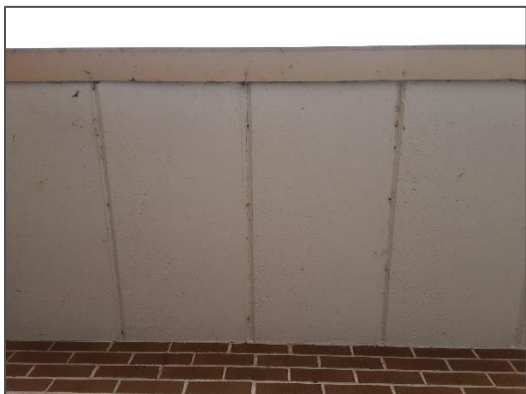
Siporex panels, containing chrysotile asbestos, are present in the 1968 original portion of the building (samples S0014A-C and S0024A-G).

Asbestos-containing Siporex panels.

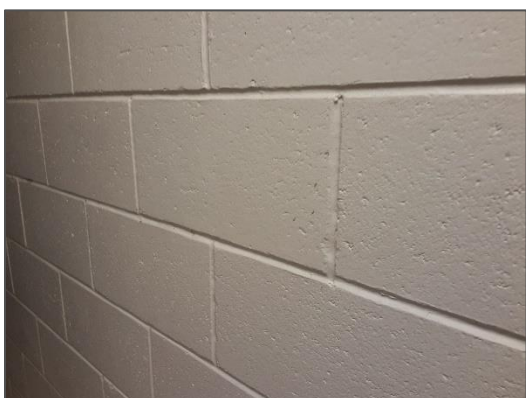
Asbestos-containing paint present on concrete block wall.

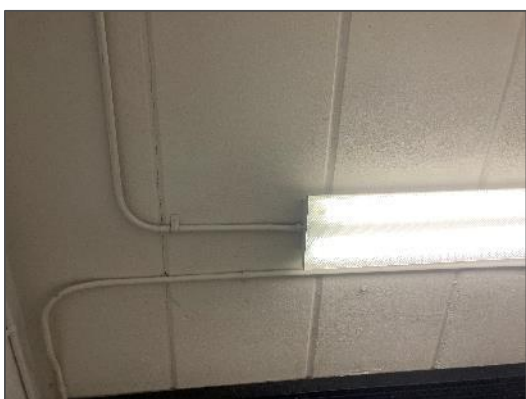
Asbestos-containing grey caulking present on the concrete deck.

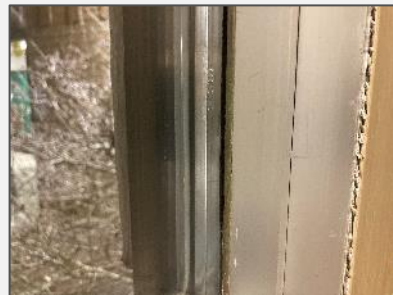
| Material, Colour, Application | Sample Location (Location #) | Sample Number | PCB (mg/kg) | Photo |
|---|---|---|---|---|
| Glazing putty, grey, window liner | Location 22 | P0006 | 1,680 | |
