Reinforced Autoclaved Aerated Concrete Assessment (Siporex) Report

Pineview Public School

Report Prepared by:
Shoalts and Zaback Architects Ltd.
SZA Project #: 24028

Report Date: 2024-08-28

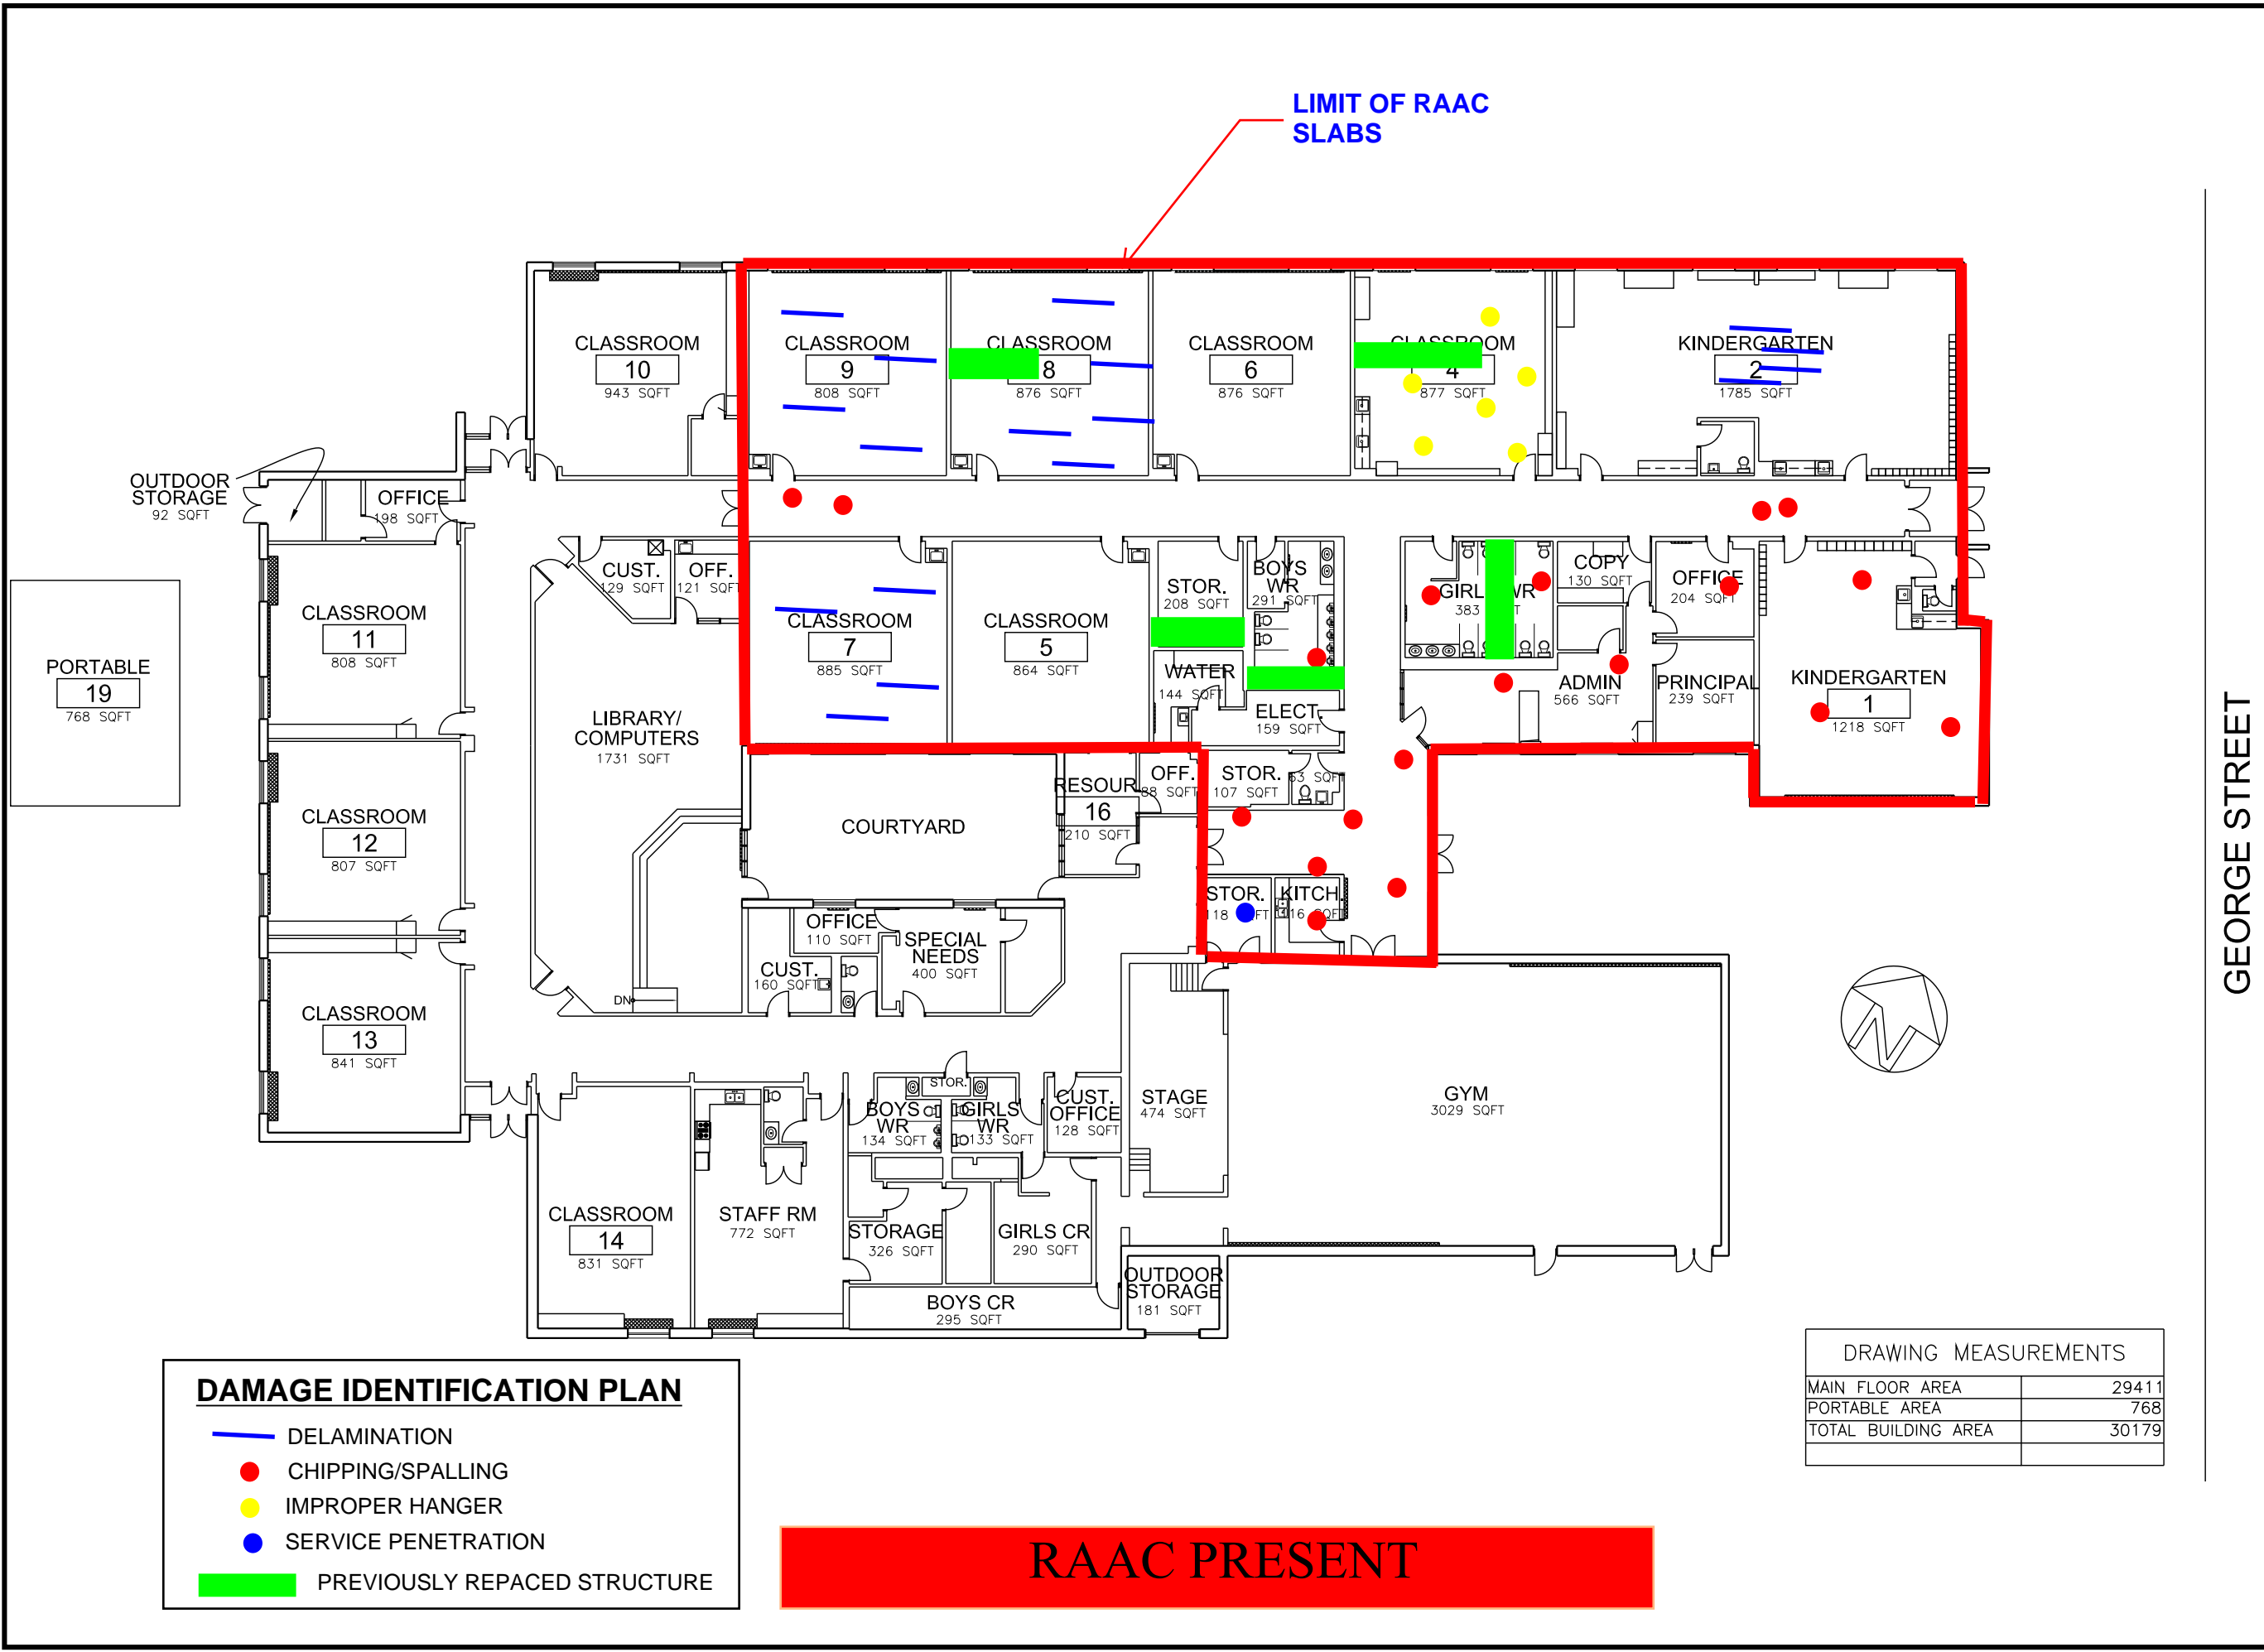
DAMAGE IDENTIFICATION PLAN

This chart identifies severity of damage noted on the identification map in Appendix A.

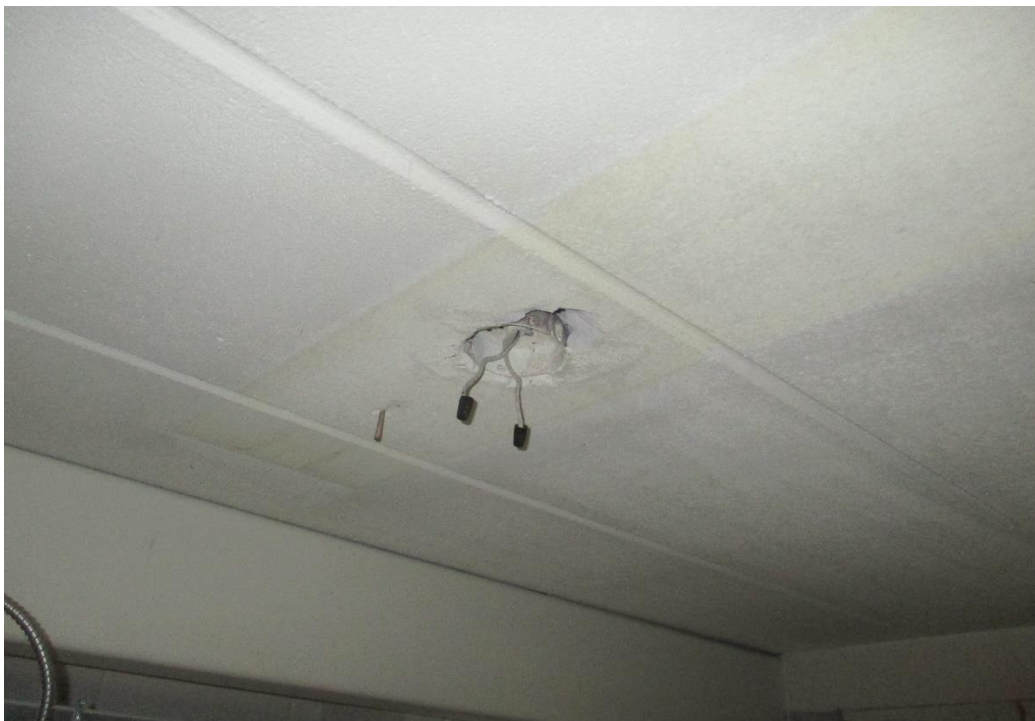
Improper Fixture Installation

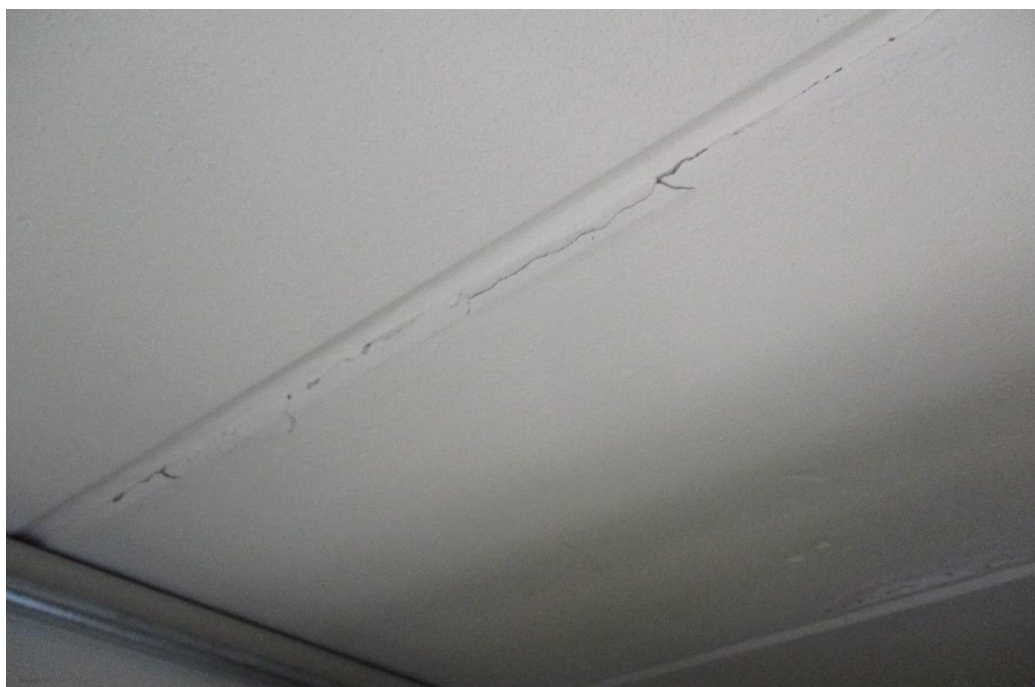
Spalling Edges

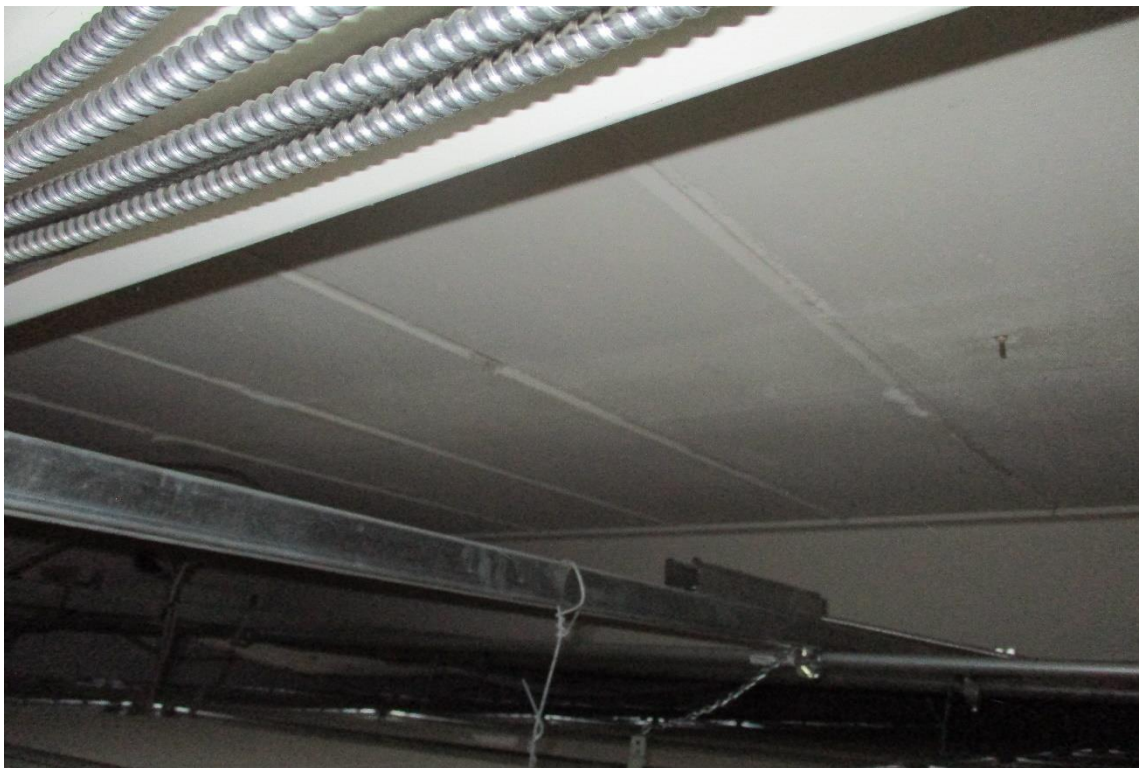
Spalling Edges

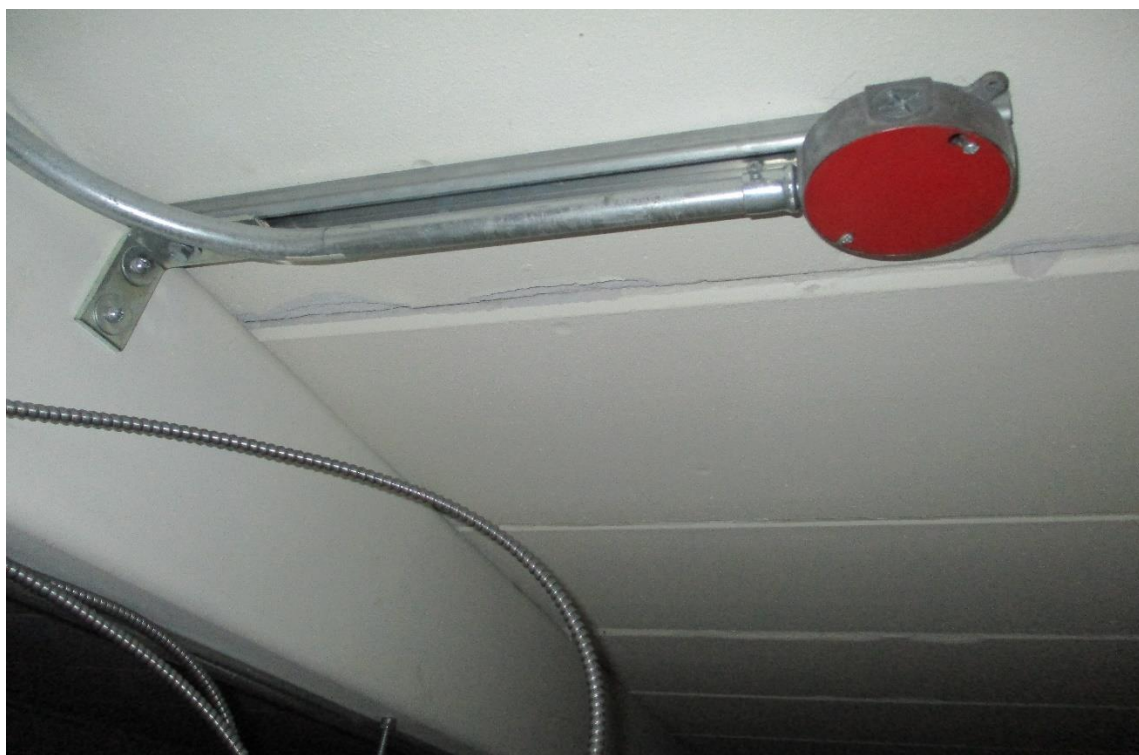
Surface Mount Services

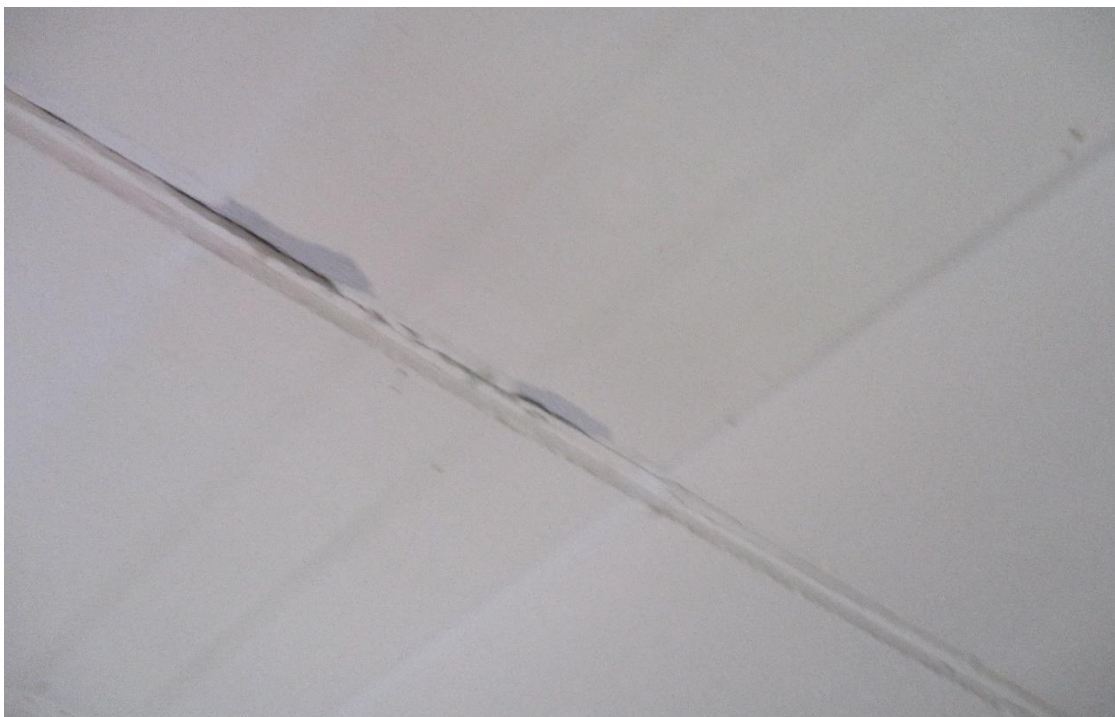
Chipping and Spalling

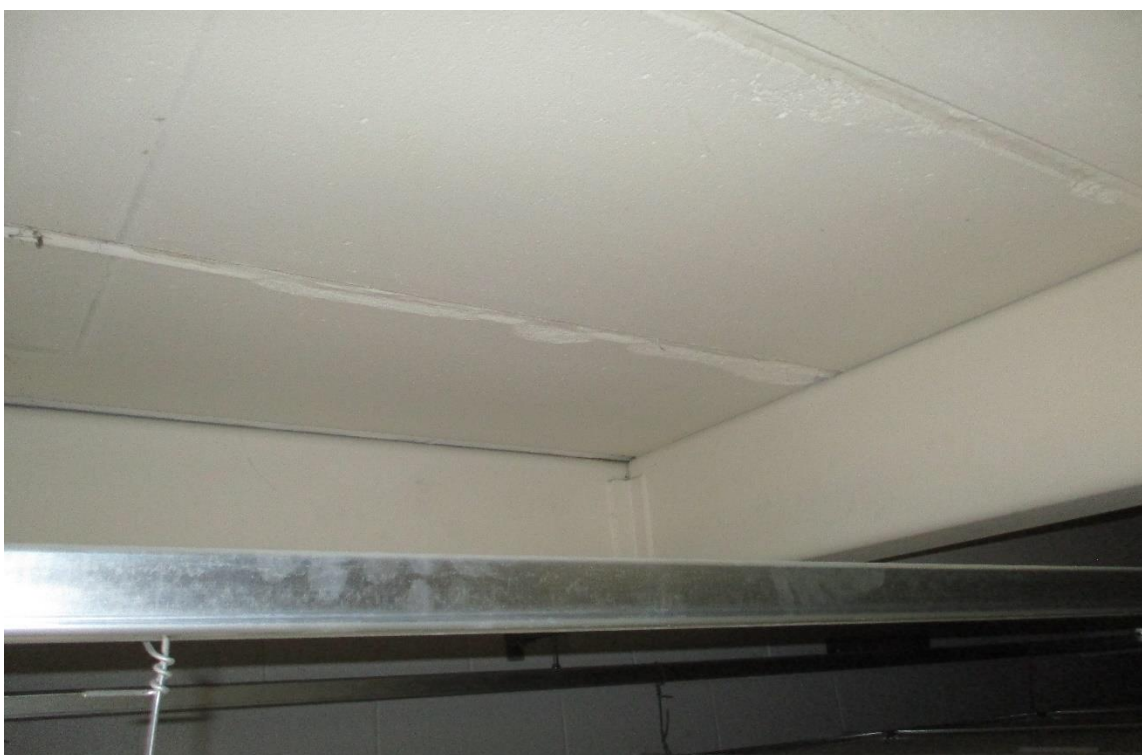
Delamination at Edges

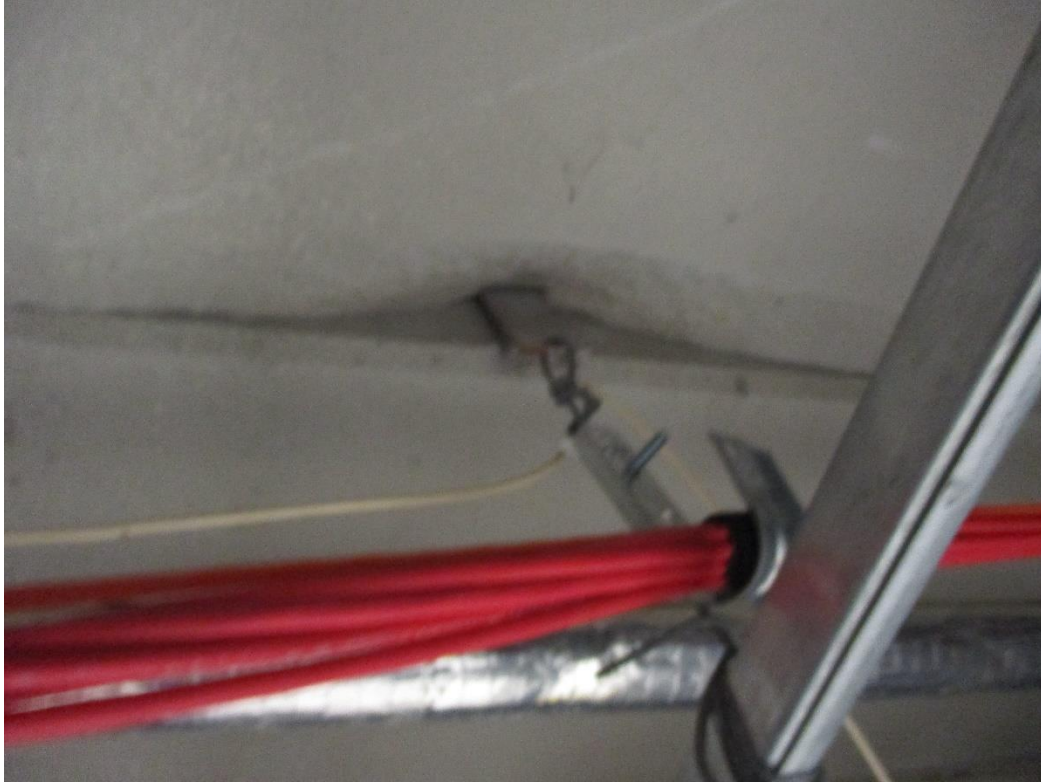
Improper Hangers/Chipping

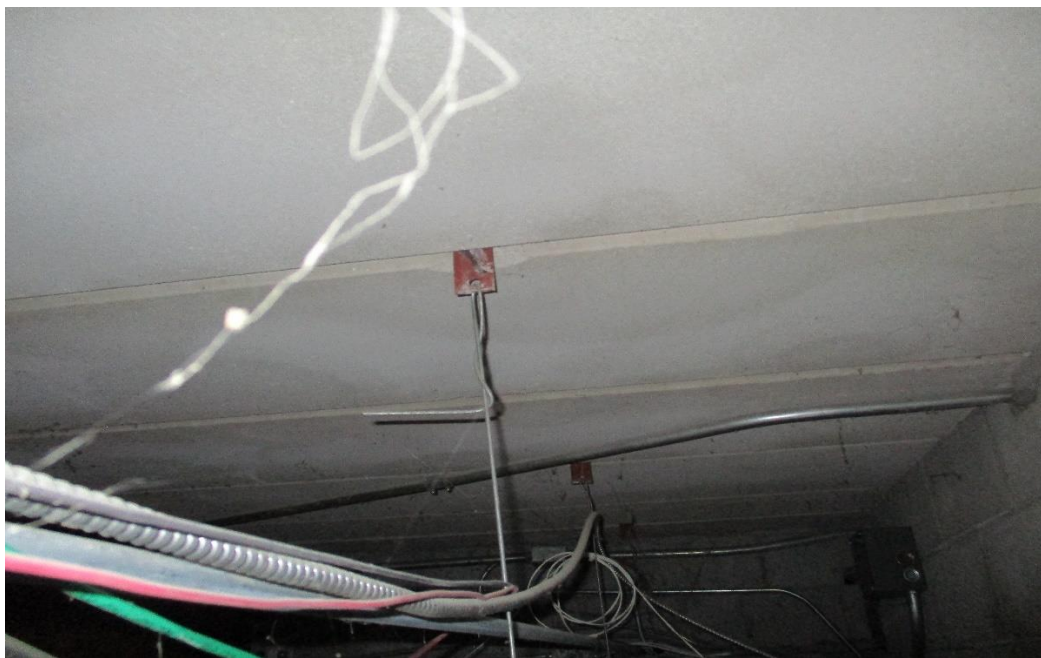
Improper Hangers/Chipping

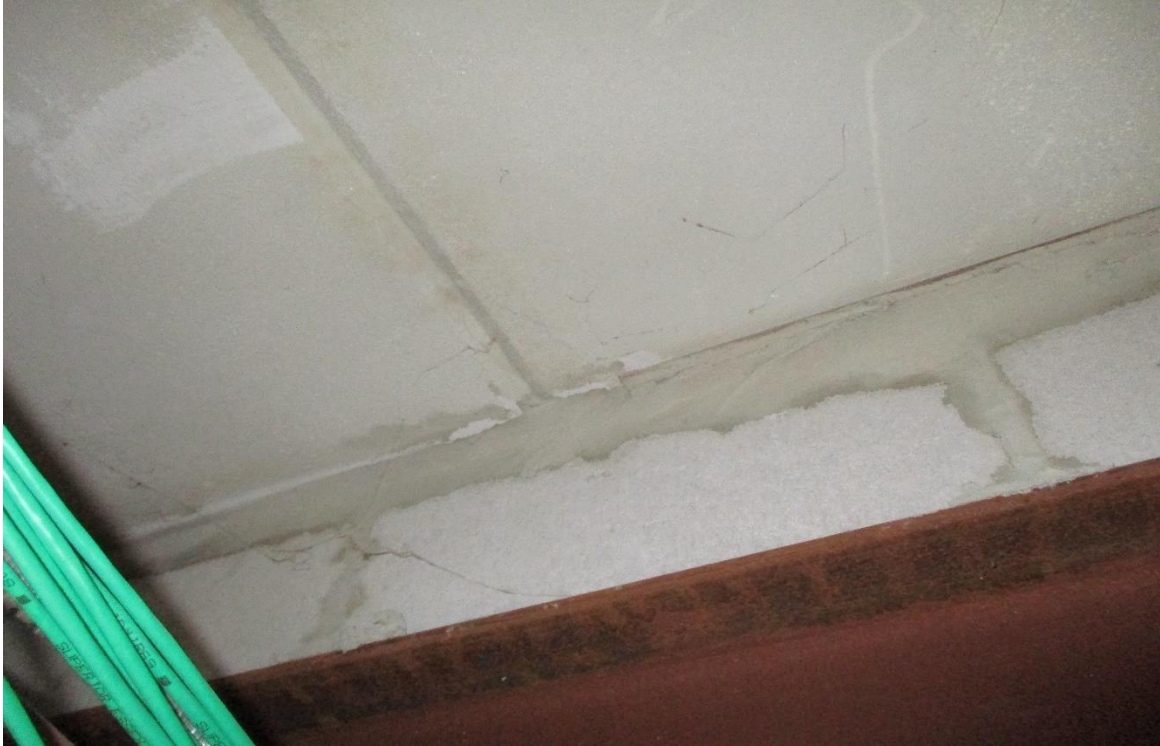
Previous Repair with Grouting

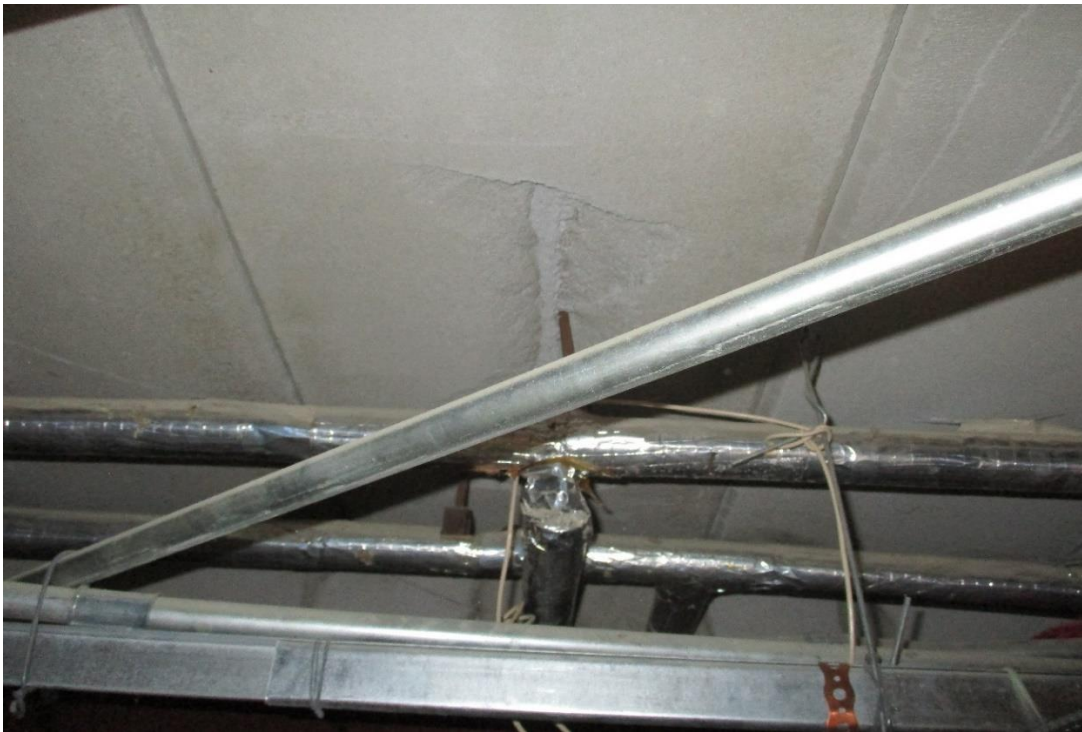
Chipping of Slab

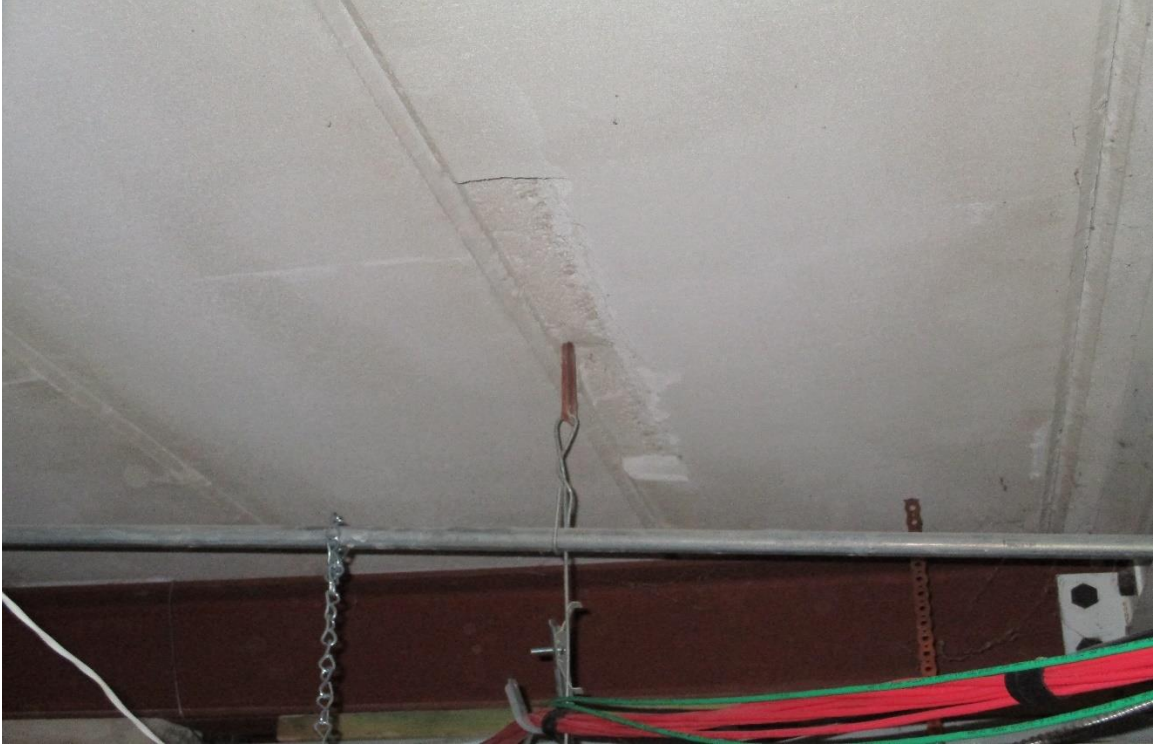
Delamination of Slab

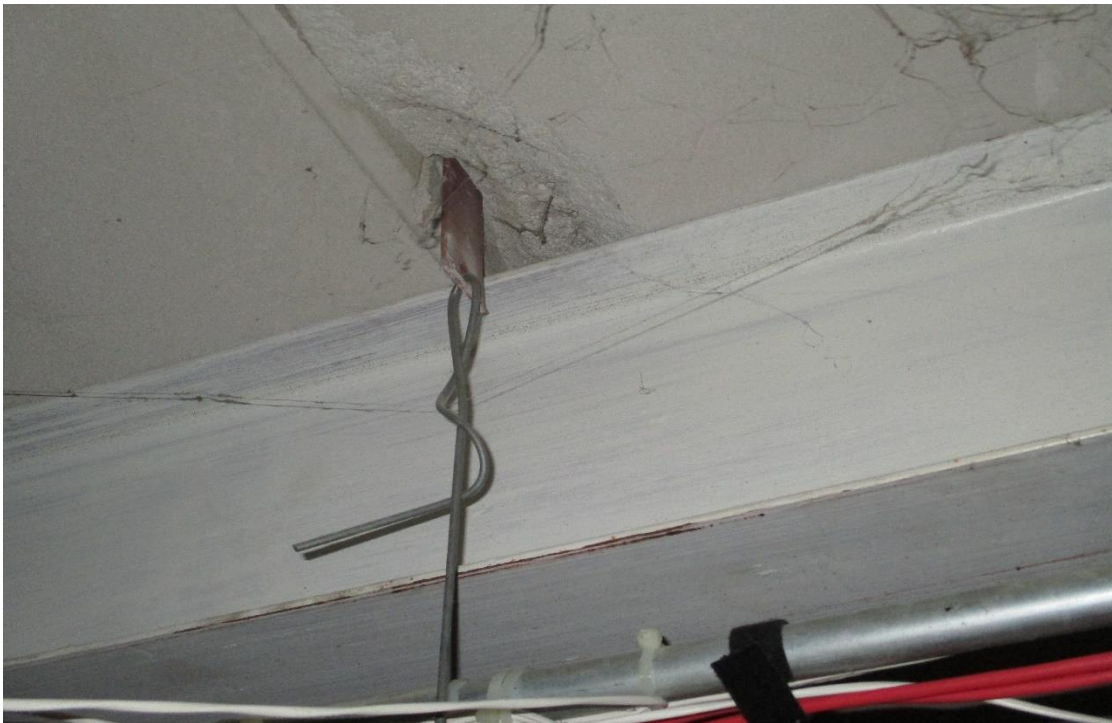
Chipping around Hanger

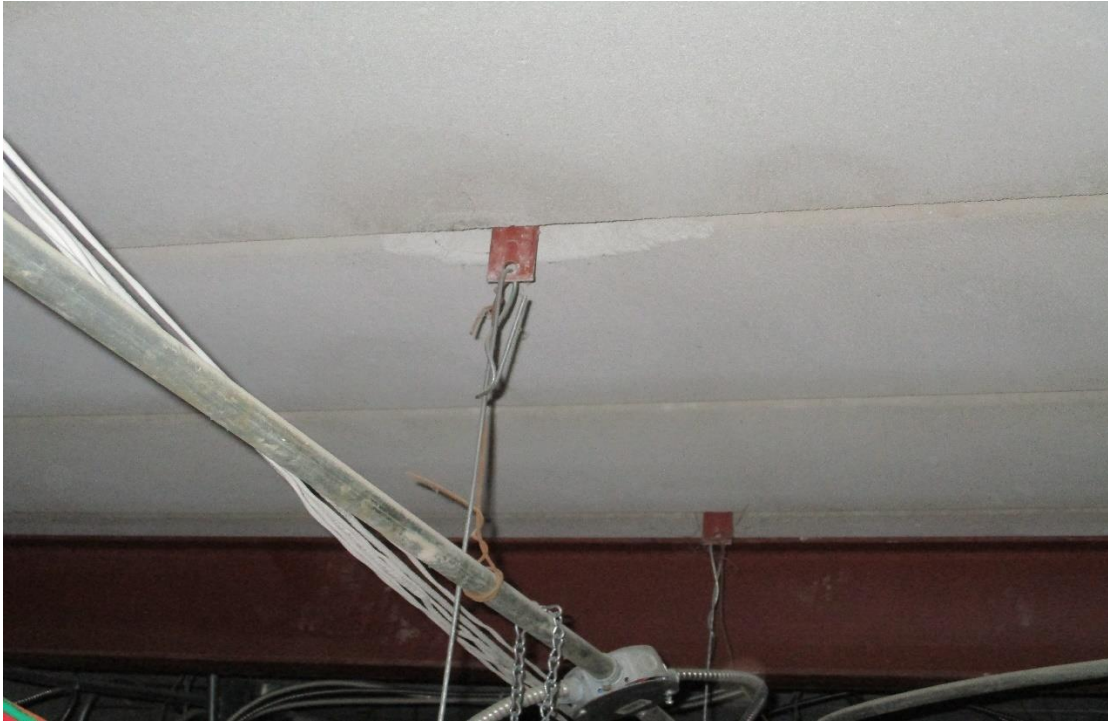
Chipping around Hanger

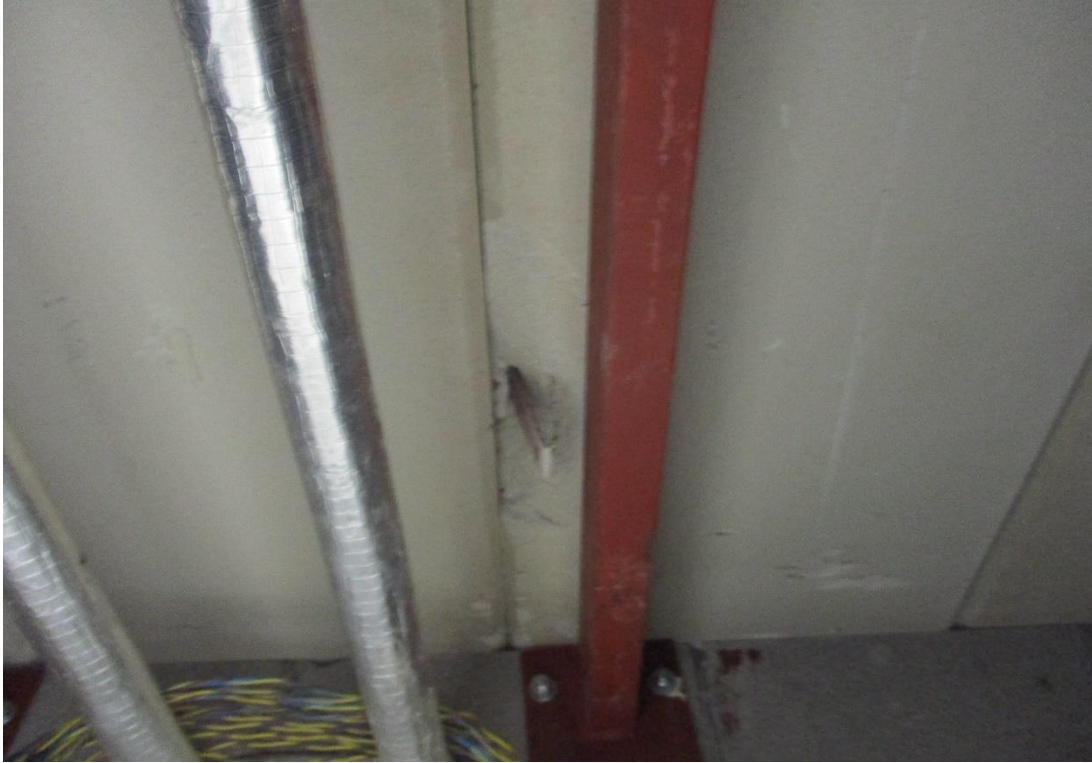
Improper Hanger

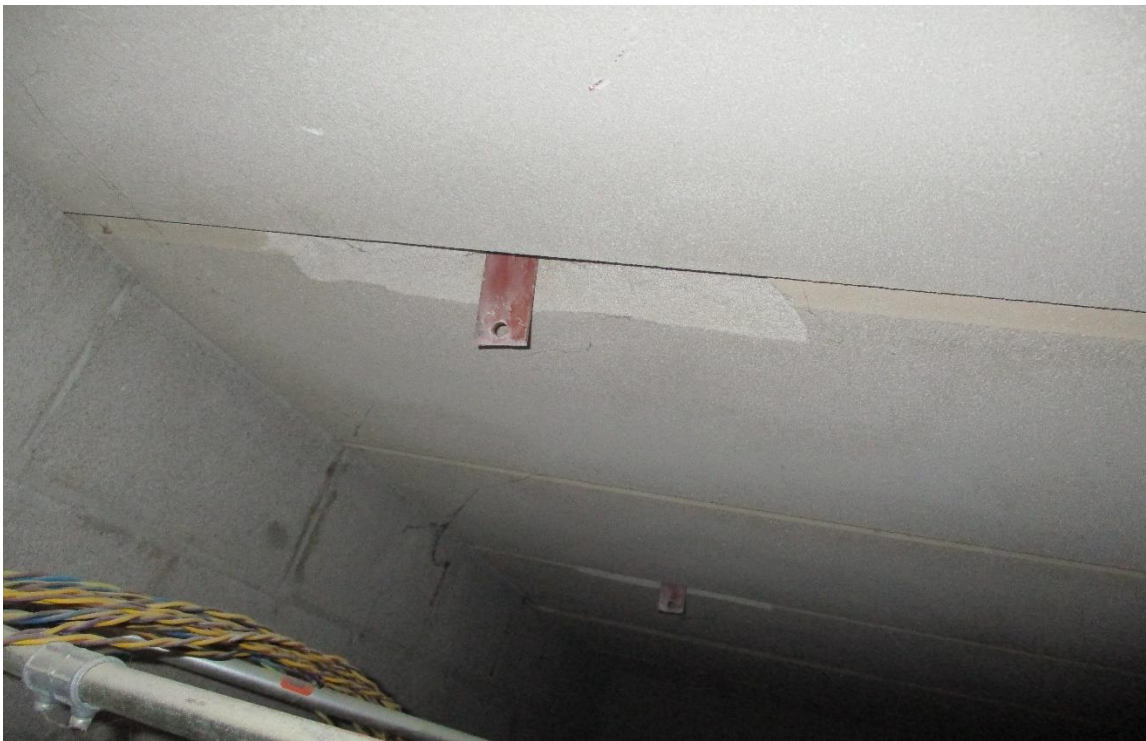
Large Gouge around Hanger

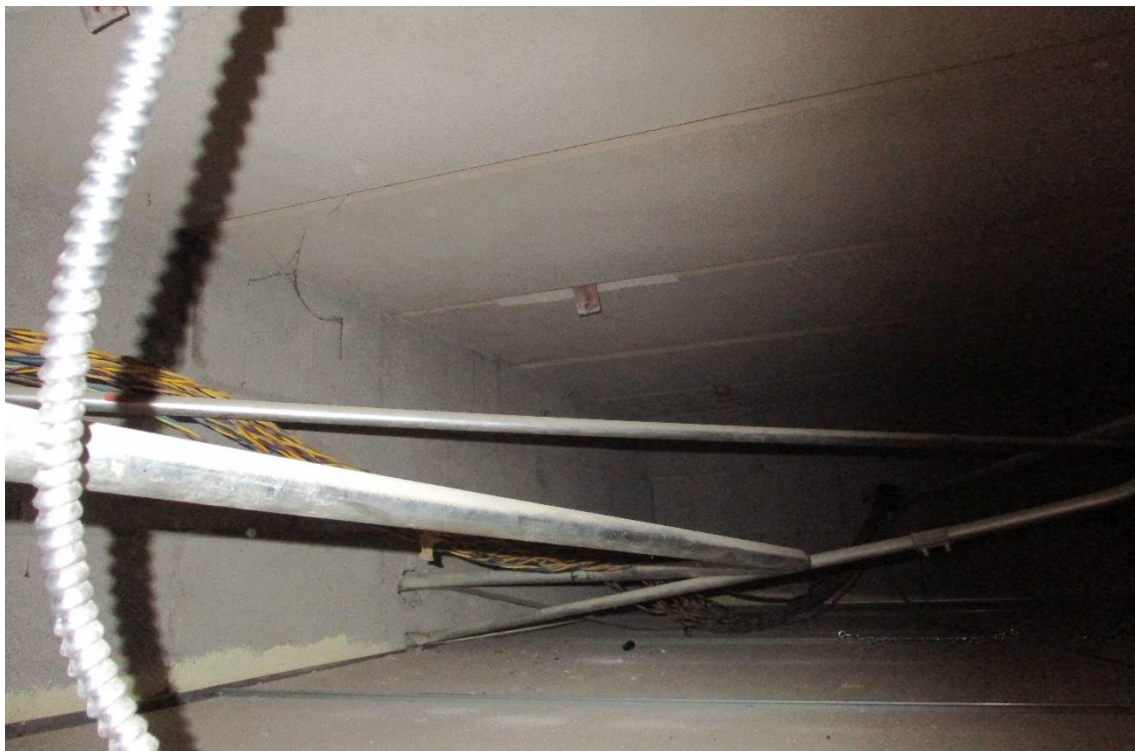
Chipping around Hanger

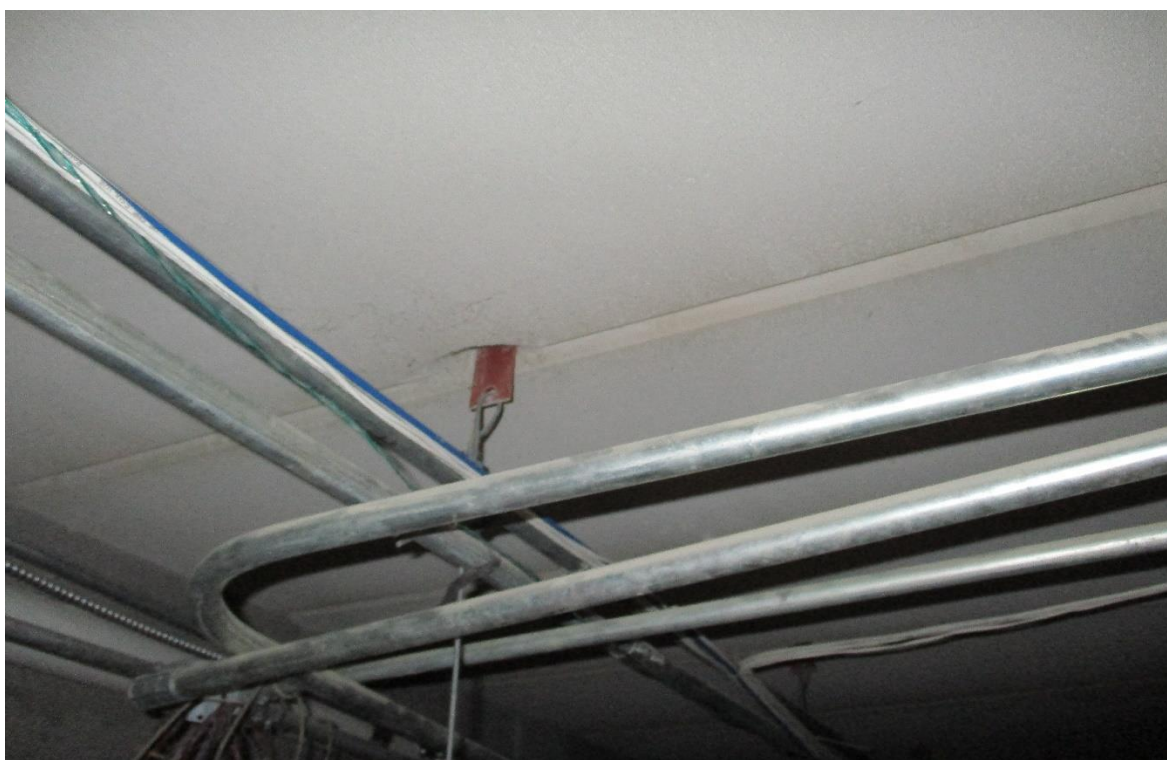
Chipping around Hanger

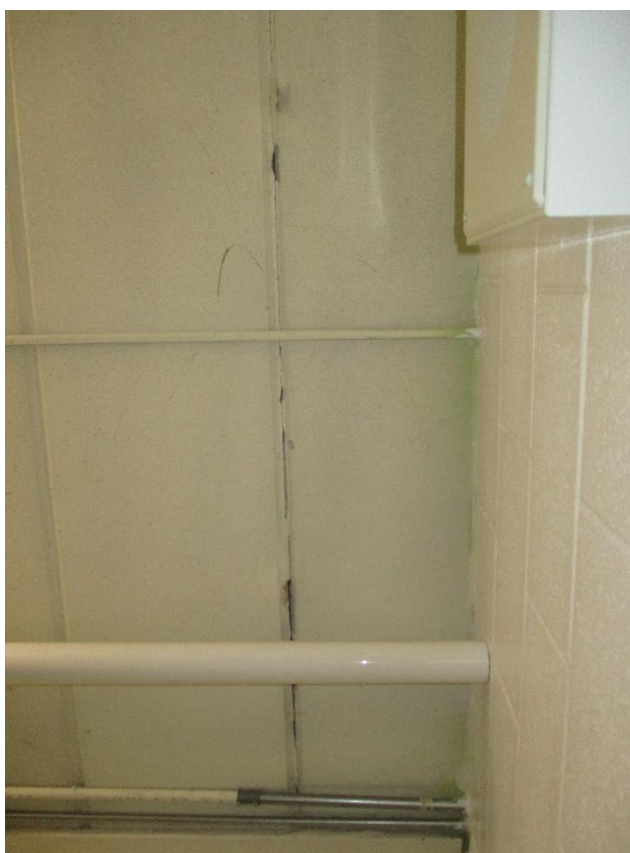
Delamination/Missing Grout

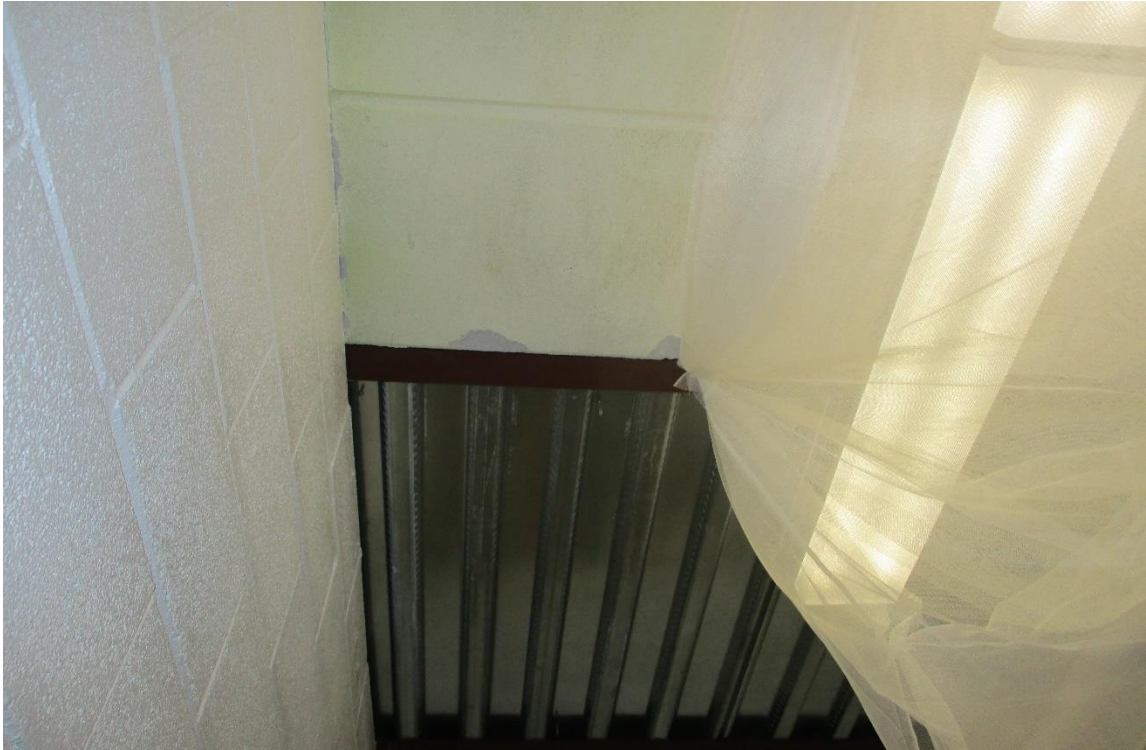
Chipping around Replacement

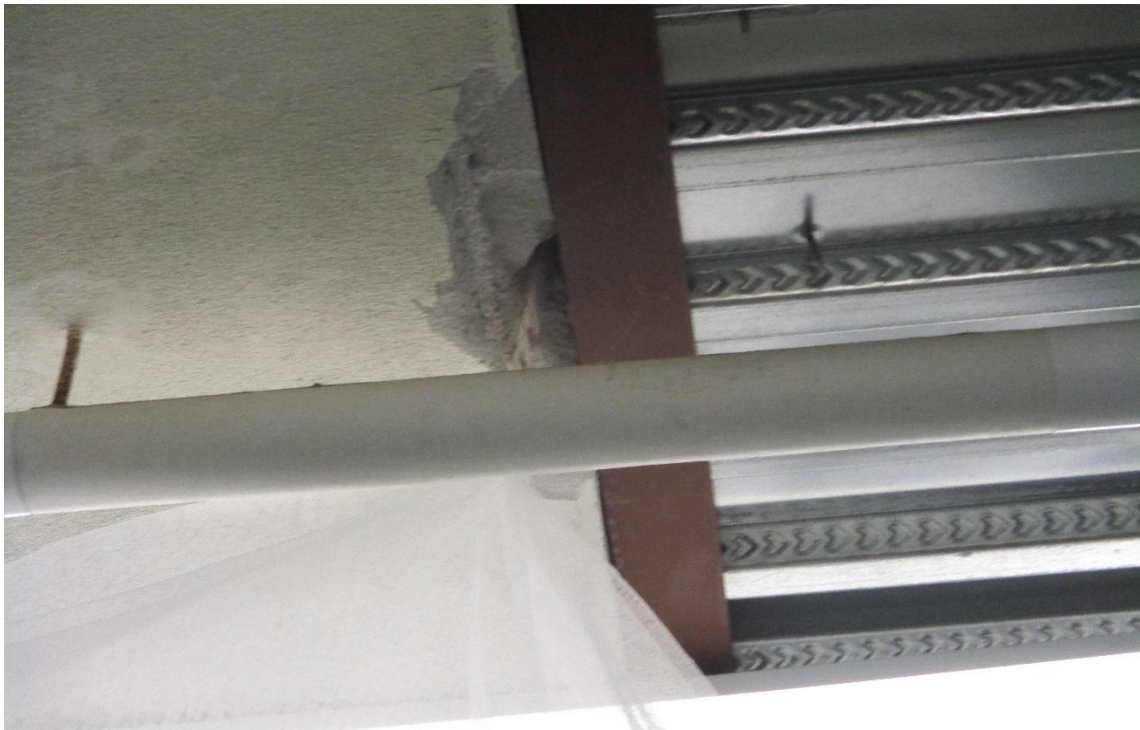
Chipping around Replacement

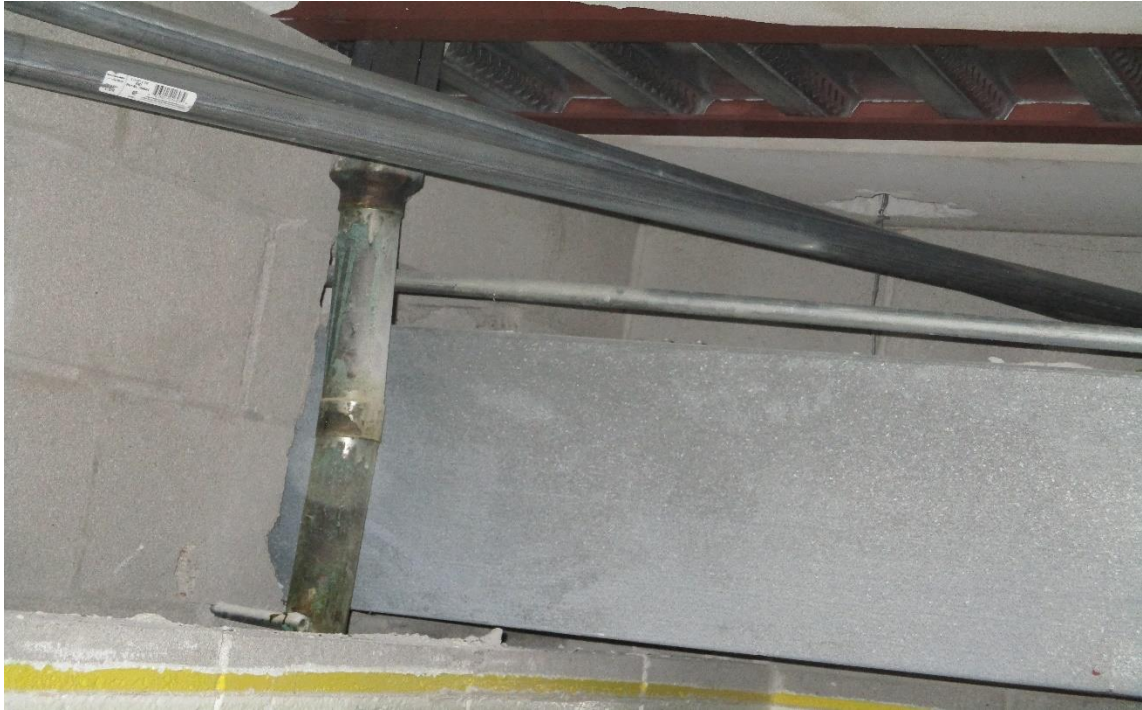
Replaced Slabs

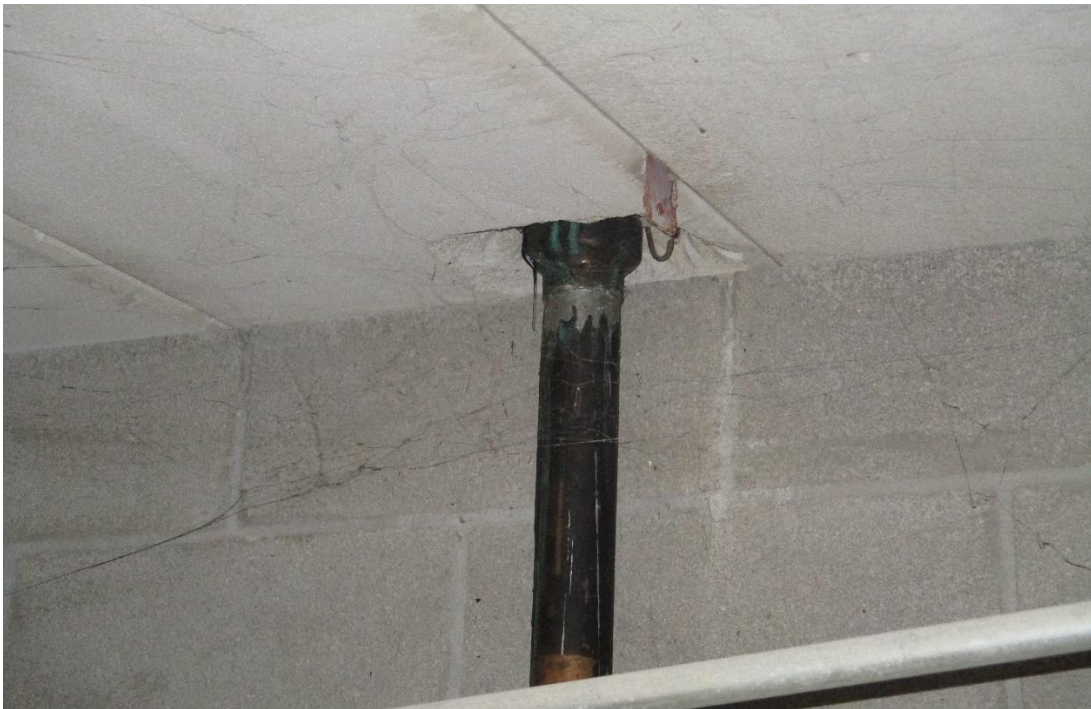
Improper Drain Penetration

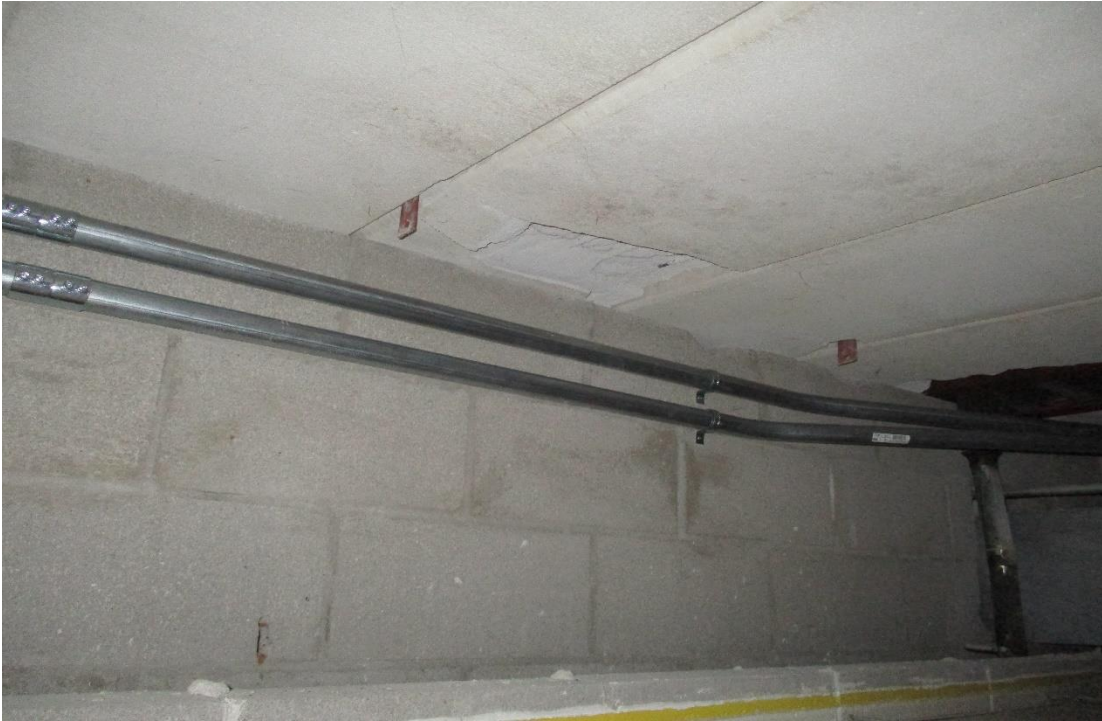
Large Surface Delamination

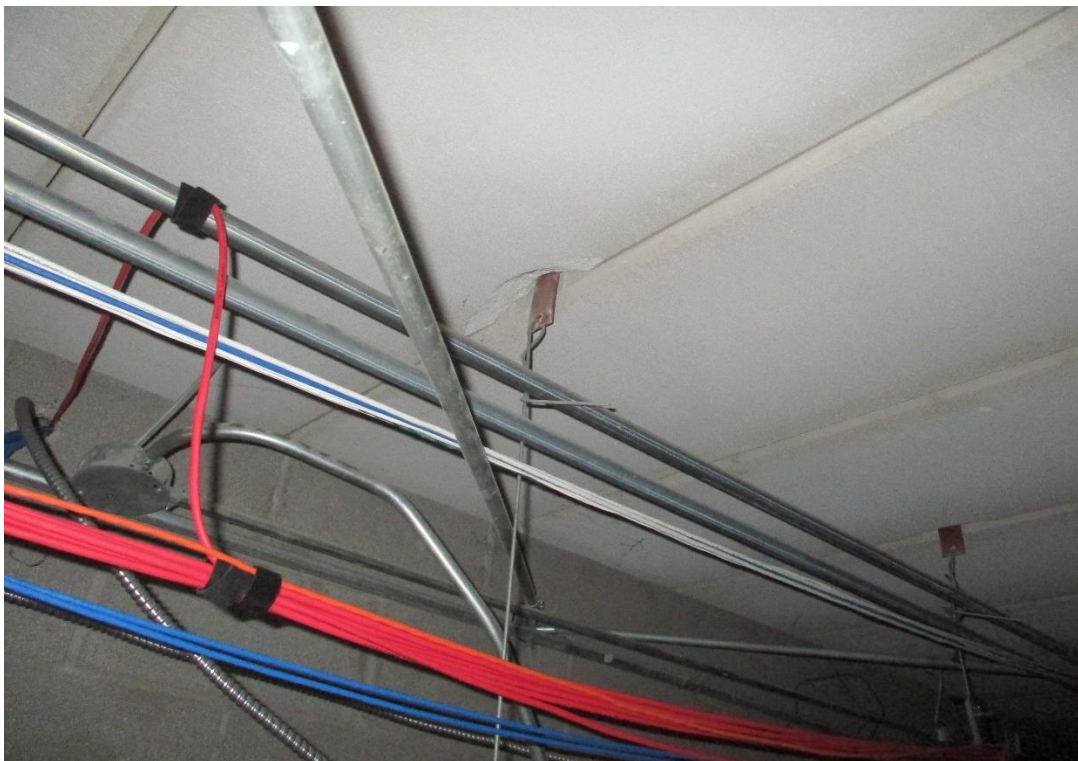
Large Surface Chipping
