Reinforced Autoclaved Aerated Concrete Assessment (Siporex) Report

Pineview Public School

Report Prepared by:
Shoalts and Zaback Architects Ltd.
SZA Project #: 24028

Report Date: 2024-08-28

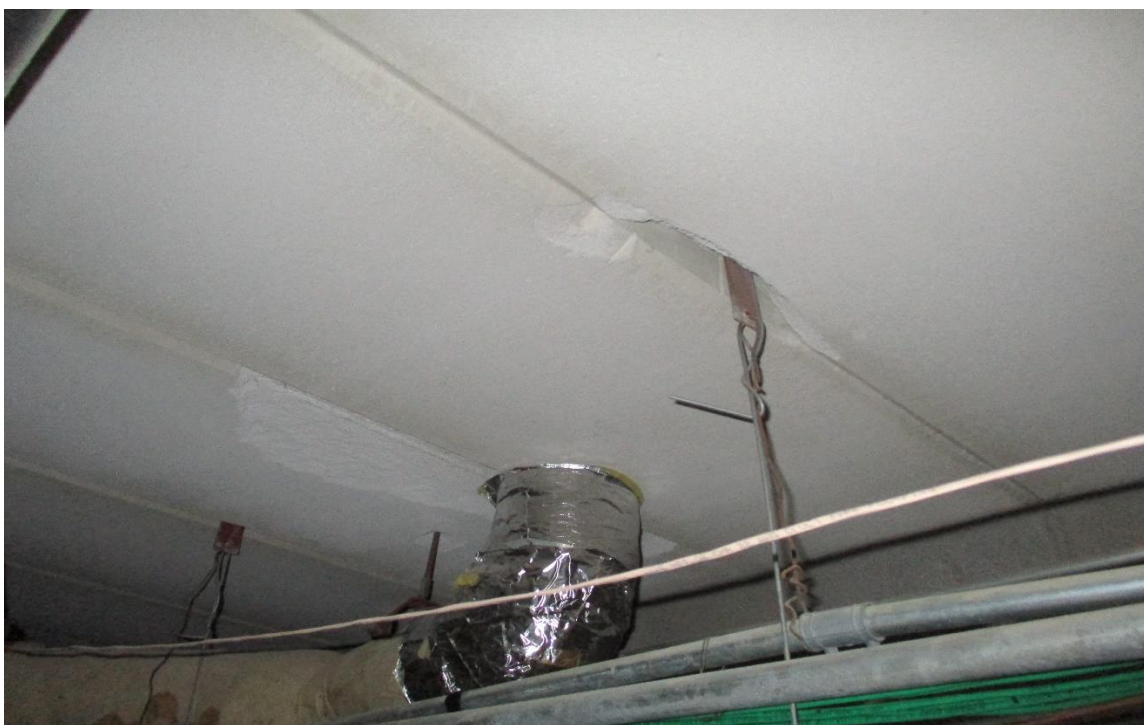
Large Surface Chipping

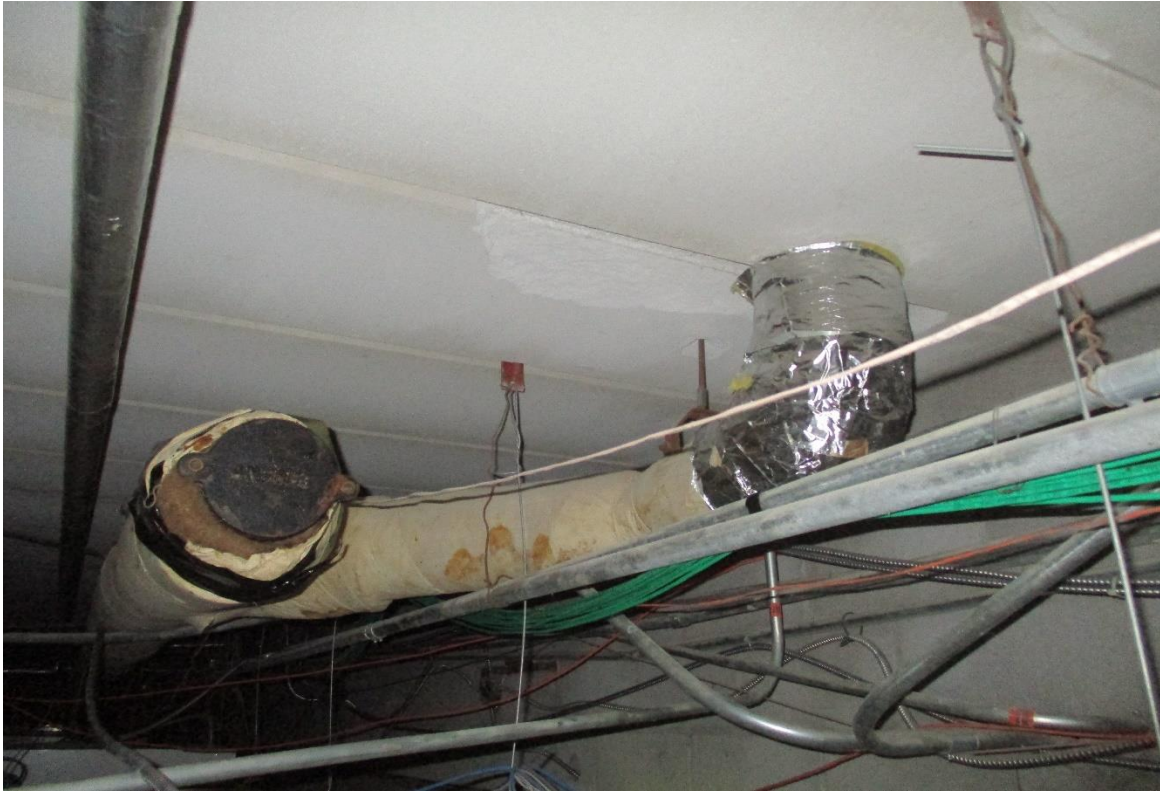
Large Surface Delamination

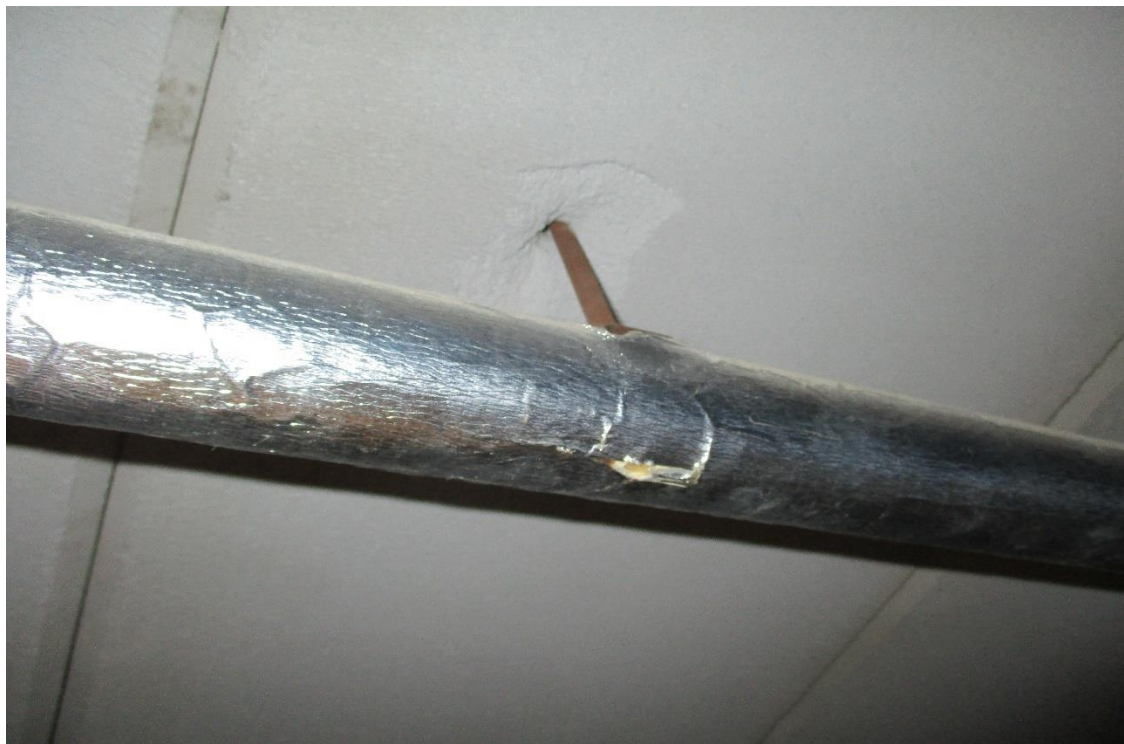
Chipping around Hanger

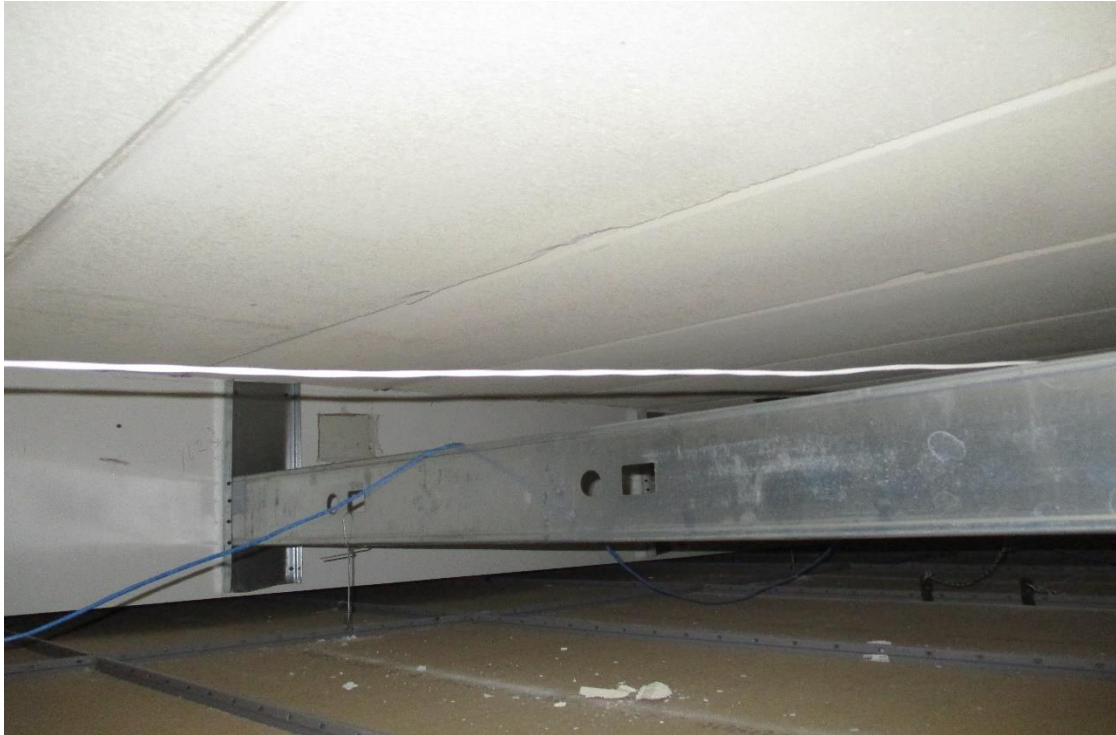
Delamination of Slabs

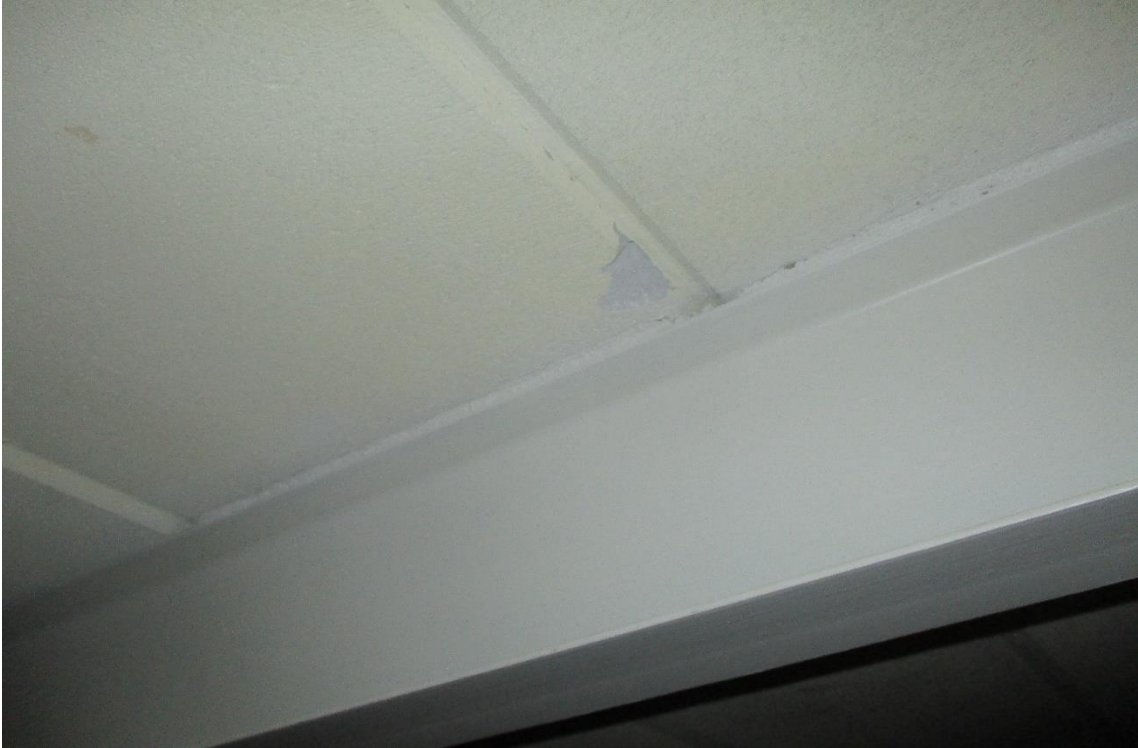
Chipping of Slabs

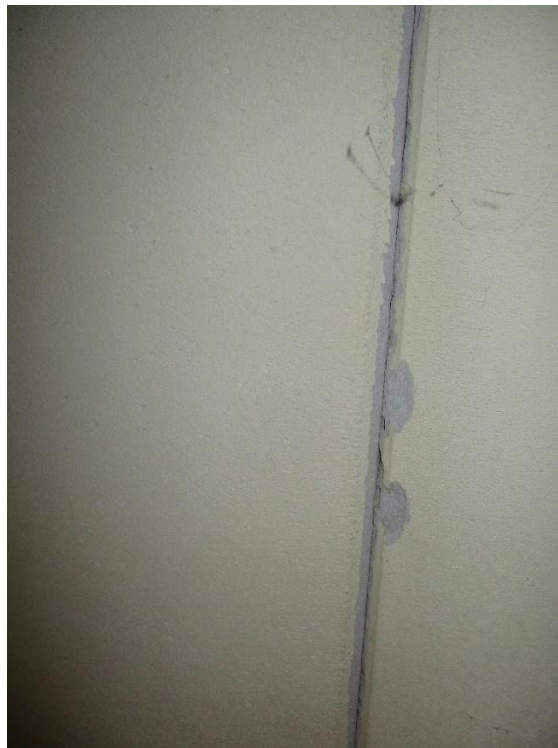
Missing Grout

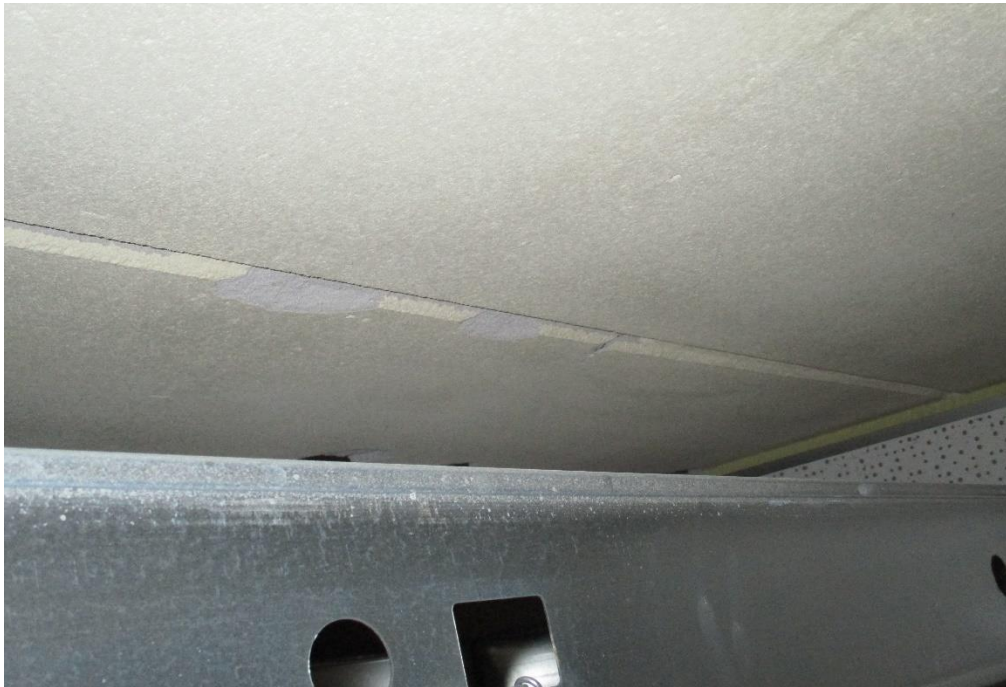
Delamination of Slabs

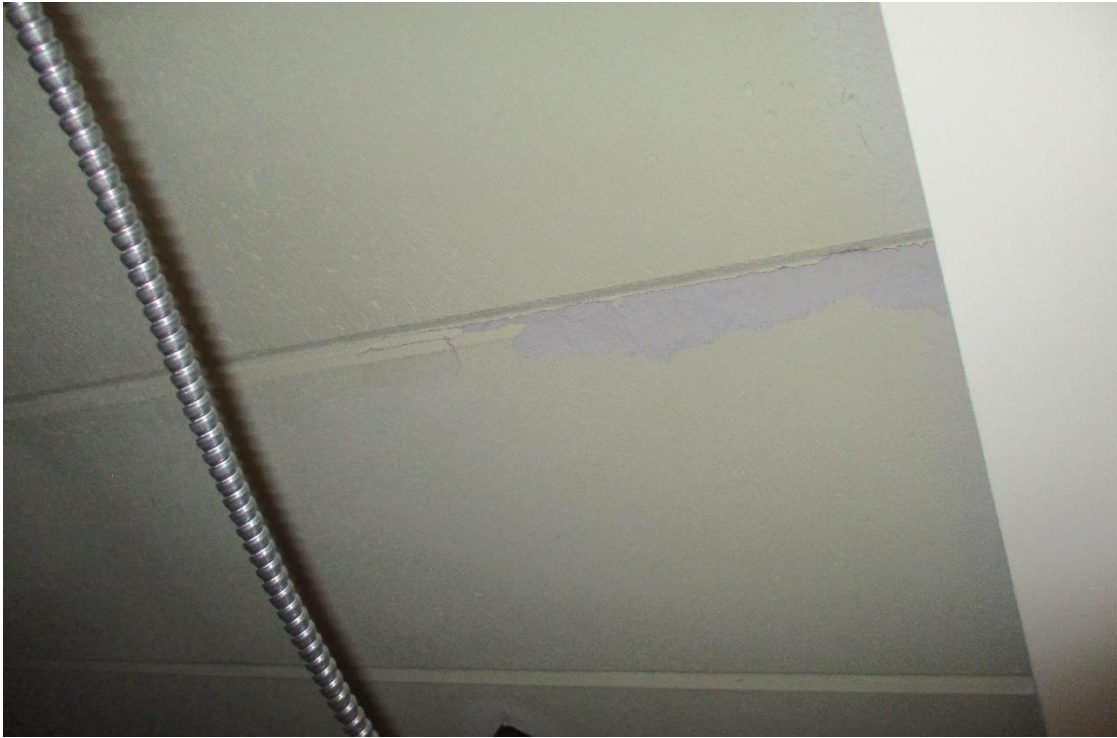
Delamination of Slabs

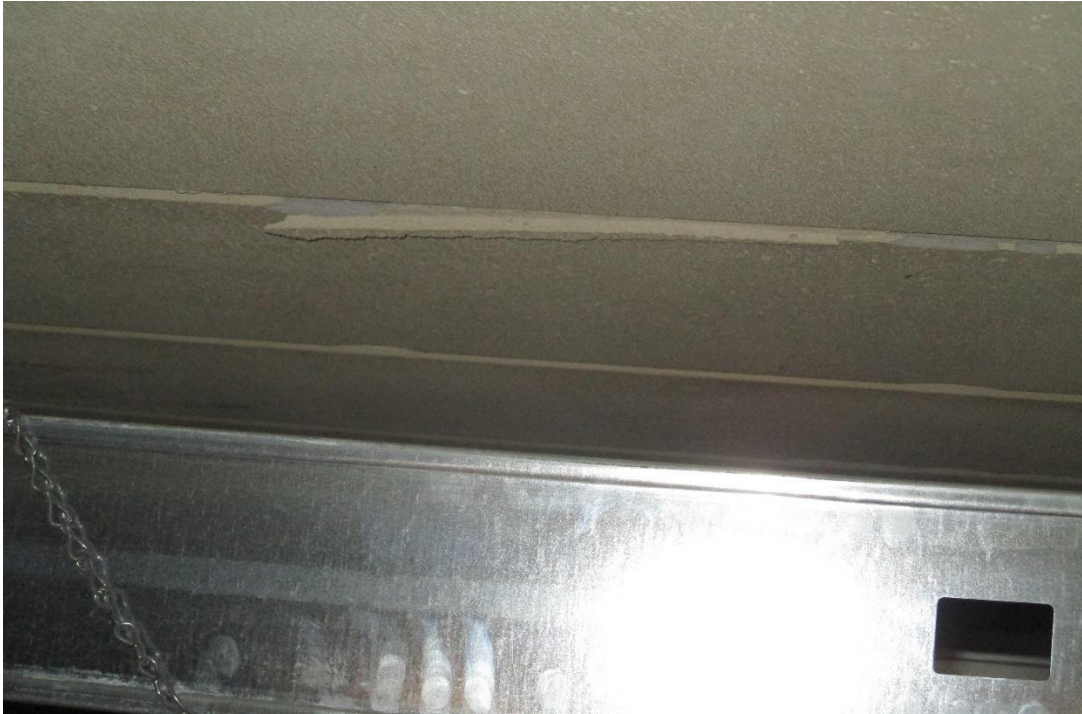
Missing Grout

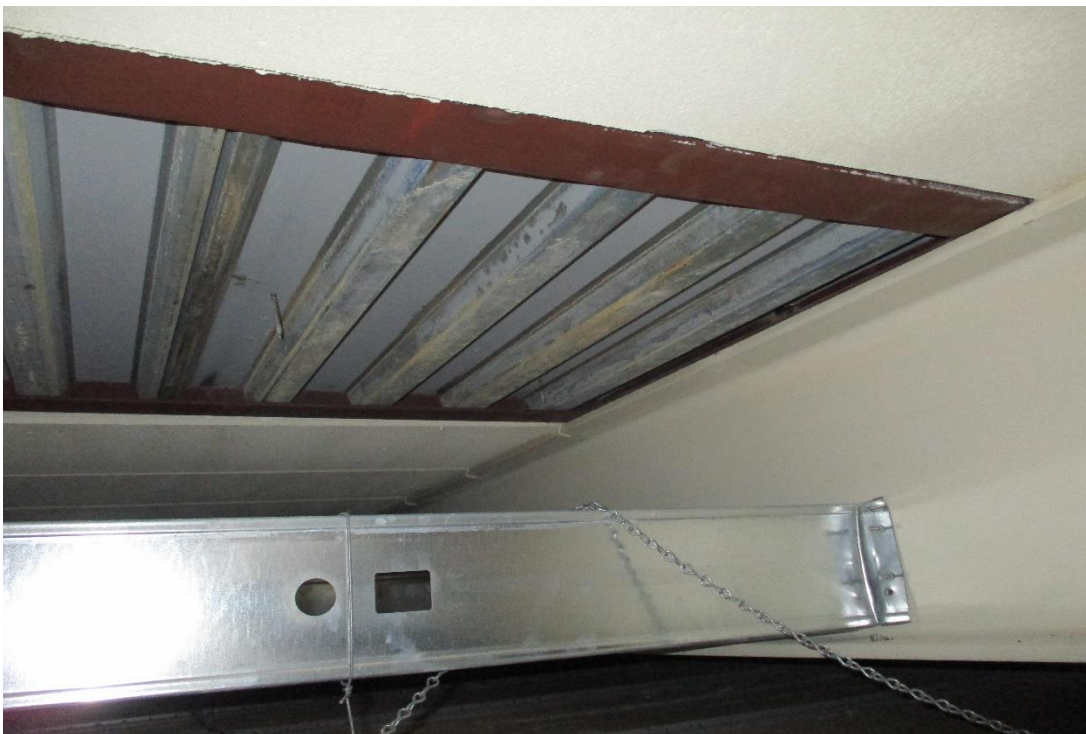
Sample of Replaced Slab

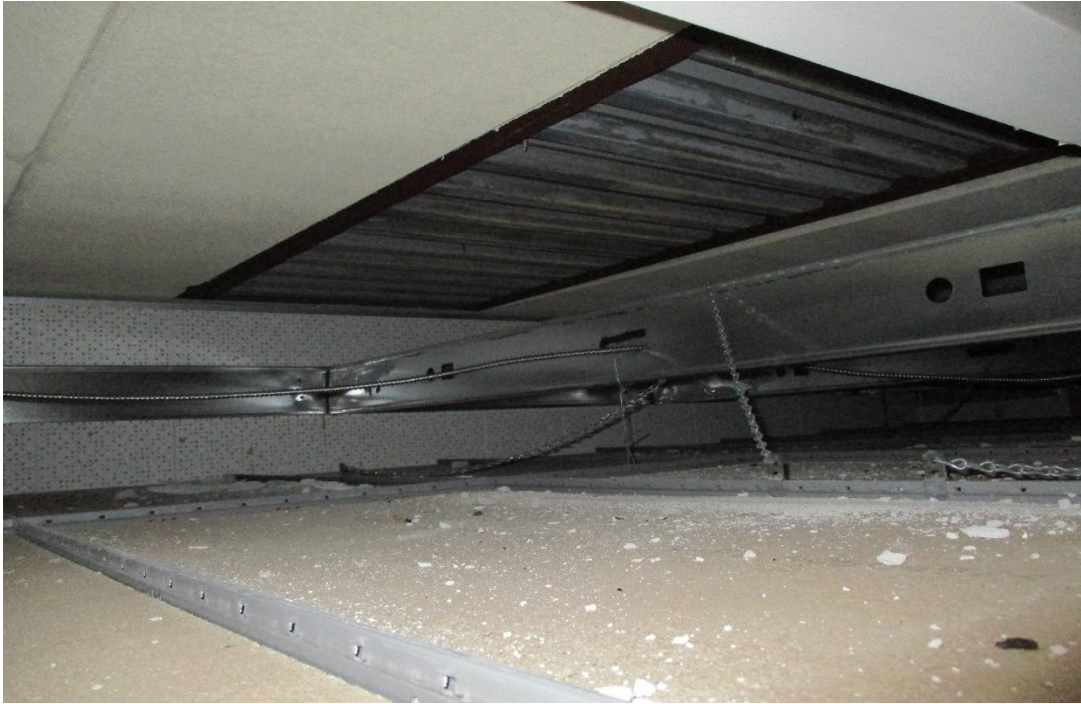
Chipping and Spalling

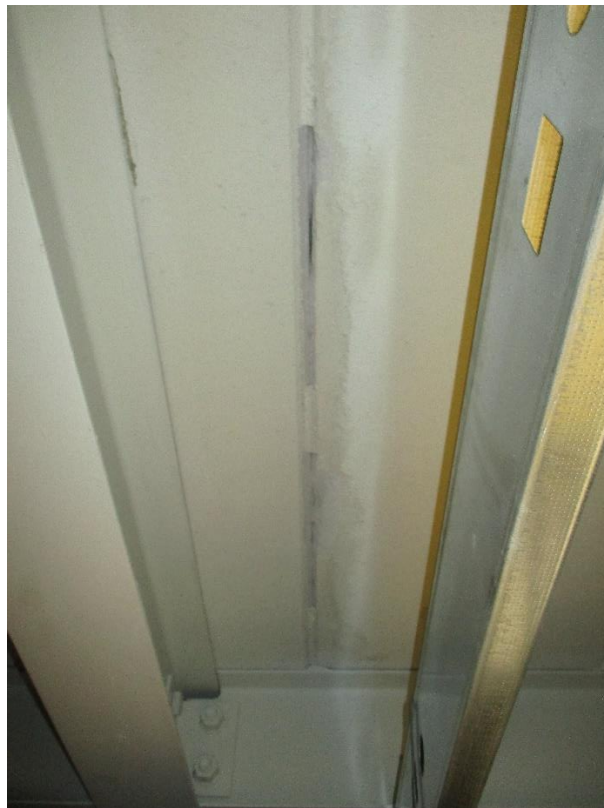
Missing Grout

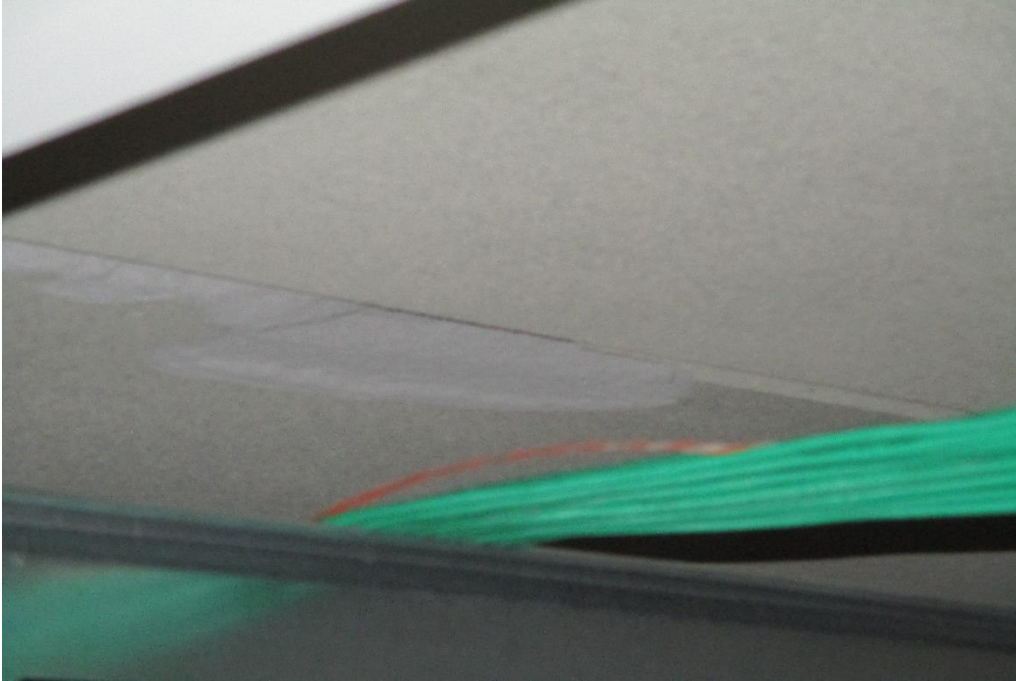
Delamination

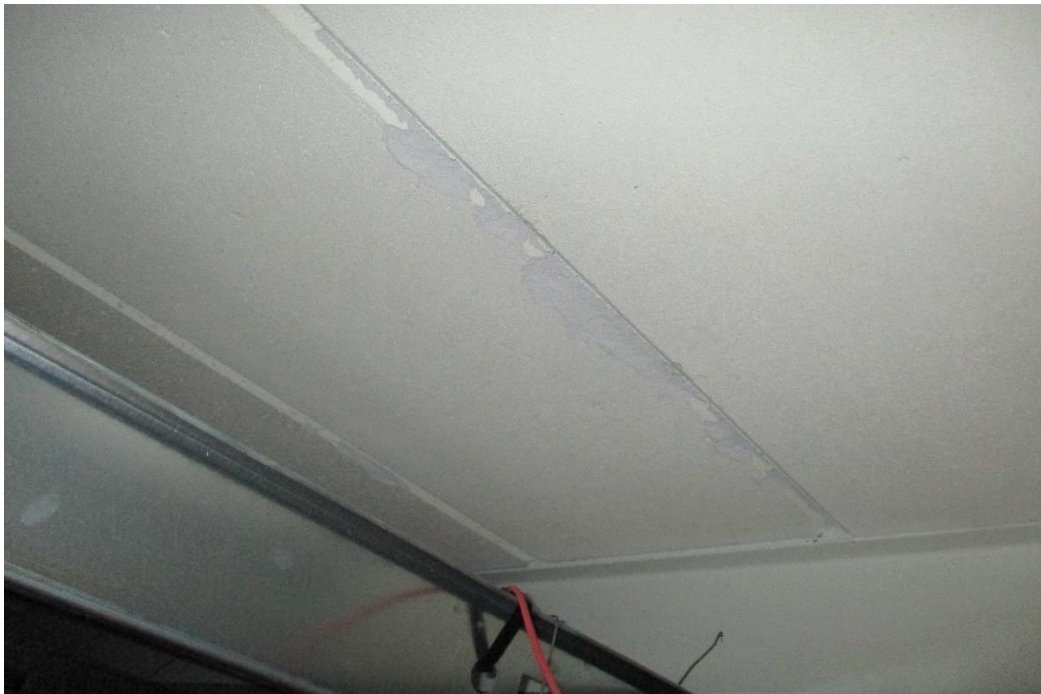
Delamination/Missing Grout

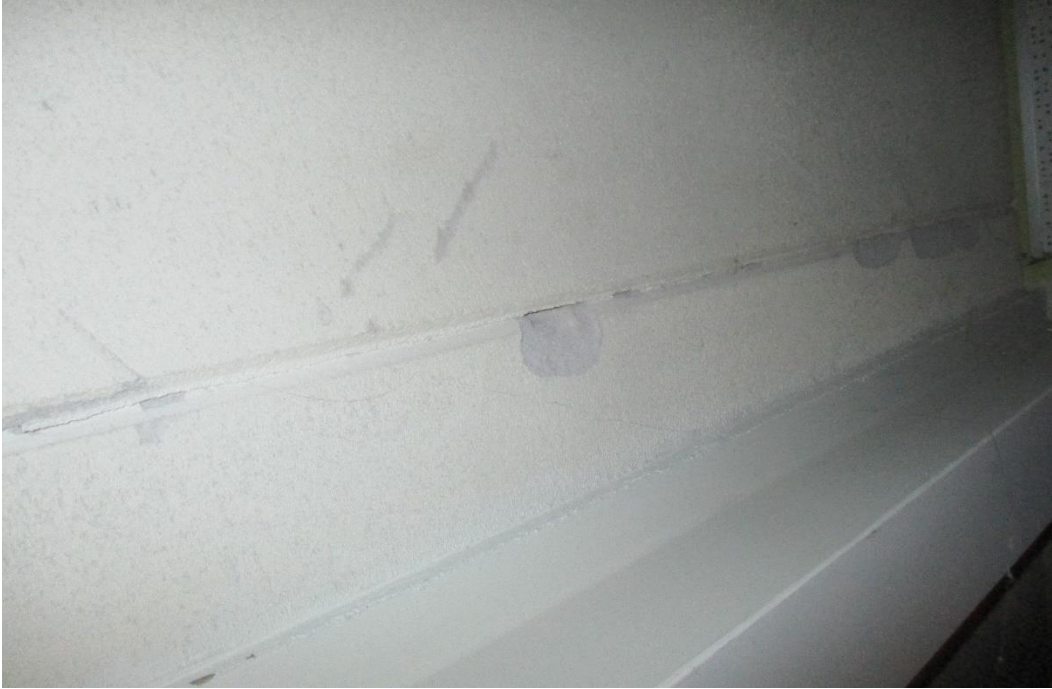
Delamination

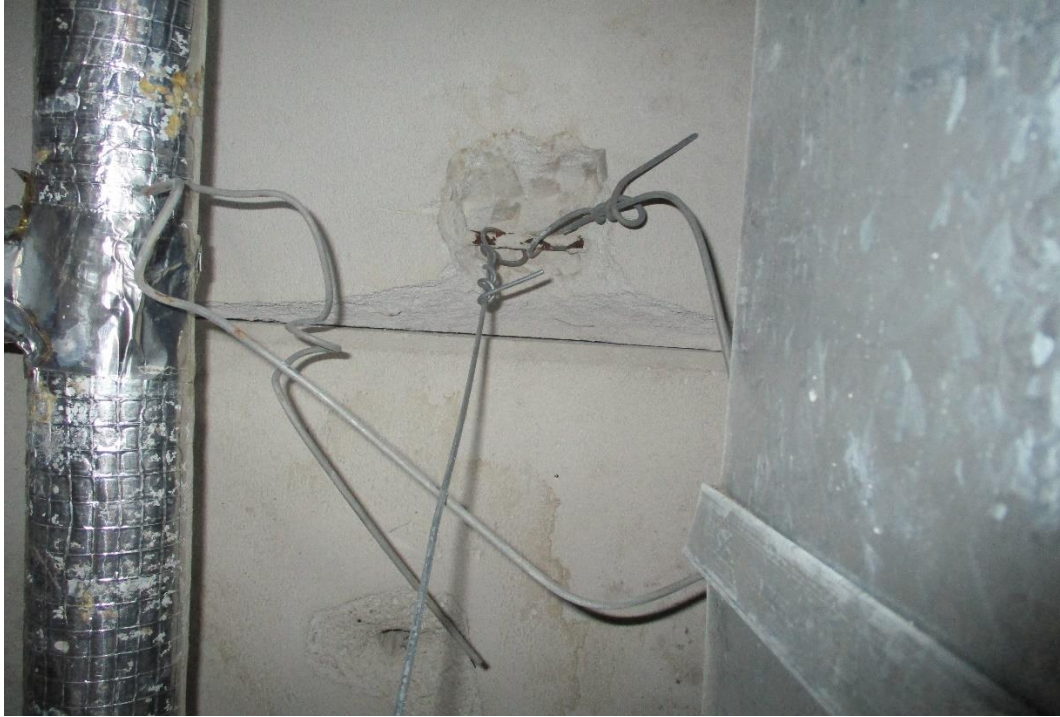
Improper Hanger

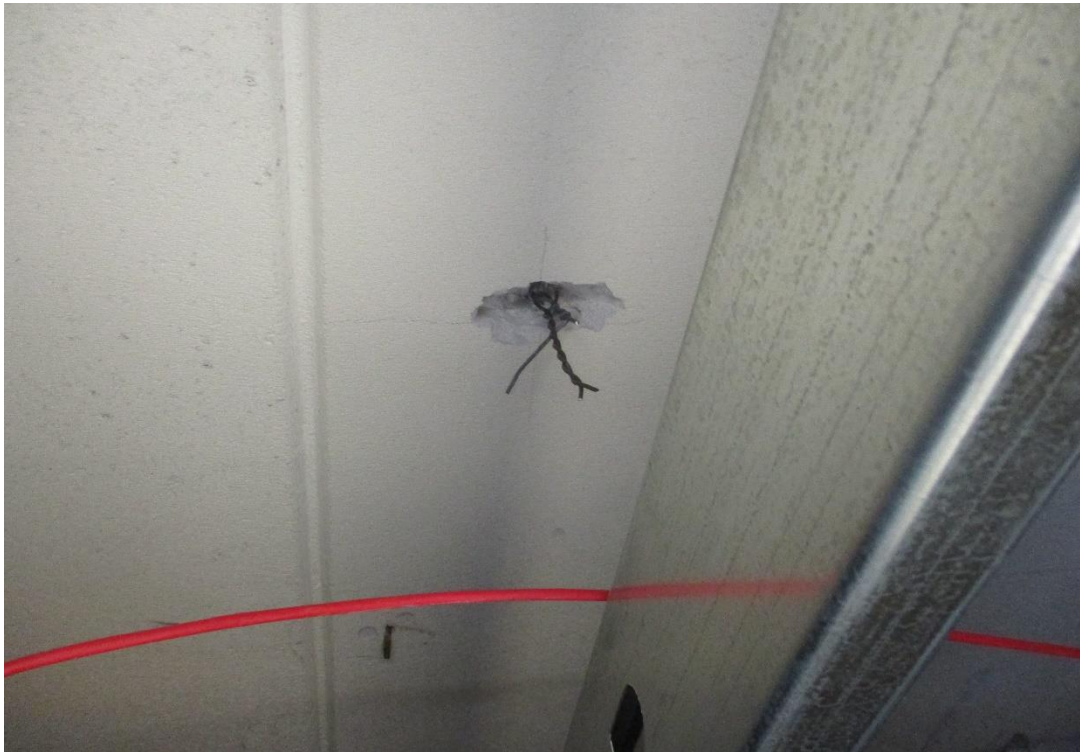
Improper Hanger

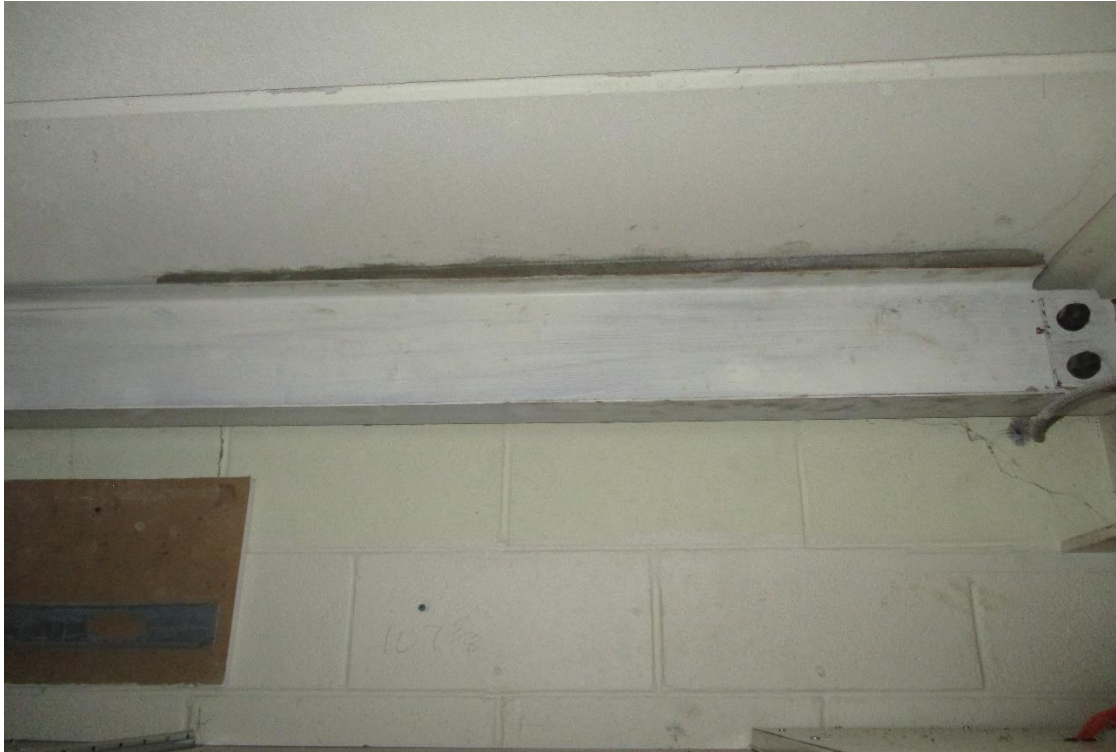
Missing Grout

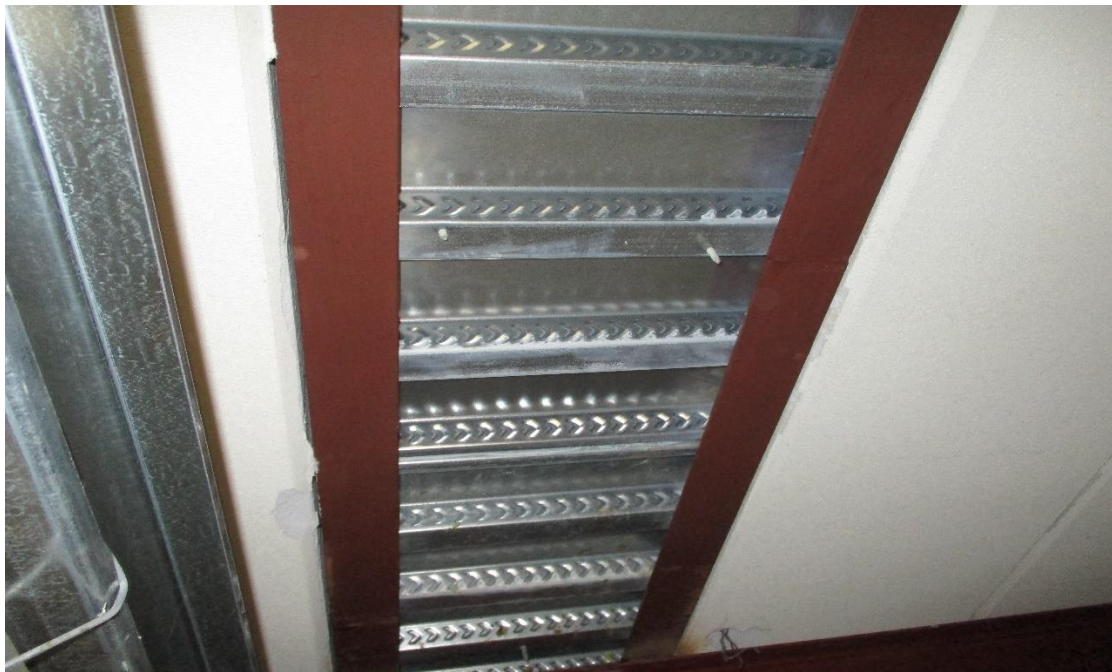
Chipping around Replacement

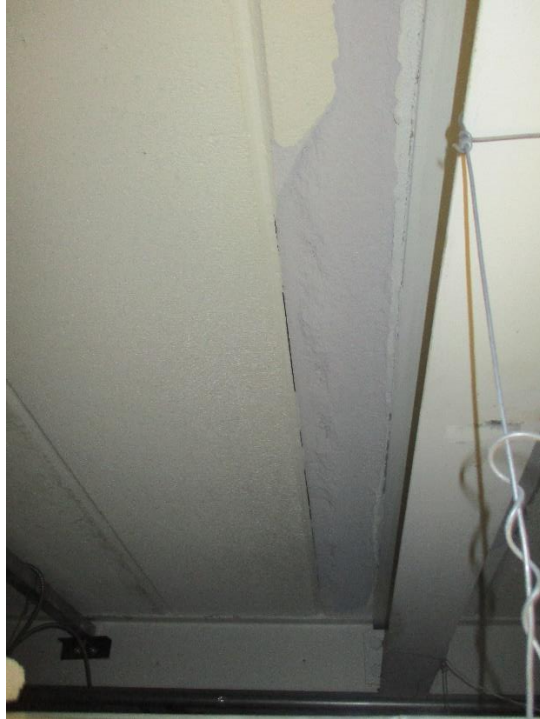
Large Surface Delamination

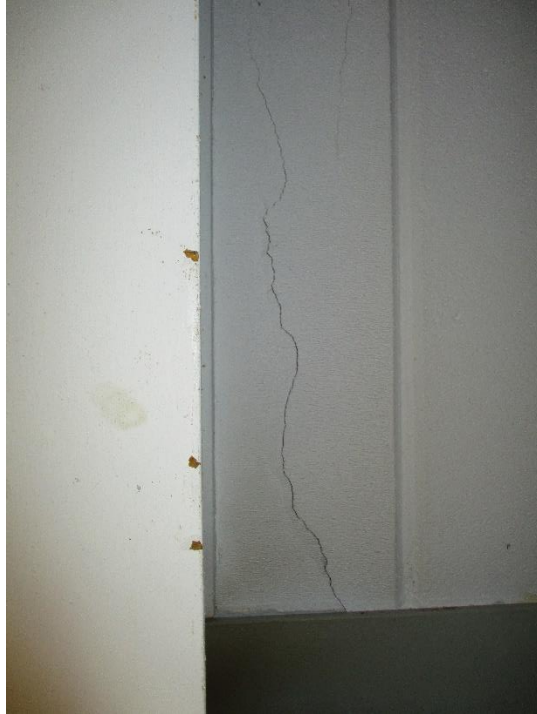
Severe Longitudinal Crack

The most severe damage observed included delamination of approximately 30% of the slab, transverse and longitudinal cracking in the slabs pose a risk for structural failure. We would advise for the installation of temporary hoarding to protect against slab failure at these locations (6 areas identified). We recommend immediate intervention to ensure the safety of building occupants.

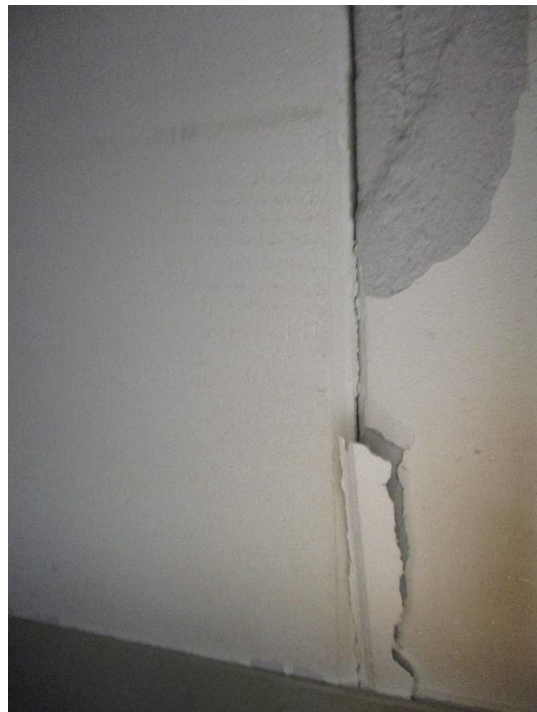
Severe Delamination and Cracking

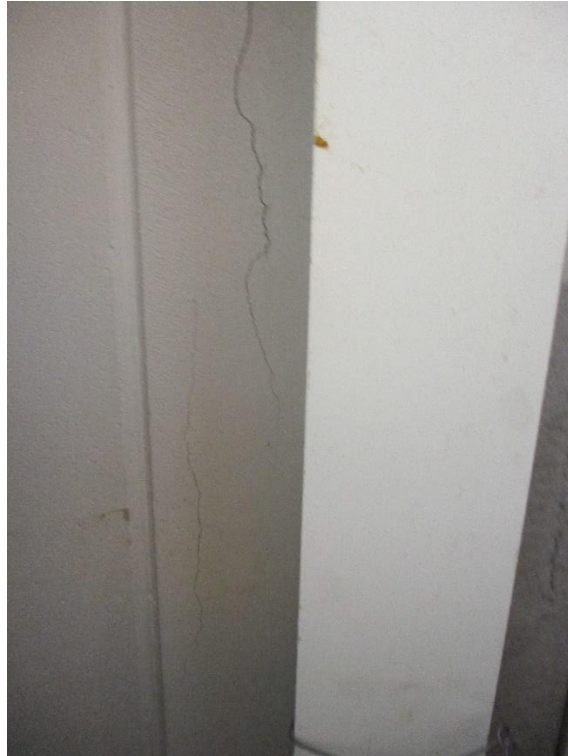
Severe Longitudinal Cracking

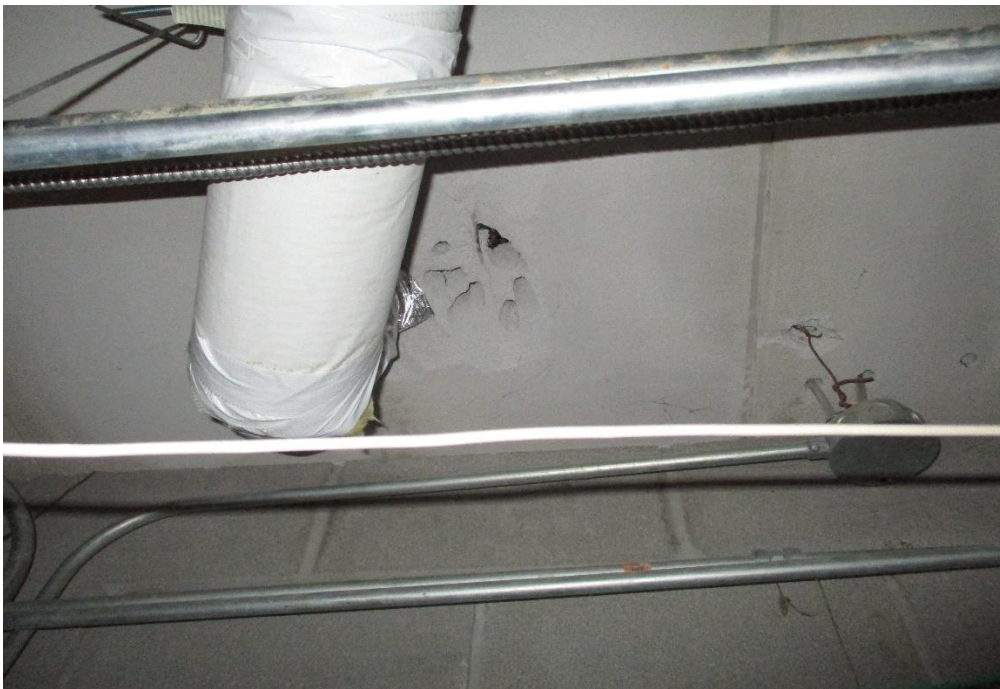
Chipping and Gouging

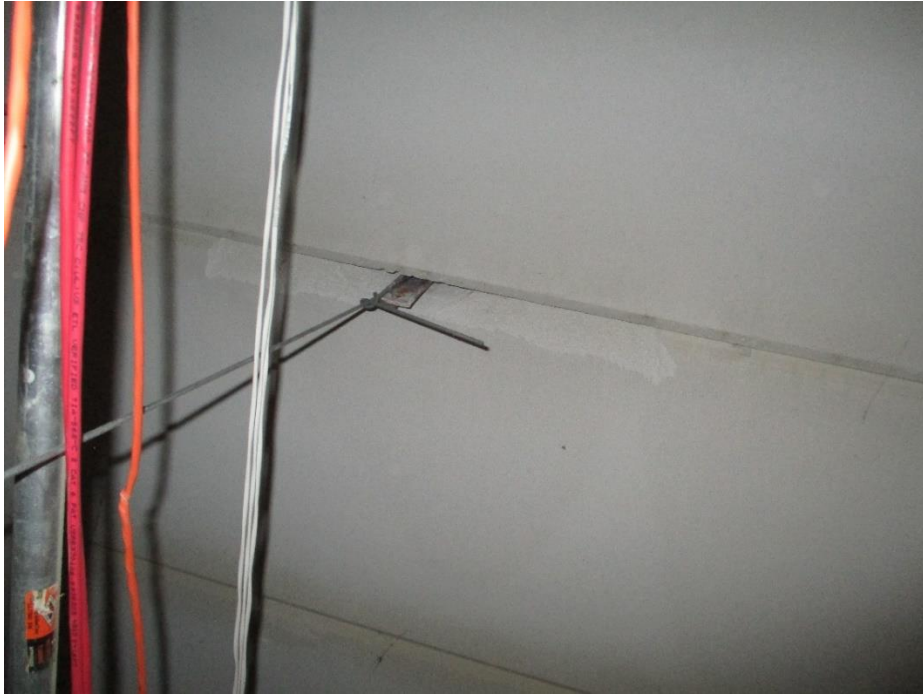
Improper Hanger

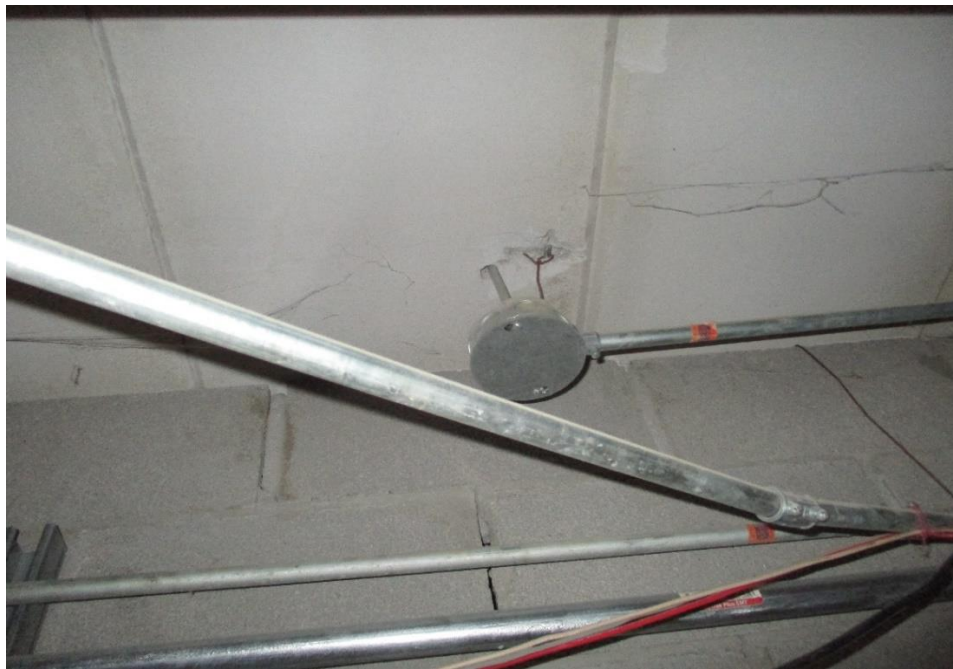
Improper Service Penetration

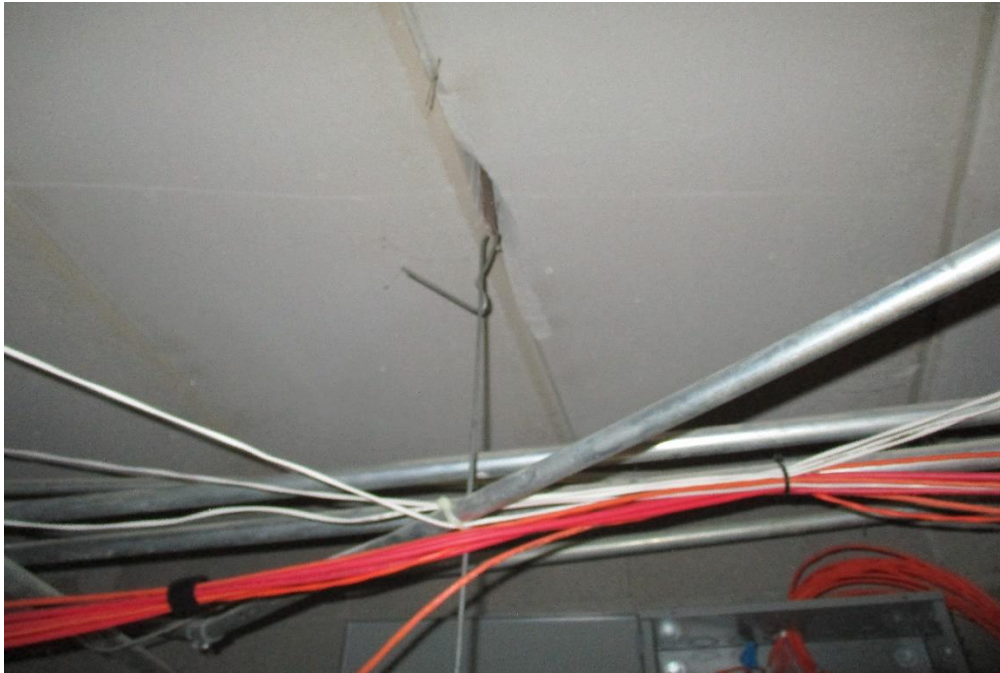
Improper Hanger

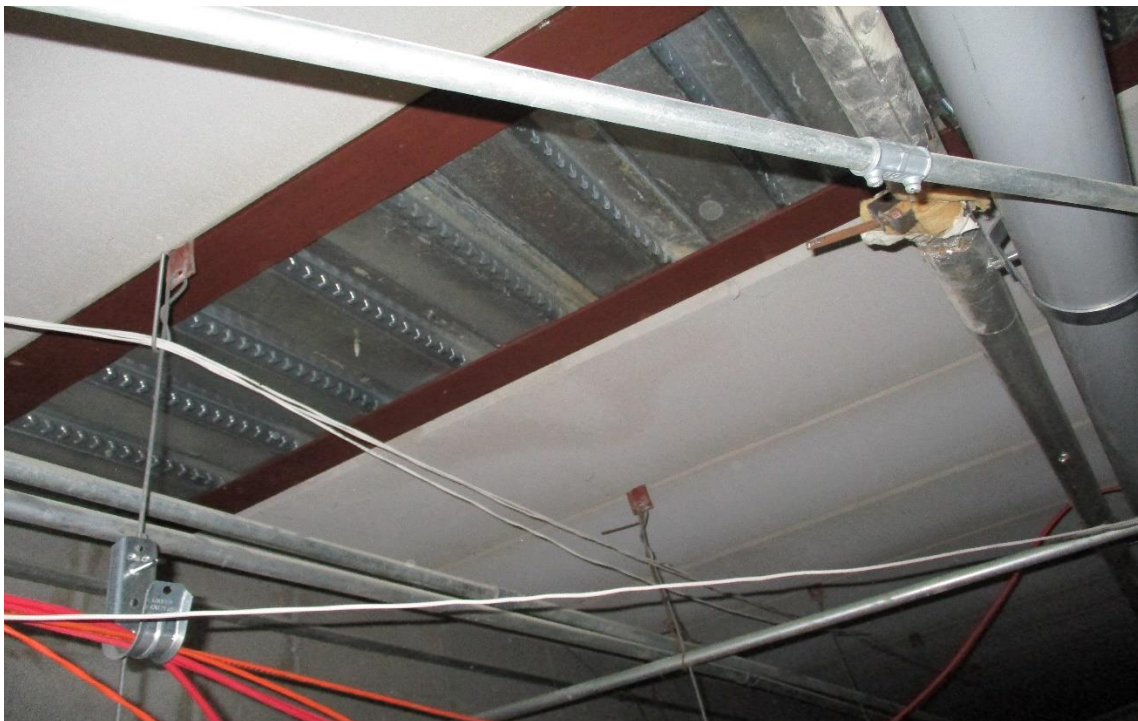
Slab Replaced

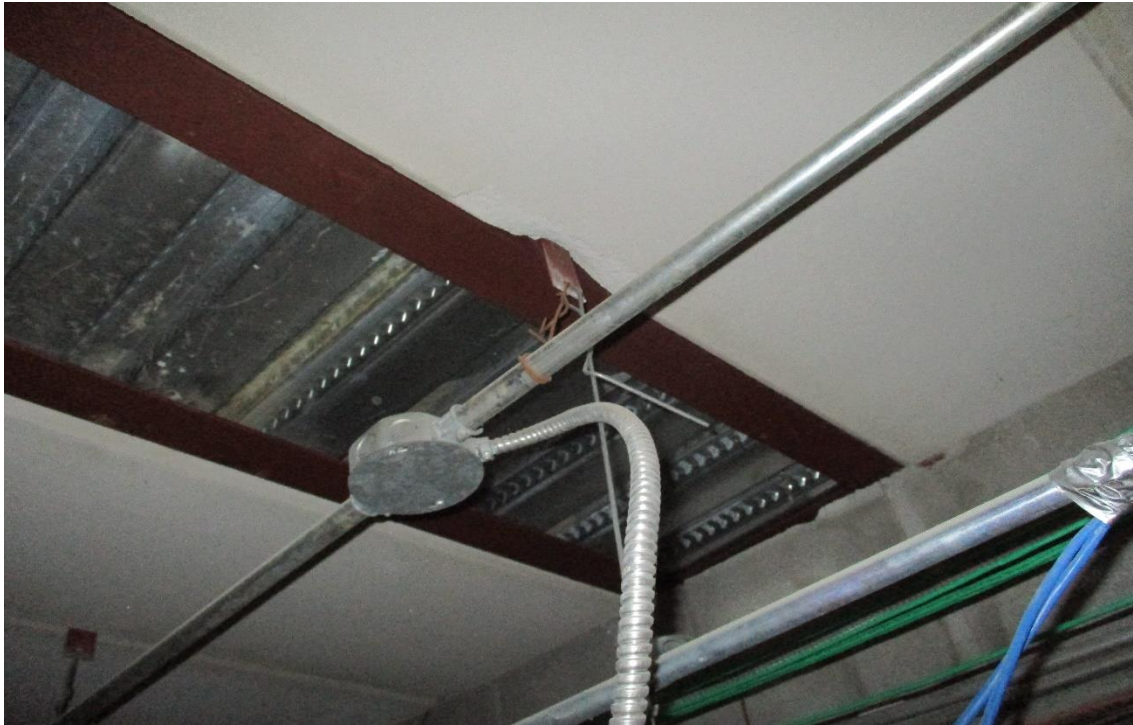
Chipping around Replaced Slab

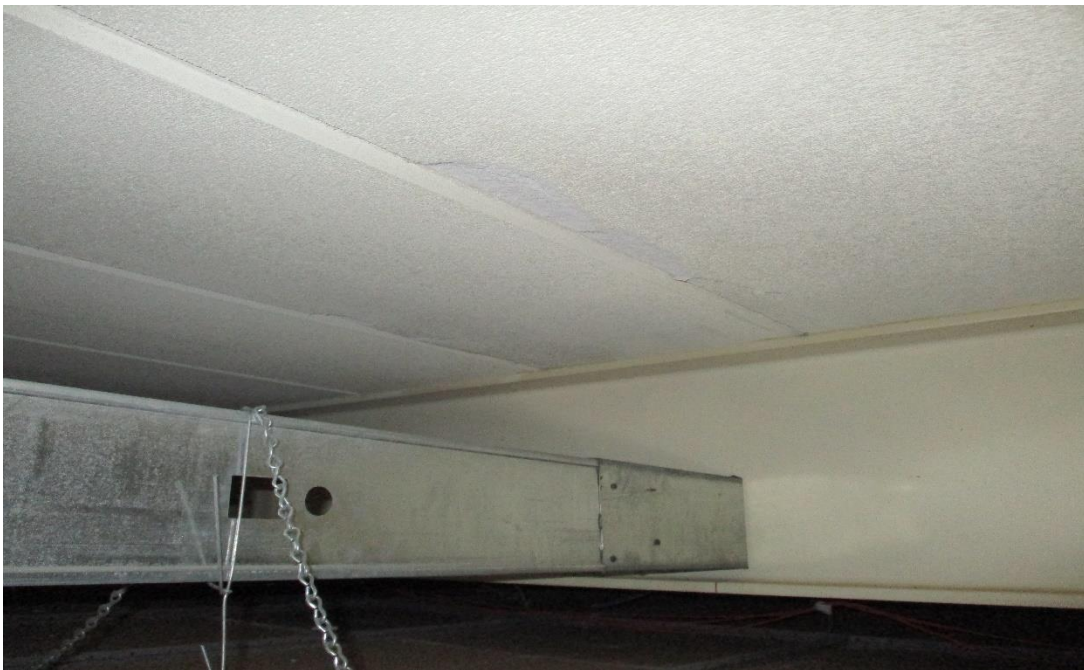
Delamination

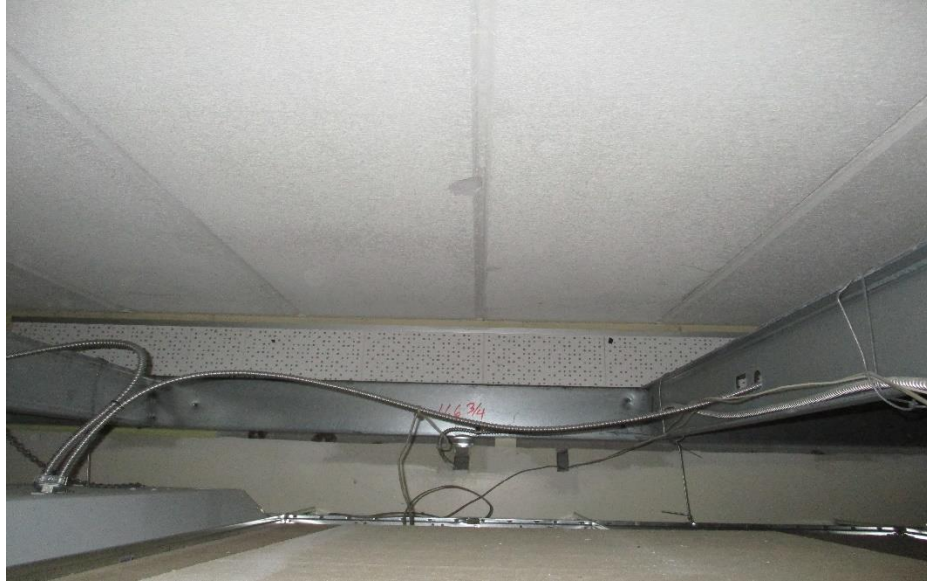
Previous Repaired Grout

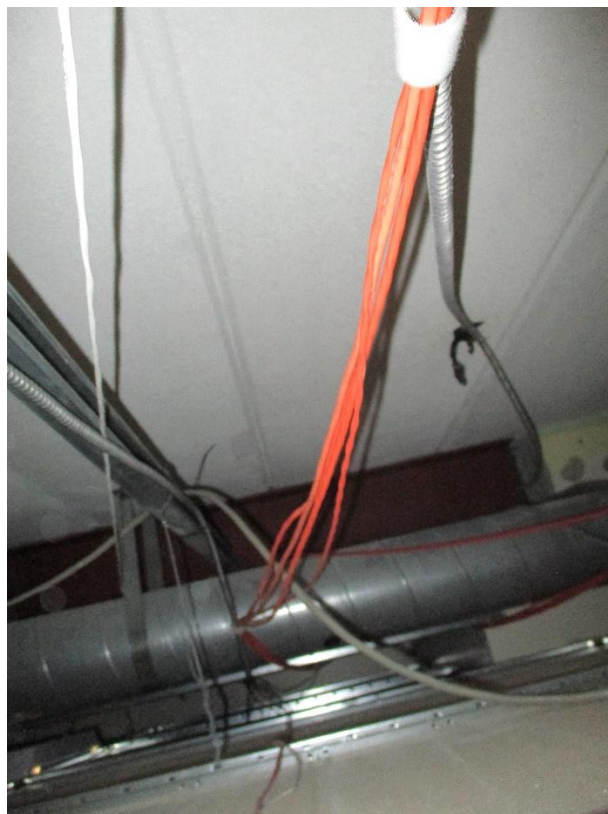
Chipping and Spalling

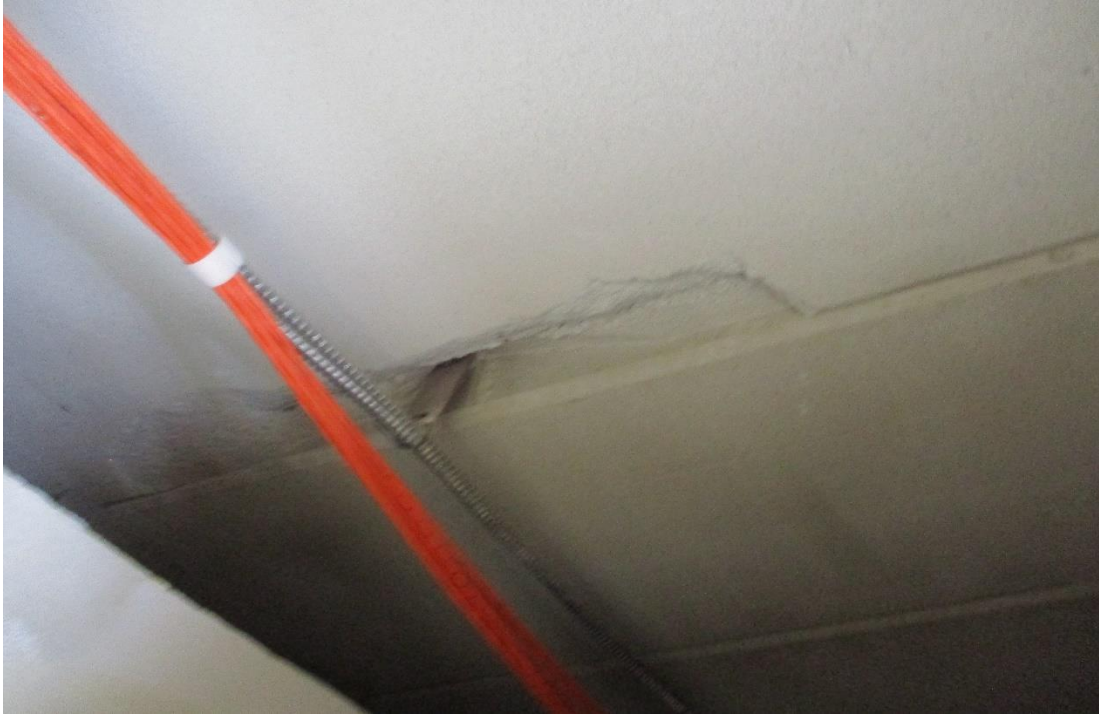
Chipped at Hanger
