Reinforced Autoclaved Aerated Concrete Assessment (Siporex) Report

Pineview Public School

Report Prepared by:
Shoalts and Zaback Architects Ltd.
SZA Project #: 24028

Report Date: 2024-08-28

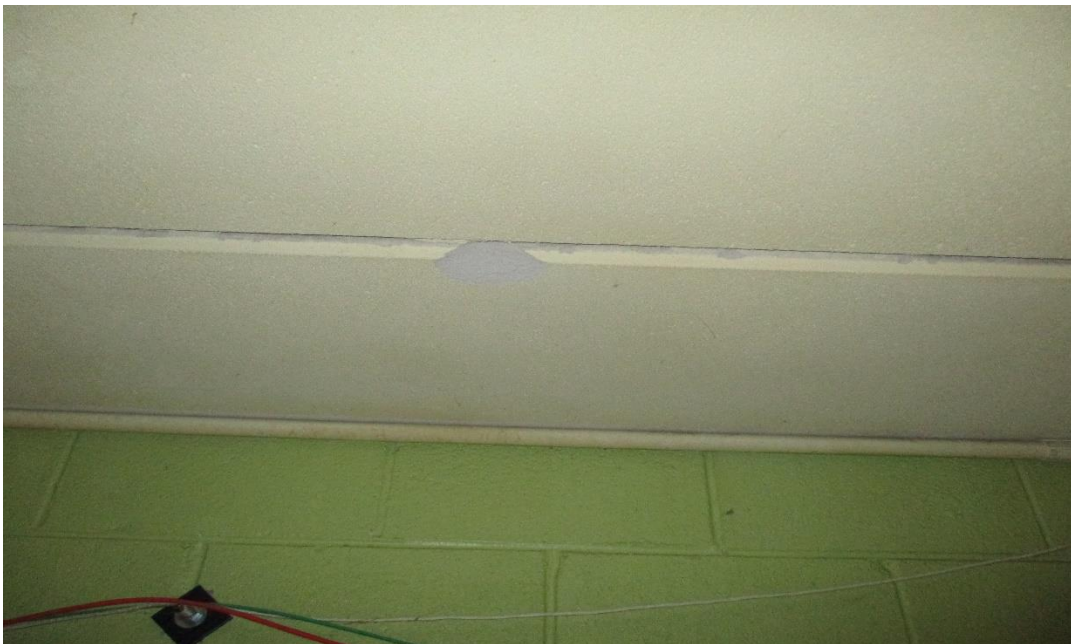
Spalled Edges

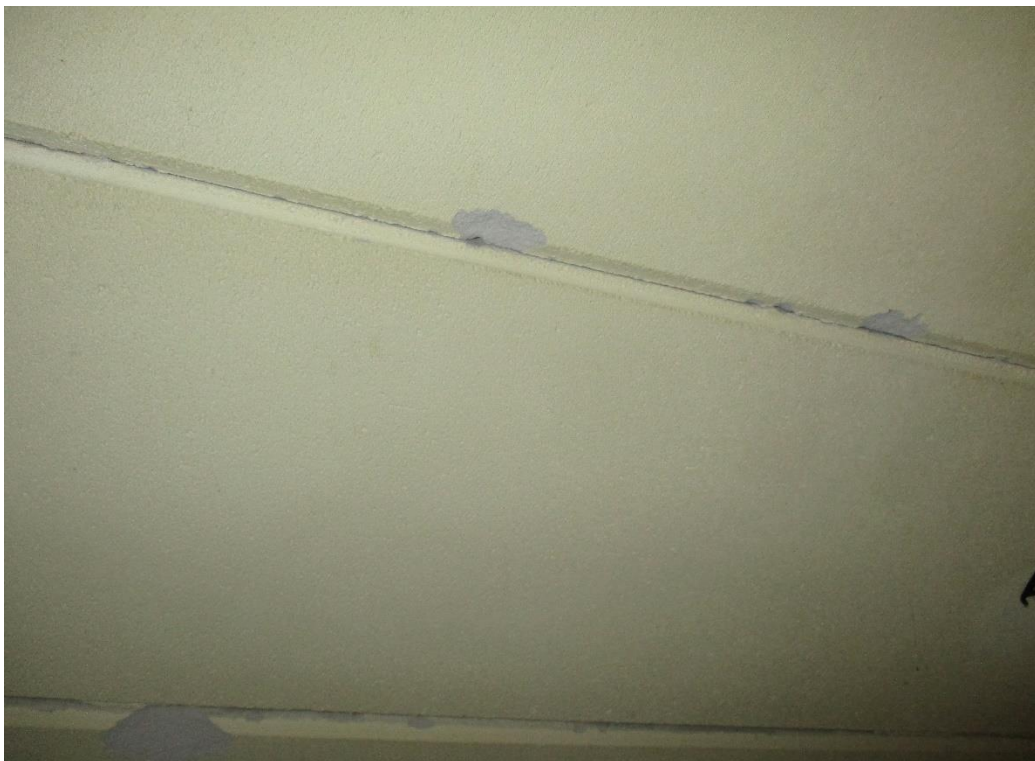
Spalled Edges

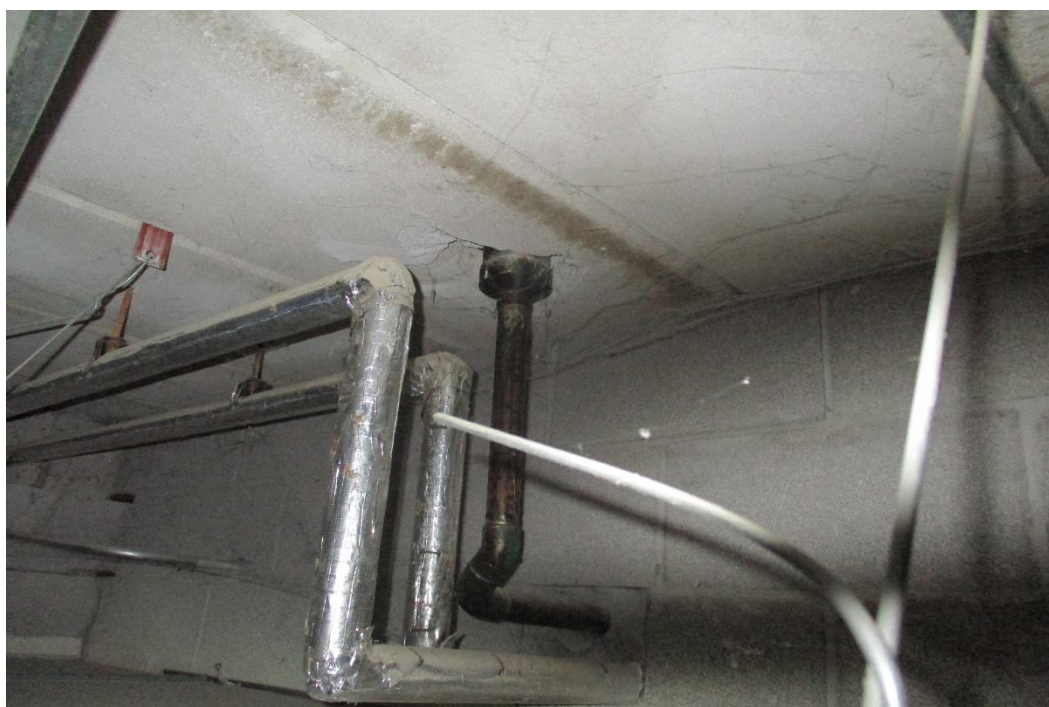
Roof Drain Penetration Not Framed

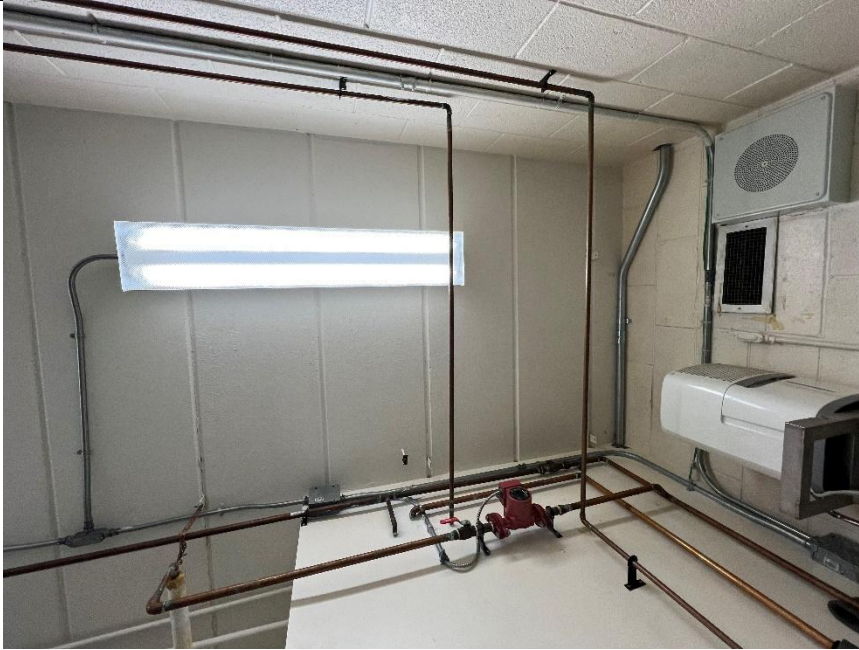
View of RAAC panels in Service Room

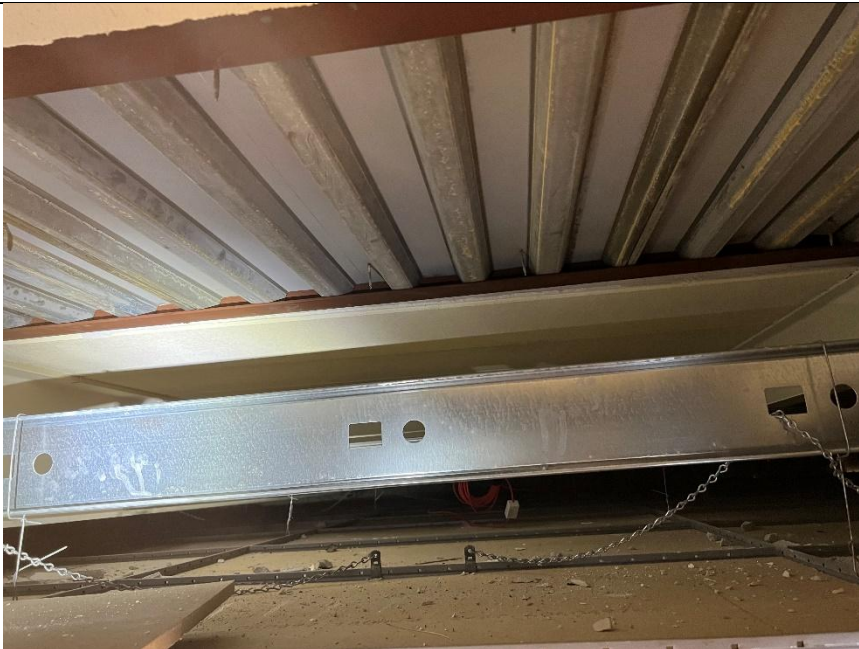
View of former RAAC replacement in Classroom

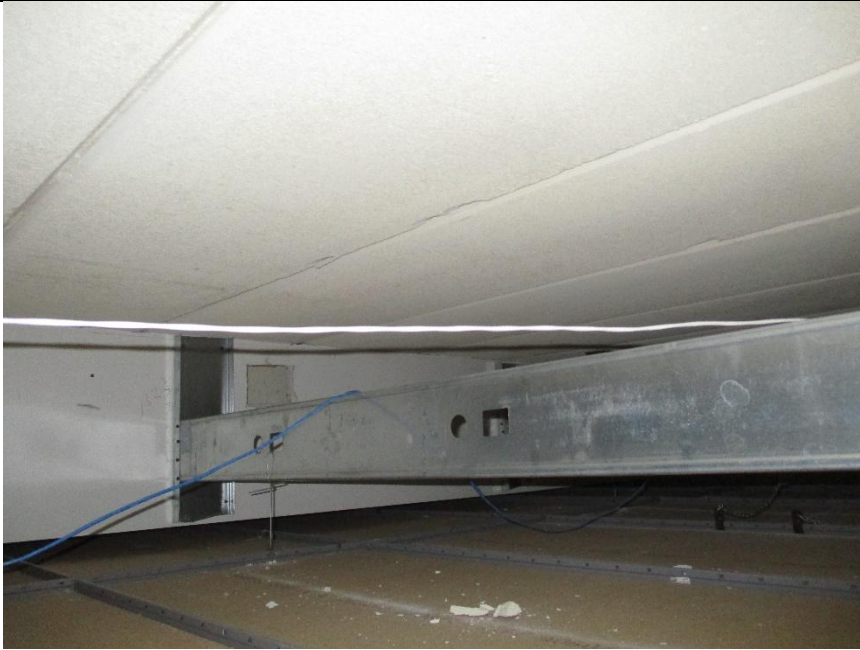
View of secondary framing below RAAC panels to support ceiling

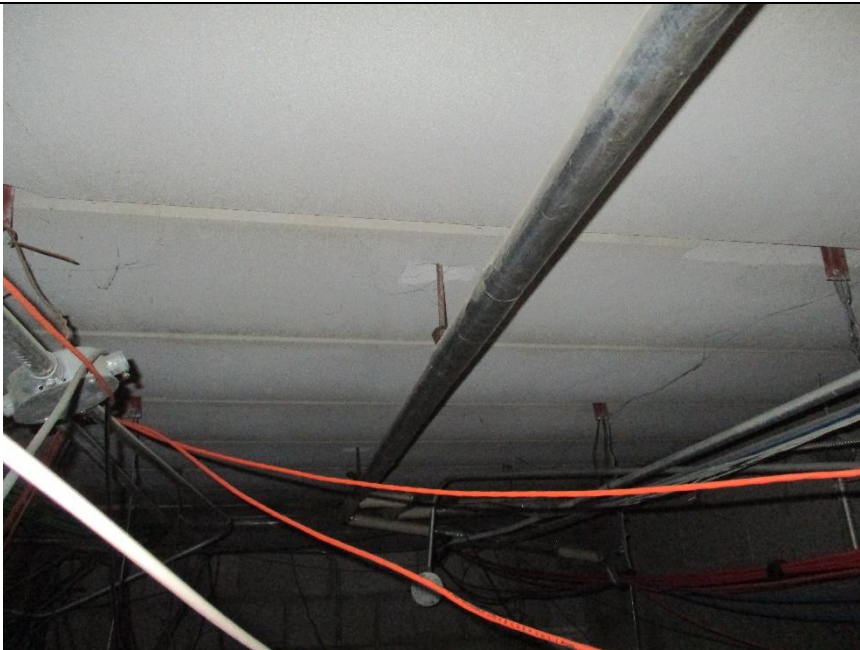
View of improper hanger in RAAC panels

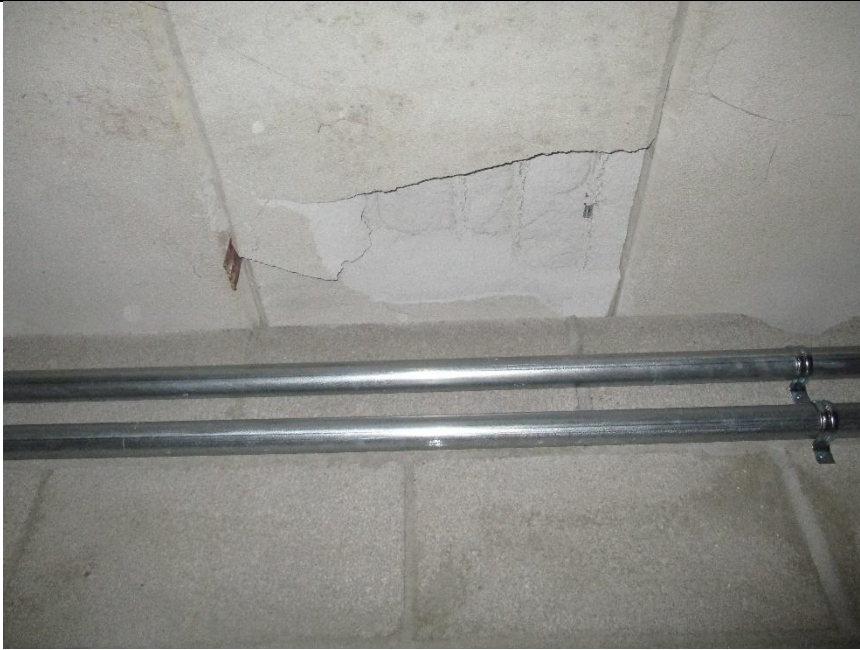
View of major area of spalling RAAC panels

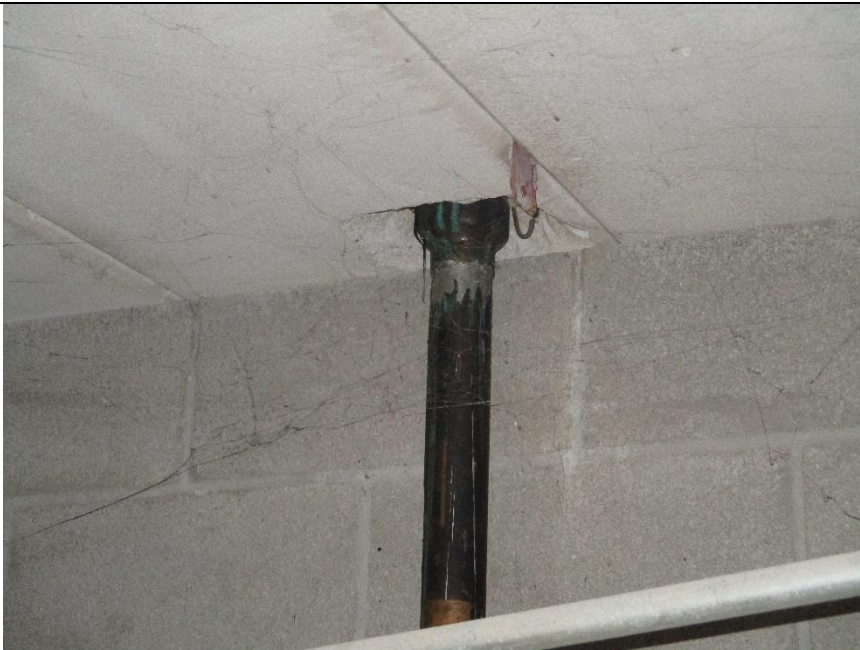
View of improper opening and hanger in RAAC panels
