## Hazardous Materials and Designated Substances Report

Kingston Secondary School  
145 Kirkpatrick St, Kingston, Ontario

**BCE Project:** K26-139  
**Report Issued:** May 25, 2026

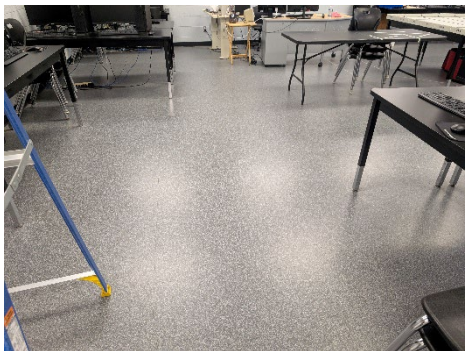
Rubber flooring within the Project Areas is unlikely to contain asbestos base on date of installation.
2

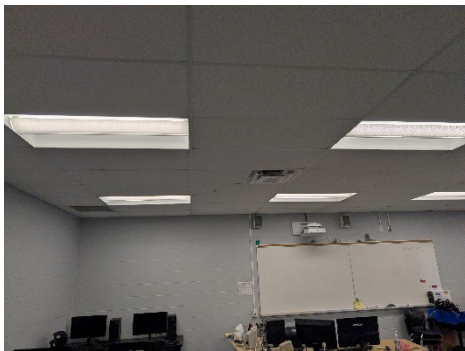
Ceiling tiles within the Project Area are unlikely to contain asbestos base on date of installation.
3

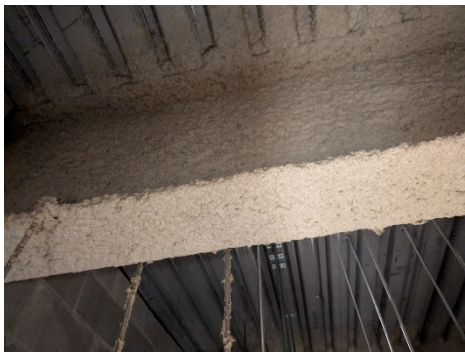
Spray applied fireproofing on steel beams within the Project Areas is unlikely to contain asbestos base on date of installation.
4

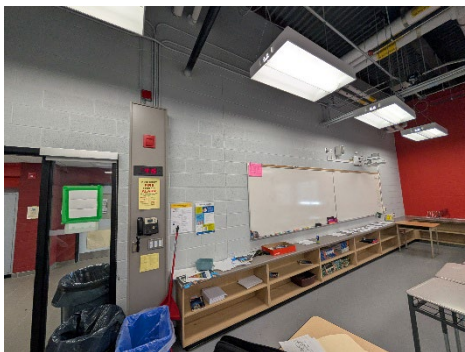
Sample Reference	Material Description / Location	Results $\mu\text{g/g}$	EACC Lead Classification	Condition
LS1	Grey paint on concrete block walls, Rooms 141 and 142	7	Insignificant	Good

<p>Paint and mortar on concrete block walls within the Project Area are unlikely to contain asbestos base on date of installation.</p> <p>Insignificant concentration of lead in grey paint on concrete block walls (LS1)</p>

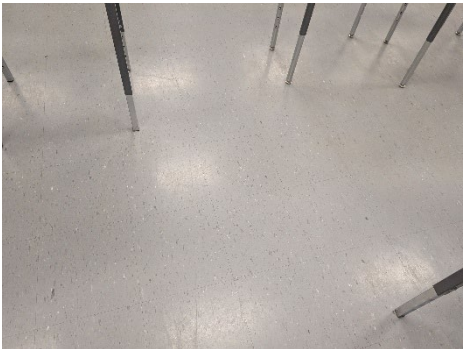
Vinyl floor tiles and mastic within the Project Area are unlikely to contain asbestos base on date of installation.
6

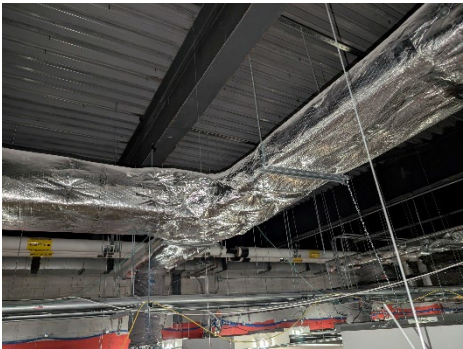
View of fiberglass insulated ducts and piping unlikely to contain asbestos base on material composition.
7

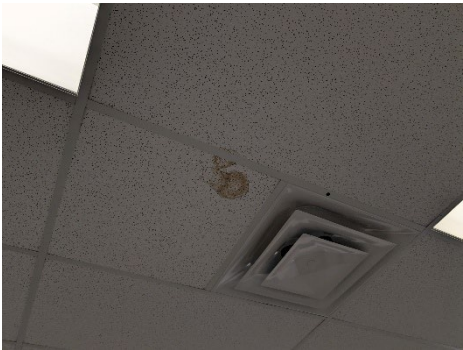
Approximately 2 square feet of suspect mould growth and associated water staining was observed on a ceiling tile within Room 141.

BCE did not conduct a mould assessment to delineate the extent of any concealed mould within the Project Area. This assessment was limited to visible conditions only, the extent of hidden mould behind finishes or within concealed building assemblies could not be determined.

View of suspect mould growth and water-staining on a ceiling tile within room 141.
6

Suspected mould growth and water staining was observed on approximately 2 square feet of ceiling tile within room 141 in the Project Area. BCE did not delineate the full extent of mould growth and did not perform intrusive inspection to determine whether concealed suspect mould may be present within adjacent building assemblies. Once the full extent of suspect mould growth and water-staining is established, the affected areas should be cleaned and remediated in accordance with recognized mould remediation guidelines, such as the Environmental Abatement Council of Canada (EACC) Mould Abatement Guidelines.

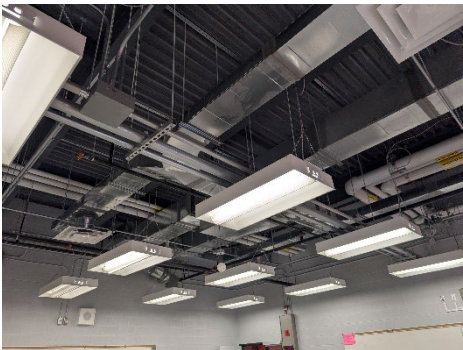
View of LED light fixture within the Project Area unlikely to contain mercury or PCBs.
