# Designated Substances and Hazardous Materials Survey

*DCC Project No. HQ1562DC, 52 North Star Drive, CFB Trenton, ON  
Building 52 - Hanger 10*

20442331

August 2021

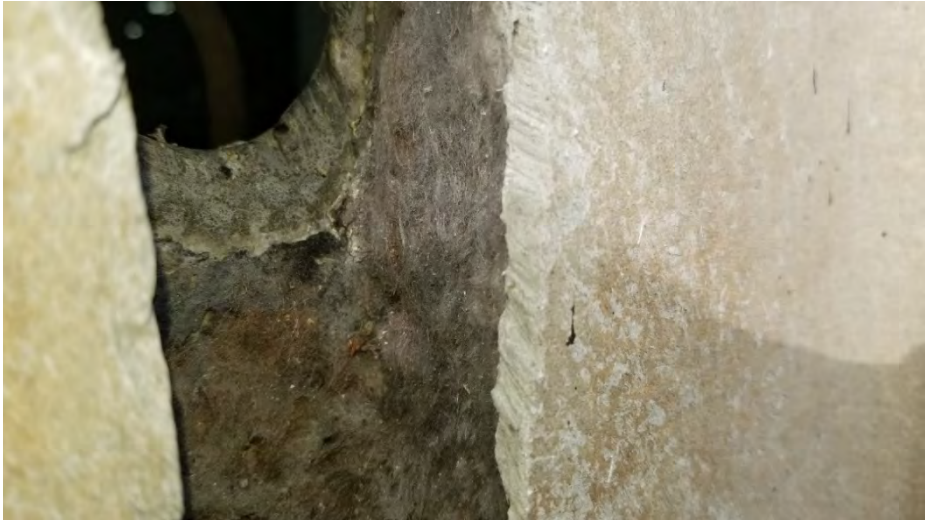
| Locations | Description of Materials<br>(From Upper Layer to Lower Layer) | Photograph |
|---|---|---|
| Exterior of North and South Perimeter Walls –<br>Exploratory Opening:<br>Typical perimeter wall construction for north and south<br>facades of Building 52 above cinderblock wall base | Exterior corrugated Transite panel,<br>fibreglass insulation, tar paper layer, interior<br>flat Transite panel | |

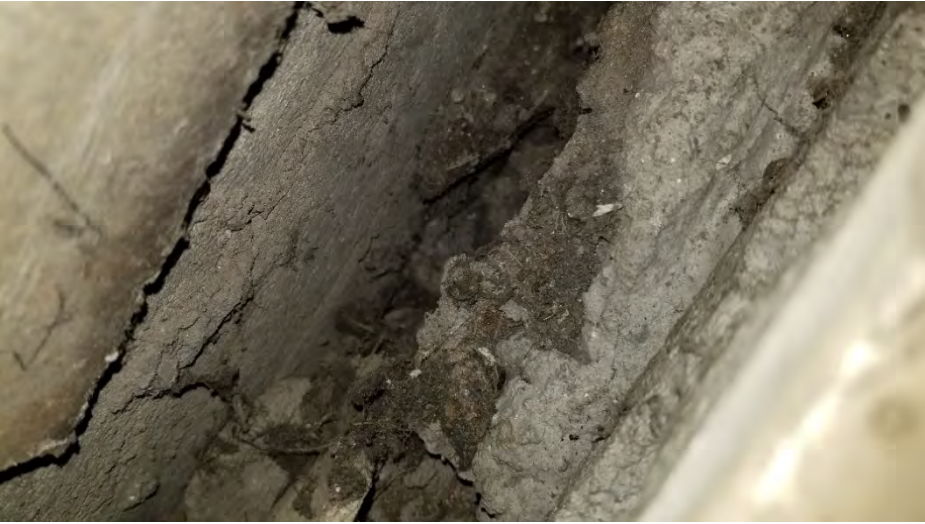
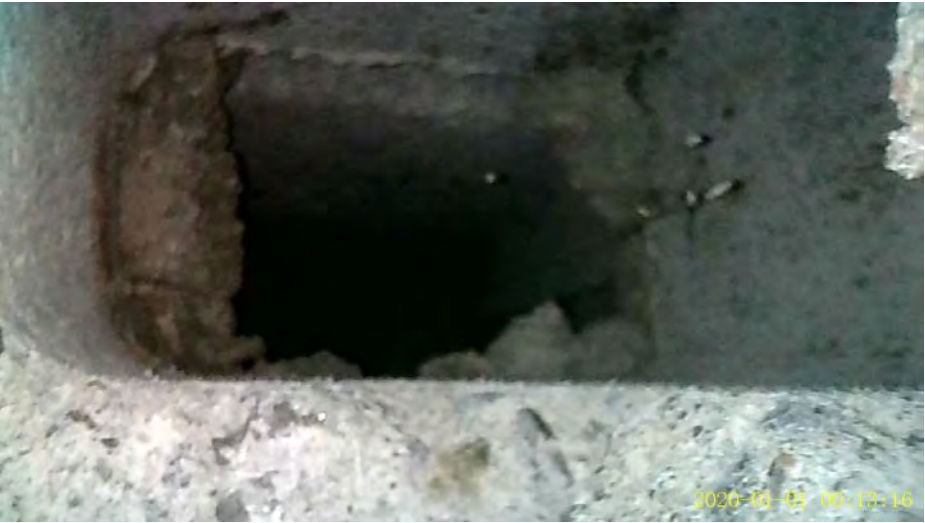
| Locations | Description of Materials<br>(From Upper Layer to Lower Layer) | Photograph |
|---|---|---|
| Interior of North and South Perimeter Walls –<br>Exploratory Opening:<br>Typical perimeter wall construction for north and south<br>facades of Building 52; cinderblock wall base | Interior cinderblock wall, empty wall cavity,<br>exterior brick wall<br>(no insulation materials observed within wall<br>cavity or cinderblock cavities) | |

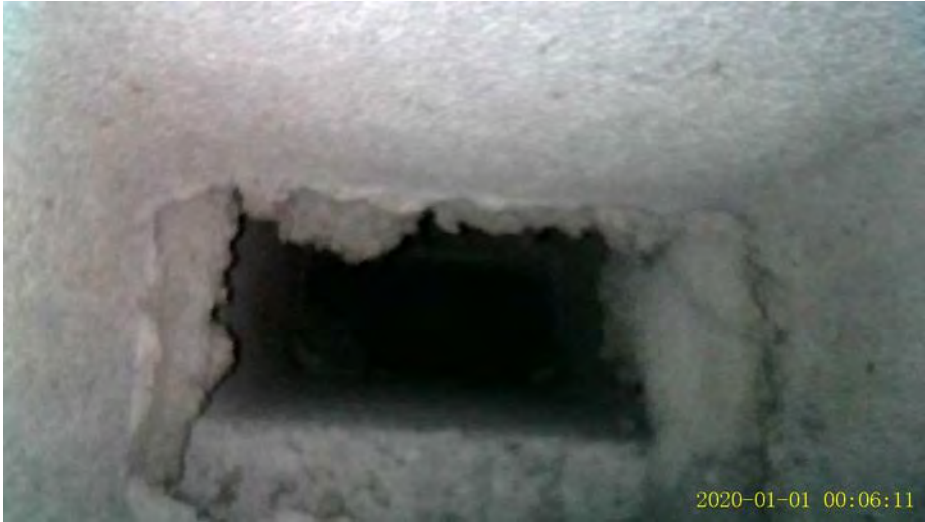
| Locations | Description of Materials<br>(From Upper Layer to Lower Layer) | Photograph |
|---|---|---|
| Central West and Central East Hanger Walls –<br>Exploratory Opening:<br>Typical perimeter wall construction for interior<br>cinderblock walls in hangers within Building 52 | Single course of cinderblock wall<br>(no insulation materials observed within<br>cinderblock cavities) | |

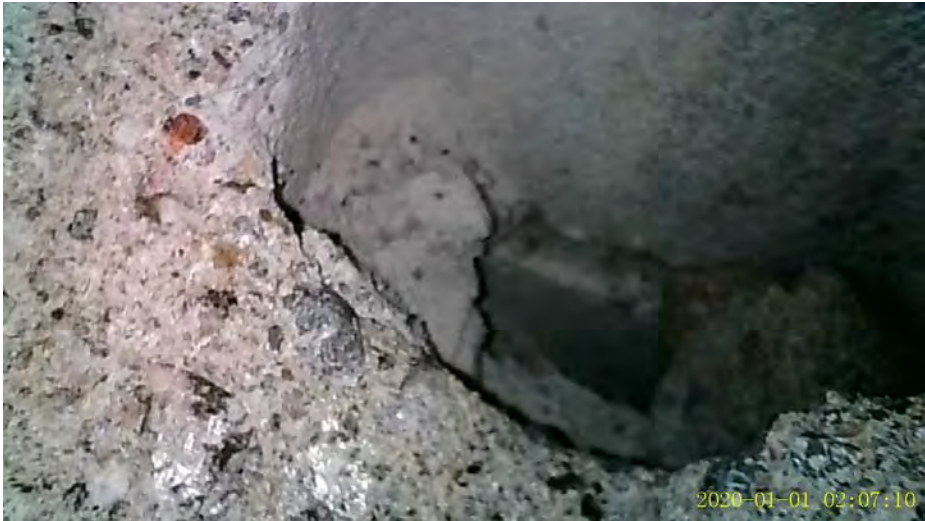
| Locations | Description of Materials<br>(From Upper Layer to Lower Layer) | Photograph |
|---|---|---|
| Central West and Central East Hanger Walls –<br>Exploratory Opening:<br>Typical perimeter wall construction for second floor<br>interior cinderblock walls in hangers within Building 52 | Single course of cinderblock wall<br>(no insulation materials observed within<br>cinderblock cavities) | |

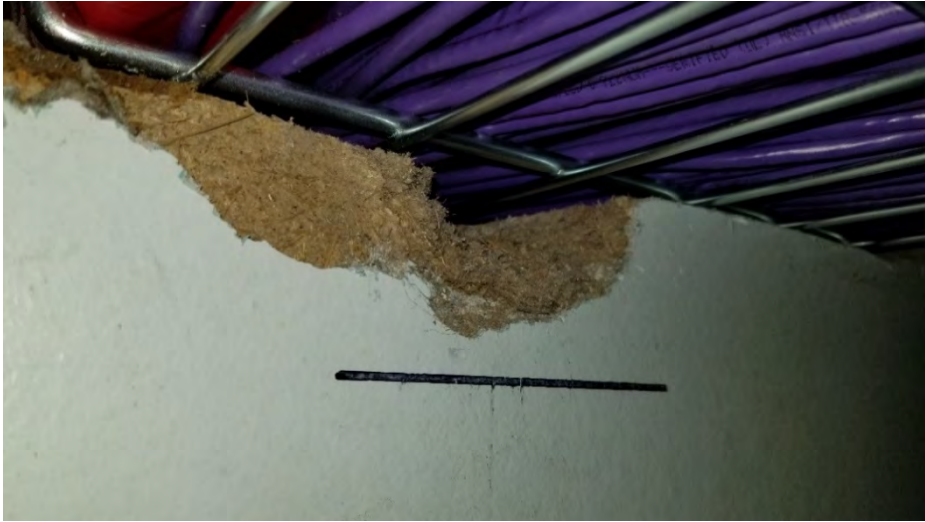
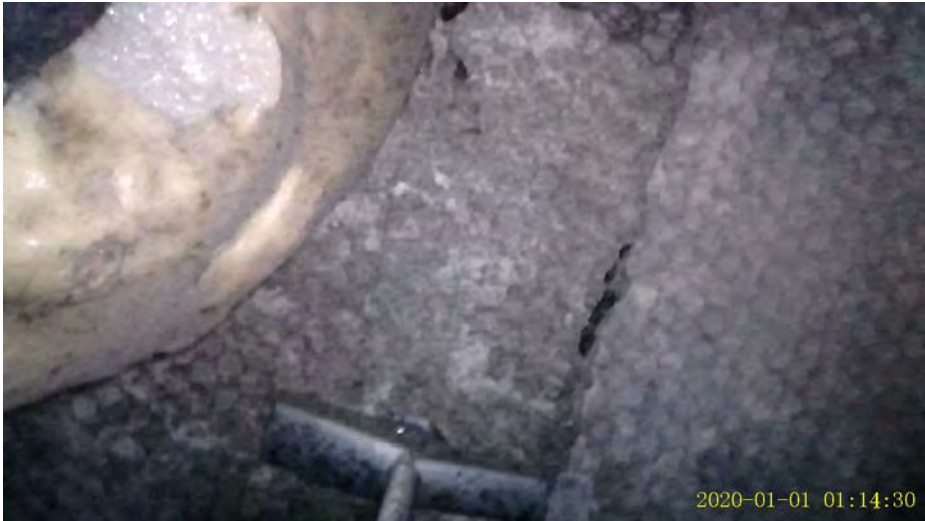
| Locations | Description of Materials<br>(From Upper Layer to Lower Layer) | Photograph |
|---|---|---|
| Interior Side of Second Floor Corridor Walls (to Roof Exterior) – Exploratory Opening:<br>Typical wall construction for second floor corridor<br>Transite panel walls | Interior flat Transite panel, cellulose fibre board, flat Transite panel, wall cavity, applications of yellow spray insulation foam, roof exterior corrugated Transite panel | |

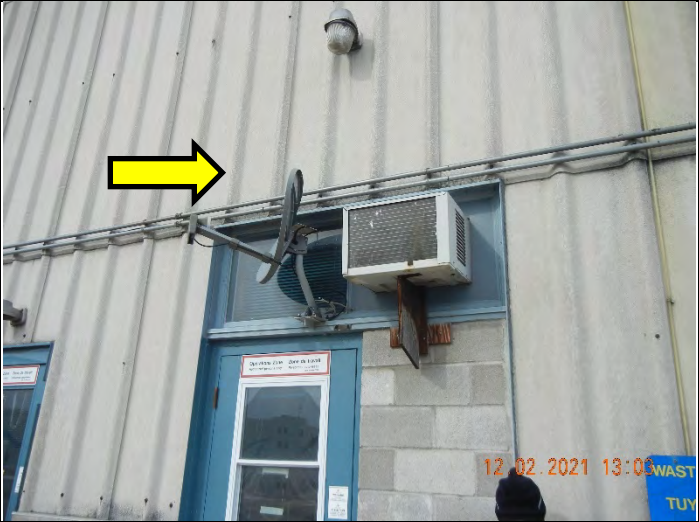
| Material <sup>(1)</sup><br>Description | Material<br>Location | Observed<br>Estimated<br>Quantity <sup>(2)</sup> | Condition | Friable<br>(Yes / No) | Accessibility <sup>(3)</sup> | Sample Number | Asbestos<br>Concentration (%)<br>and Type | Photograph |
|---|---|---|---|---|---|---|---|---|
| Corrugated<br>Transite panels | Present<br>installed as<br>exterior wall<br>finish | ~3,750 m <sup>2</sup> | Good; fair in<br>select<br>locations | No | A | A-030A<br>to<br>A-030C | 15% Chrysotile | |

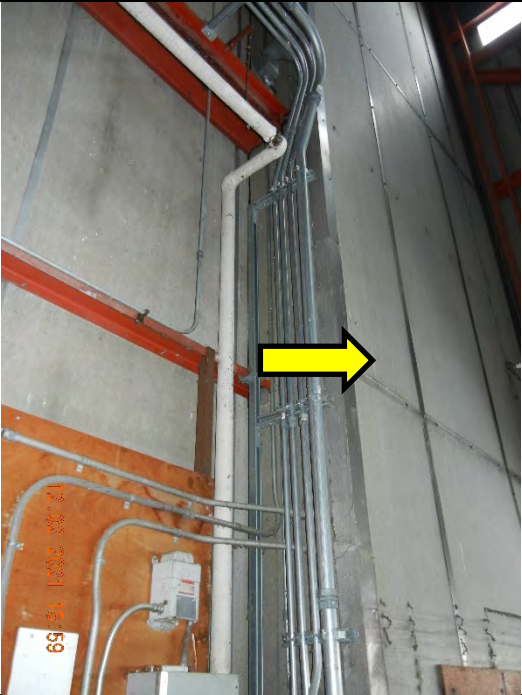
| Material <sup>(1)</sup><br>Description | Material<br>Location | Observed<br>Estimated<br>Quantity <sup>(2)</sup> | Condition | Friable<br>(Yes / No) | Accessibility <sup>(3)</sup> | Sample Number | Asbestos<br>Concentration (%)<br>and Type | Photograph |
|---|---|---|---|---|---|---|---|---|
| Flat Transite<br>panels | Present on<br>sections of<br>north and<br>south hanger<br>walls and<br>exterior finish | ~4,750 m <sup>2</sup> | Good; fair in<br>select<br>locations | No | A | A-033A<br>to<br>A-033C | 22% Chrysotile | |

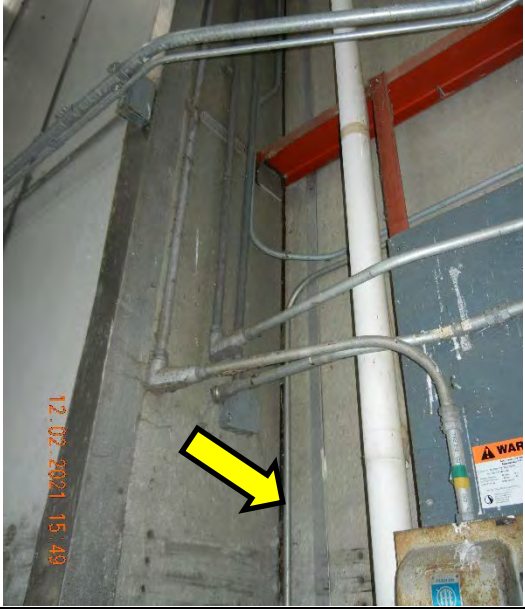
| Material <sup>(1)</sup><br>Description | Material<br>Location | Observed<br>Estimated<br>Quantity <sup>(2)</sup> | Condition | Friable<br>(Yes / No) | Accessibility <sup>(3)</sup> | Sample Number | Asbestos<br>Concentration (%)<br>and Type | Photograph |
|---|---|---|---|---|---|---|---|---|
| Grey caulking | Select seams in<br>interior<br>Transite panels<br>in hanger area | ~65 linear<br>metres | Good | No | A | A-035A<br>to<br>A-035C | 3% Chrysotile | |

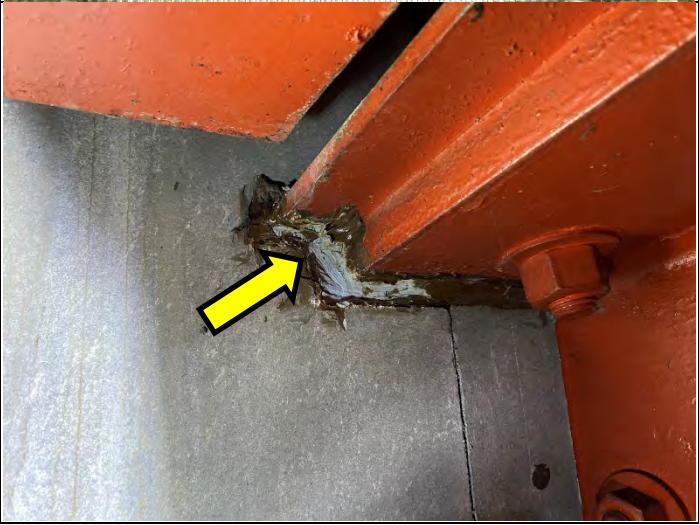
| Material <sup>(1)</sup><br>Description | Material<br>Location | Observed<br>Estimated<br>Quantity <sup>(2)</sup> | Condition | Friable<br>(Yes / No) | Accessibility <sup>(3)</sup> | Sample Number | Asbestos<br>Concentration (%)<br>and Type | Photograph |
|---|---|---|---|---|---|---|---|---|
| Grey<br>construction<br>putty | Present applied<br>to perimeter<br>wall<br>construction<br>seams above<br>perforated<br>ceiling tiles in<br>second floor<br>corridor and<br>washroom<br>spaces (where<br>observed) | ~800 linear<br>metres | Good | No | C | A-041A<br>to<br>A-041C | 6% Chrysotile | |

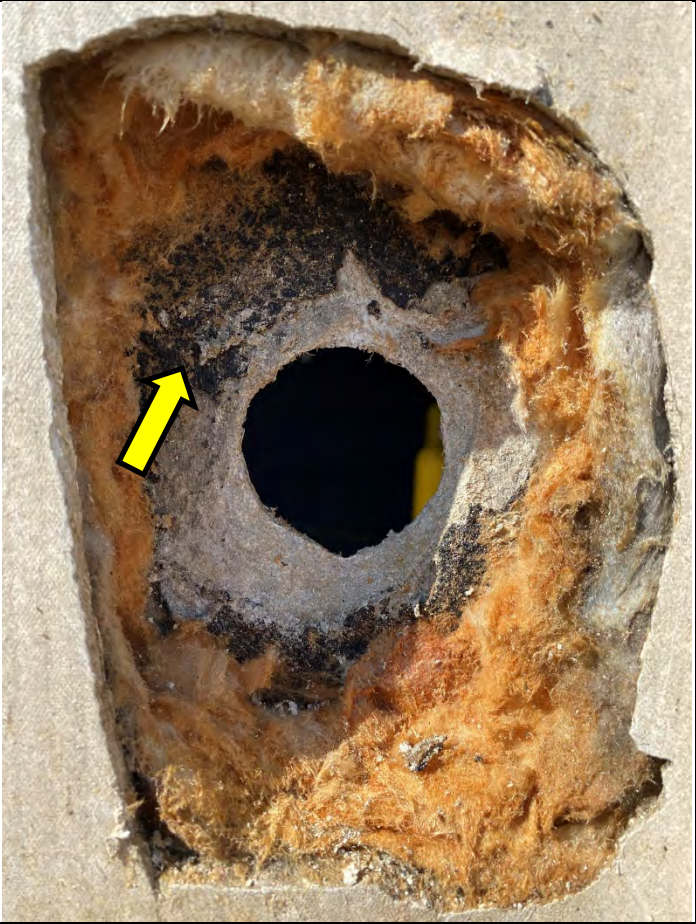
| Material <sup>(1)</sup><br>Description | Material<br>Location | Observed<br>Estimated<br>Quantity <sup>(2)</sup> | Condition | Friable<br>(Yes / No) | Accessibility <sup>(3)</sup> | Sample Number | Asbestos<br>Concentration (%)<br>and Type | Photograph |
|---|---|---|---|---|---|---|---|---|
| Black tar paper<br>layer | Present in<br>perimeter<br>building<br>envelope | ~3,750 m <sup>2</sup> | Good to fair | Yes | D | A-042A<br>to<br>A-042C | 2% Chrysotile | |

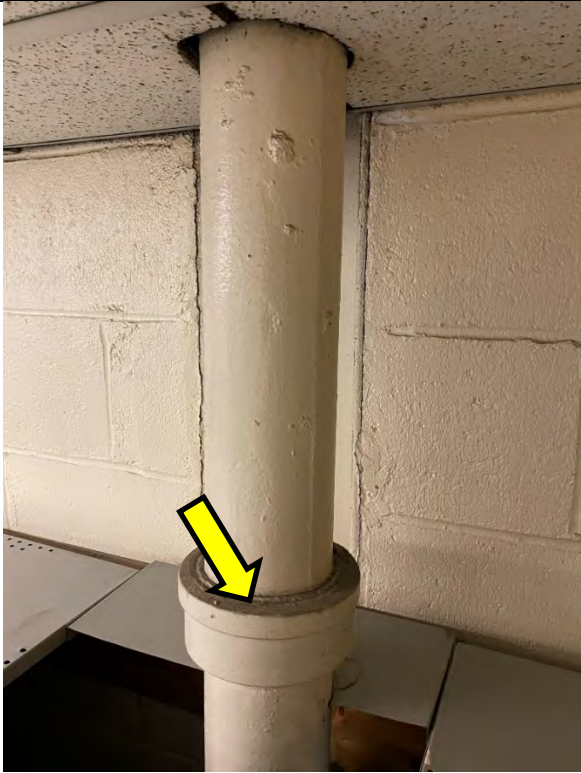
The confirmed ACMs may exist in other areas of the Site. During the DS/HM survey, Golder observed the presence of cast iron bell and spigot joints on piping installed throughout the Site. Packing material found in such joints is suspected to be asbestos-containing but was not sampled during the assessment as to not compromise the integrity of drains and piping actively in use at the time of the DS/HM survey. This packing material, in addition to materials found to be in likeness to confirmed ACMs must be assumed to be ACMs unless otherwise confirmed by laboratory analyses.

| Material <sup>(1)</sup><br>Description | Material<br>Location | Observed<br>Estimated<br>Quantity <sup>(2)</sup> | Condition | Friable<br>(Yes / No) | Accessibility <sup>(3)</sup> | Sample Number | Asbestos<br>Concentration (%)<br>and Type | Photograph |
|---|---|---|---|---|---|---|---|---|
| Cast iron Bell<br>and Spigot Joint<br>packing material<br>–<br>Present installed<br>throughout the<br>Site | Installed piping<br>and drains<br>throughout the<br>Site | ~350 units<br>observed | Good | No | A | Material not<br>sampled | Material not<br>sampled;<br>presumed<br>asbestos-<br>containing | |

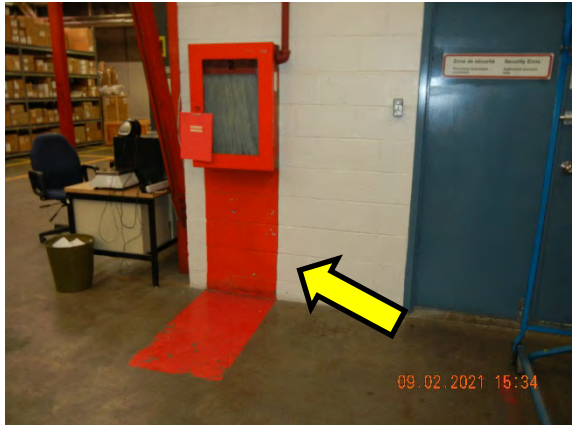
| Description <sup>(1)</sup> / Location of Material | Condition | Observed<br>Estimated<br>Quantity to<br>Be Impacted | Lead<br>(Pb)<br>Conc.<br>(ug/g) | Arsenic<br>(As)<br>Conc.<br>(ug/g) | Mercury<br>(Hg)<br>Conc.<br>(ug/g) | Sample<br>Number | Pb, As, or Hg Containing<br>Material<br>(Yes/No) | Photograph |
|---|---|---|---|---|---|---|---|---|
| Orange-red paint –<br><br>Present on fire safety<br>highlights within Room<br>1030 and throughout<br>Site | Good | ~50 m <sup>2</sup> | 37,800 | <50 | <2 | L-003 | Yes<br><br>Pb-containing paint | |

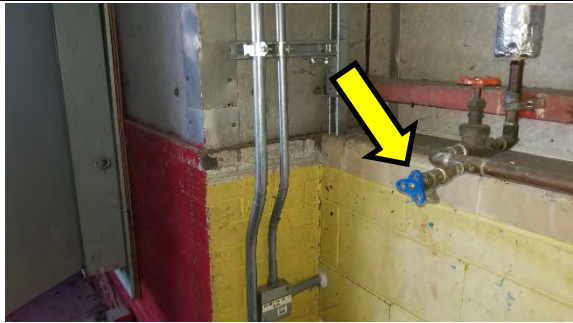
| Description <sup>(1)</sup> / Location of Material | Condition | Observed<br>Estimated<br>Quantity to<br>Be Impacted | Lead<br>(Pb)<br>Conc.<br>(ug/g) | Arsenic<br>(As)<br>Conc.<br>(ug/g) | Mercury<br>(Hg)<br>Conc.<br>(ug/g) | Sample<br>Number | Pb, As, or Hg Containing<br>Material<br>(Yes/No) | Photograph |
|---|---|---|---|---|---|---|---|---|
| Yellow trim ceramic tile<br>glazing –<br><br>Present installed on top<br>of perimeter cinderblock<br>walls along north and<br>south façade within<br>hanger spaces | Good | ~35 m <sup>2</sup> | 94 | 4 | <0.1 | L-004 | Yes<br><br>Pb-containing paint | |

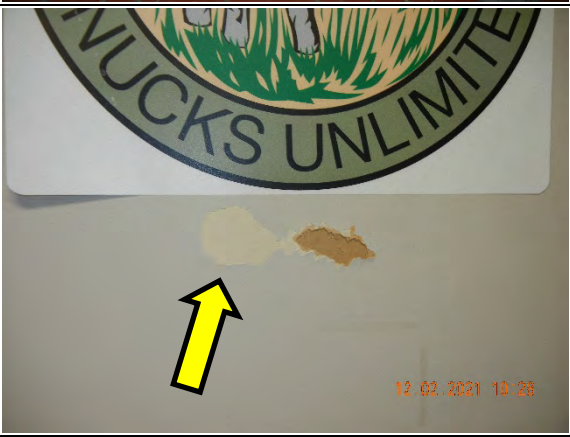
| Description <sup>(1)</sup> / Location of Material | Condition | Observed<br>Estimated<br>Quantity to<br>Be Impacted | Lead<br>(Pb)<br>Conc.<br>(ug/g) | Arsenic<br>(As)<br>Conc.<br>(ug/g) | Mercury<br>(Hg)<br>Conc.<br>(ug/g) | Sample<br>Number | Pb, As, or Hg Containing<br>Material<br>(Yes/No) | Photograph |
|---|---|---|---|---|---|---|---|---|
| Grey/beige paint –<br><br>Present on select<br>second floor office walls<br>(Room 2087) | Good to fair | ~875 m² | 466 | <50 | <2 | L-008 | Yes<br><br>Pb-containing paint | |

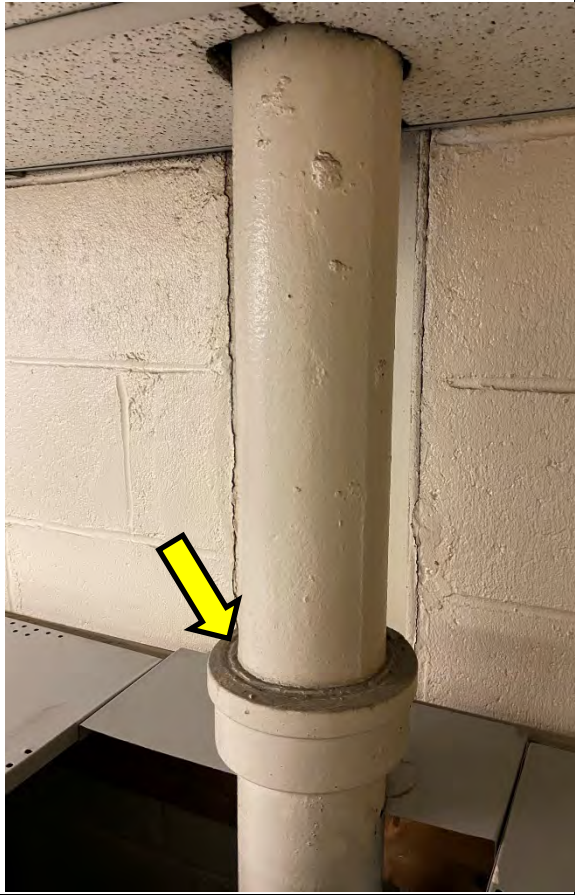
| Description <sup>(1)</sup> / Location of Material | Condition | Observed<br>Estimated<br>Quantity to<br>Be Impacted | Lead<br>(Pb)<br>Conc.<br>(ug/g) | Arsenic<br>(As)<br>Conc.<br>(ug/g) | Mercury<br>(Hg)<br>Conc.<br>(ug/g) | Sample<br>Number | Pb, As, or Hg Containing<br>Material<br>(Yes/No) | Photograph |
|---|---|---|---|---|---|---|---|---|
| Cast iron Bell and Spigot<br>Joint packing material –<br>Present installed<br>throughout the Site | Good | ~350 units<br>observed | N/A | N/A | N/A | Material<br>not<br>sampled | Material not sampled, presumed<br>Pb-containing | |

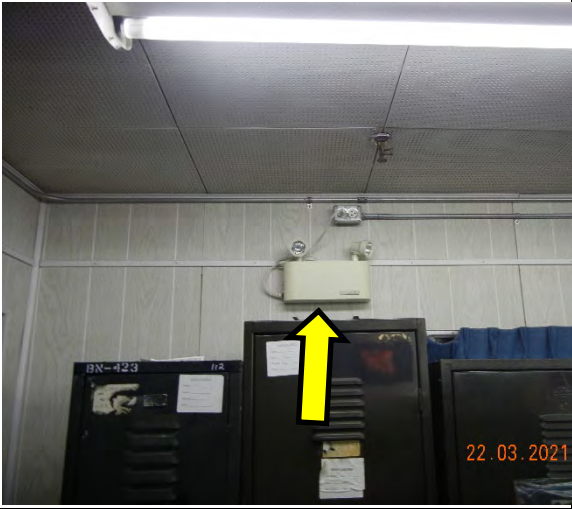
| Description <sup>(1)</sup> / Location of Material | Condition | Observed<br>Estimated<br>Quantity to<br>Be Impacted | Lead<br>(Pb)<br>Conc.<br>(ug/g) | Arsenic<br>(As)<br>Conc.<br>(ug/g) | Mercury<br>(Hg)<br>Conc.<br>(ug/g) | Sample<br>Number | Pb, As, or Hg Containing<br>Material<br>(Yes/No) | Photograph |
|---|---|---|---|---|---|---|---|---|
| Emergency lighting (lead-acid battery) – Present installed throughout the Site | Good | Observed installed throughout Site | N/A | N/A | N/A | Material not sampled | Material not sampled, presumed Pb-containing | |

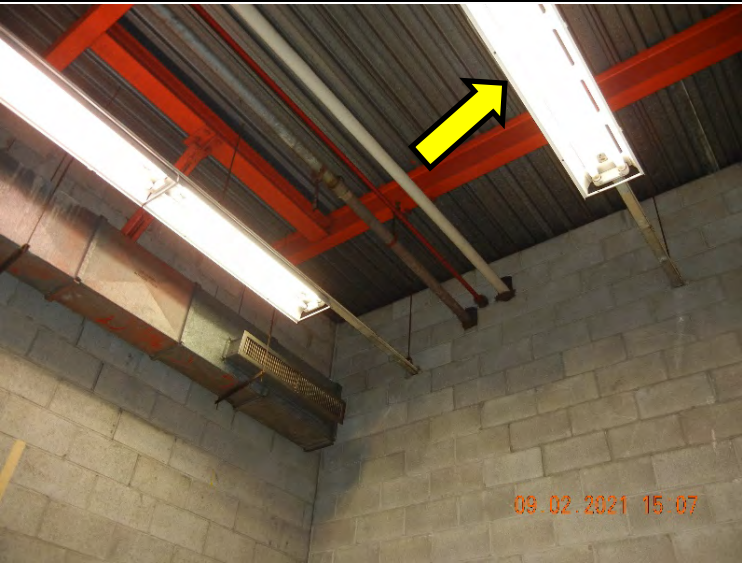
| Description / Location of Material | Photograph |
|---|---|
| <p>Fluorescent Light Tubes –<br/><br/>Present installed throughout the Site</p> | <p>A photograph showing two long fluorescent light tubes mounted on a ceiling. A yellow arrow points to the right tube. The ceiling has red metal beams and white pipes. The wall is made of grey concrete blocks. A timestamp '09.02.2021 15:07' is visible in the bottom right corner.</p> |

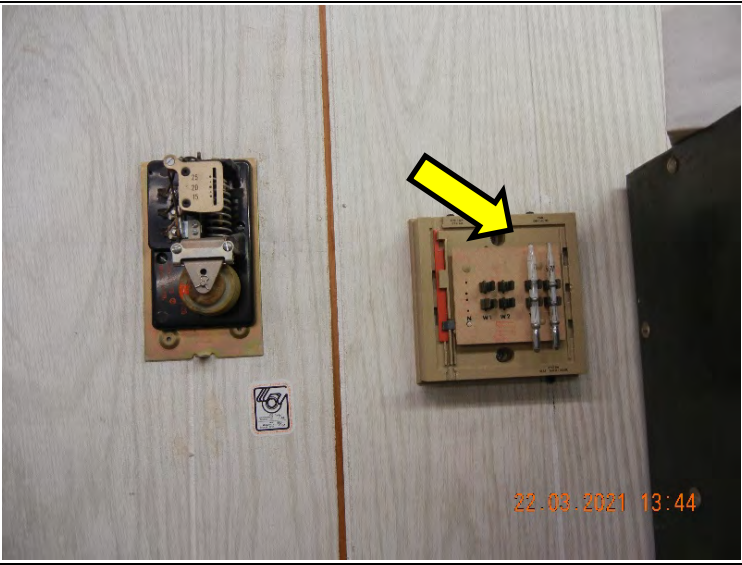
| Description / Location of Material | Photograph |
|---|---|
| <p>Mercury-Containing Thermostats –<br/><br/>Present installed in select rooms throughout the Site</p> | <p>A photograph of two thermostats mounted on a light-colored wood-paneled wall. A yellow arrow points to the thermostat on the right. The thermostat on the left is a round dial type, and the one on the right is a rectangular electronic type. A timestamp '22.03.2021 13:44' is visible in the bottom right corner.</p> |

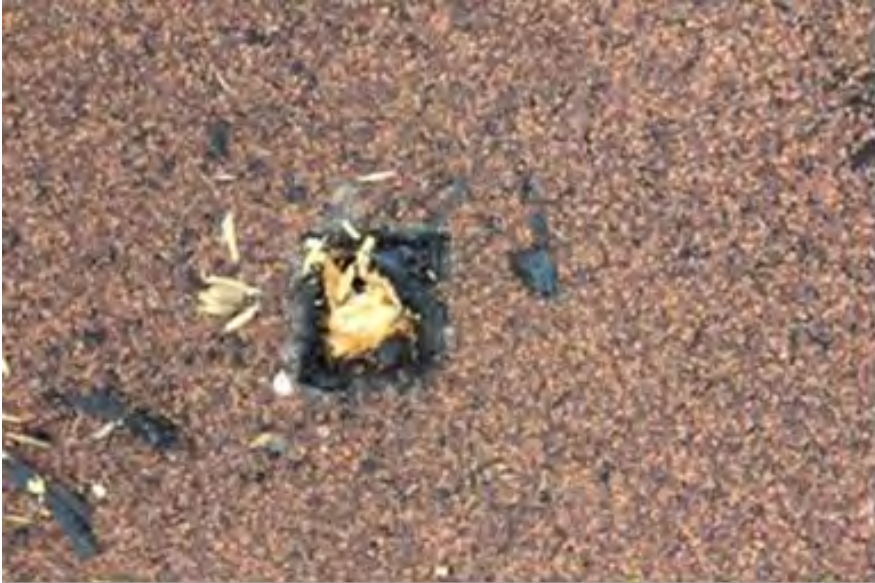
| | <p><b>Photo 1:</b><br/>Brown roofing materials (Samples 4A-C) was sampled from the east and west sloped roof and were found to contain 7% Chrysotile asbestos.</p> <p><b>Condition:</b><br/>Good</p> |

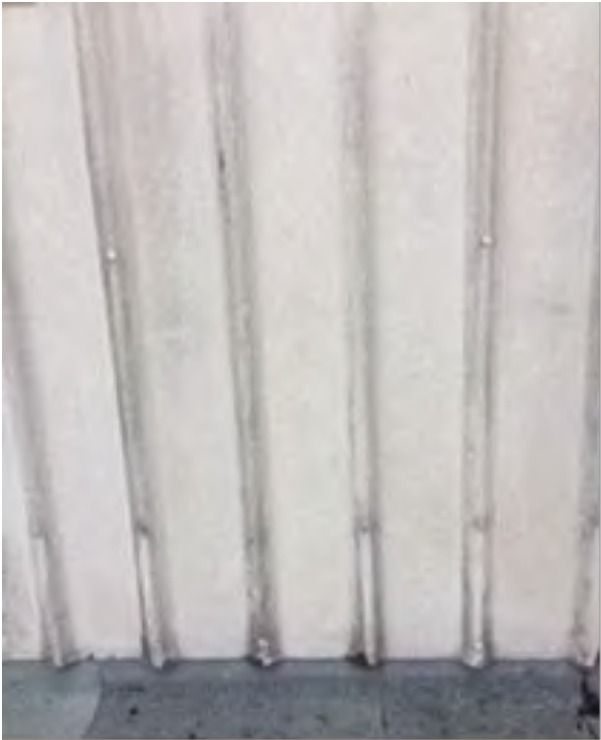
| | <p><b>Photo 2:</b><br/>Transite (Samples 6A-C) was sampled from the Middle Roof of the building and was found to contain 40% Amosite asbestos.</p> <p><b>Condition:</b><br/>Good</p> |
