FINAL **Hazardous Building** **Materials Assessment**

South Grenville District High
School
1000 Edward Street, Prescott,
Ontario

Pinchin File: 302783.041

South Grenville District High School, 1000 Edward Street, Prescott, Ontario
Upper Canada District High School

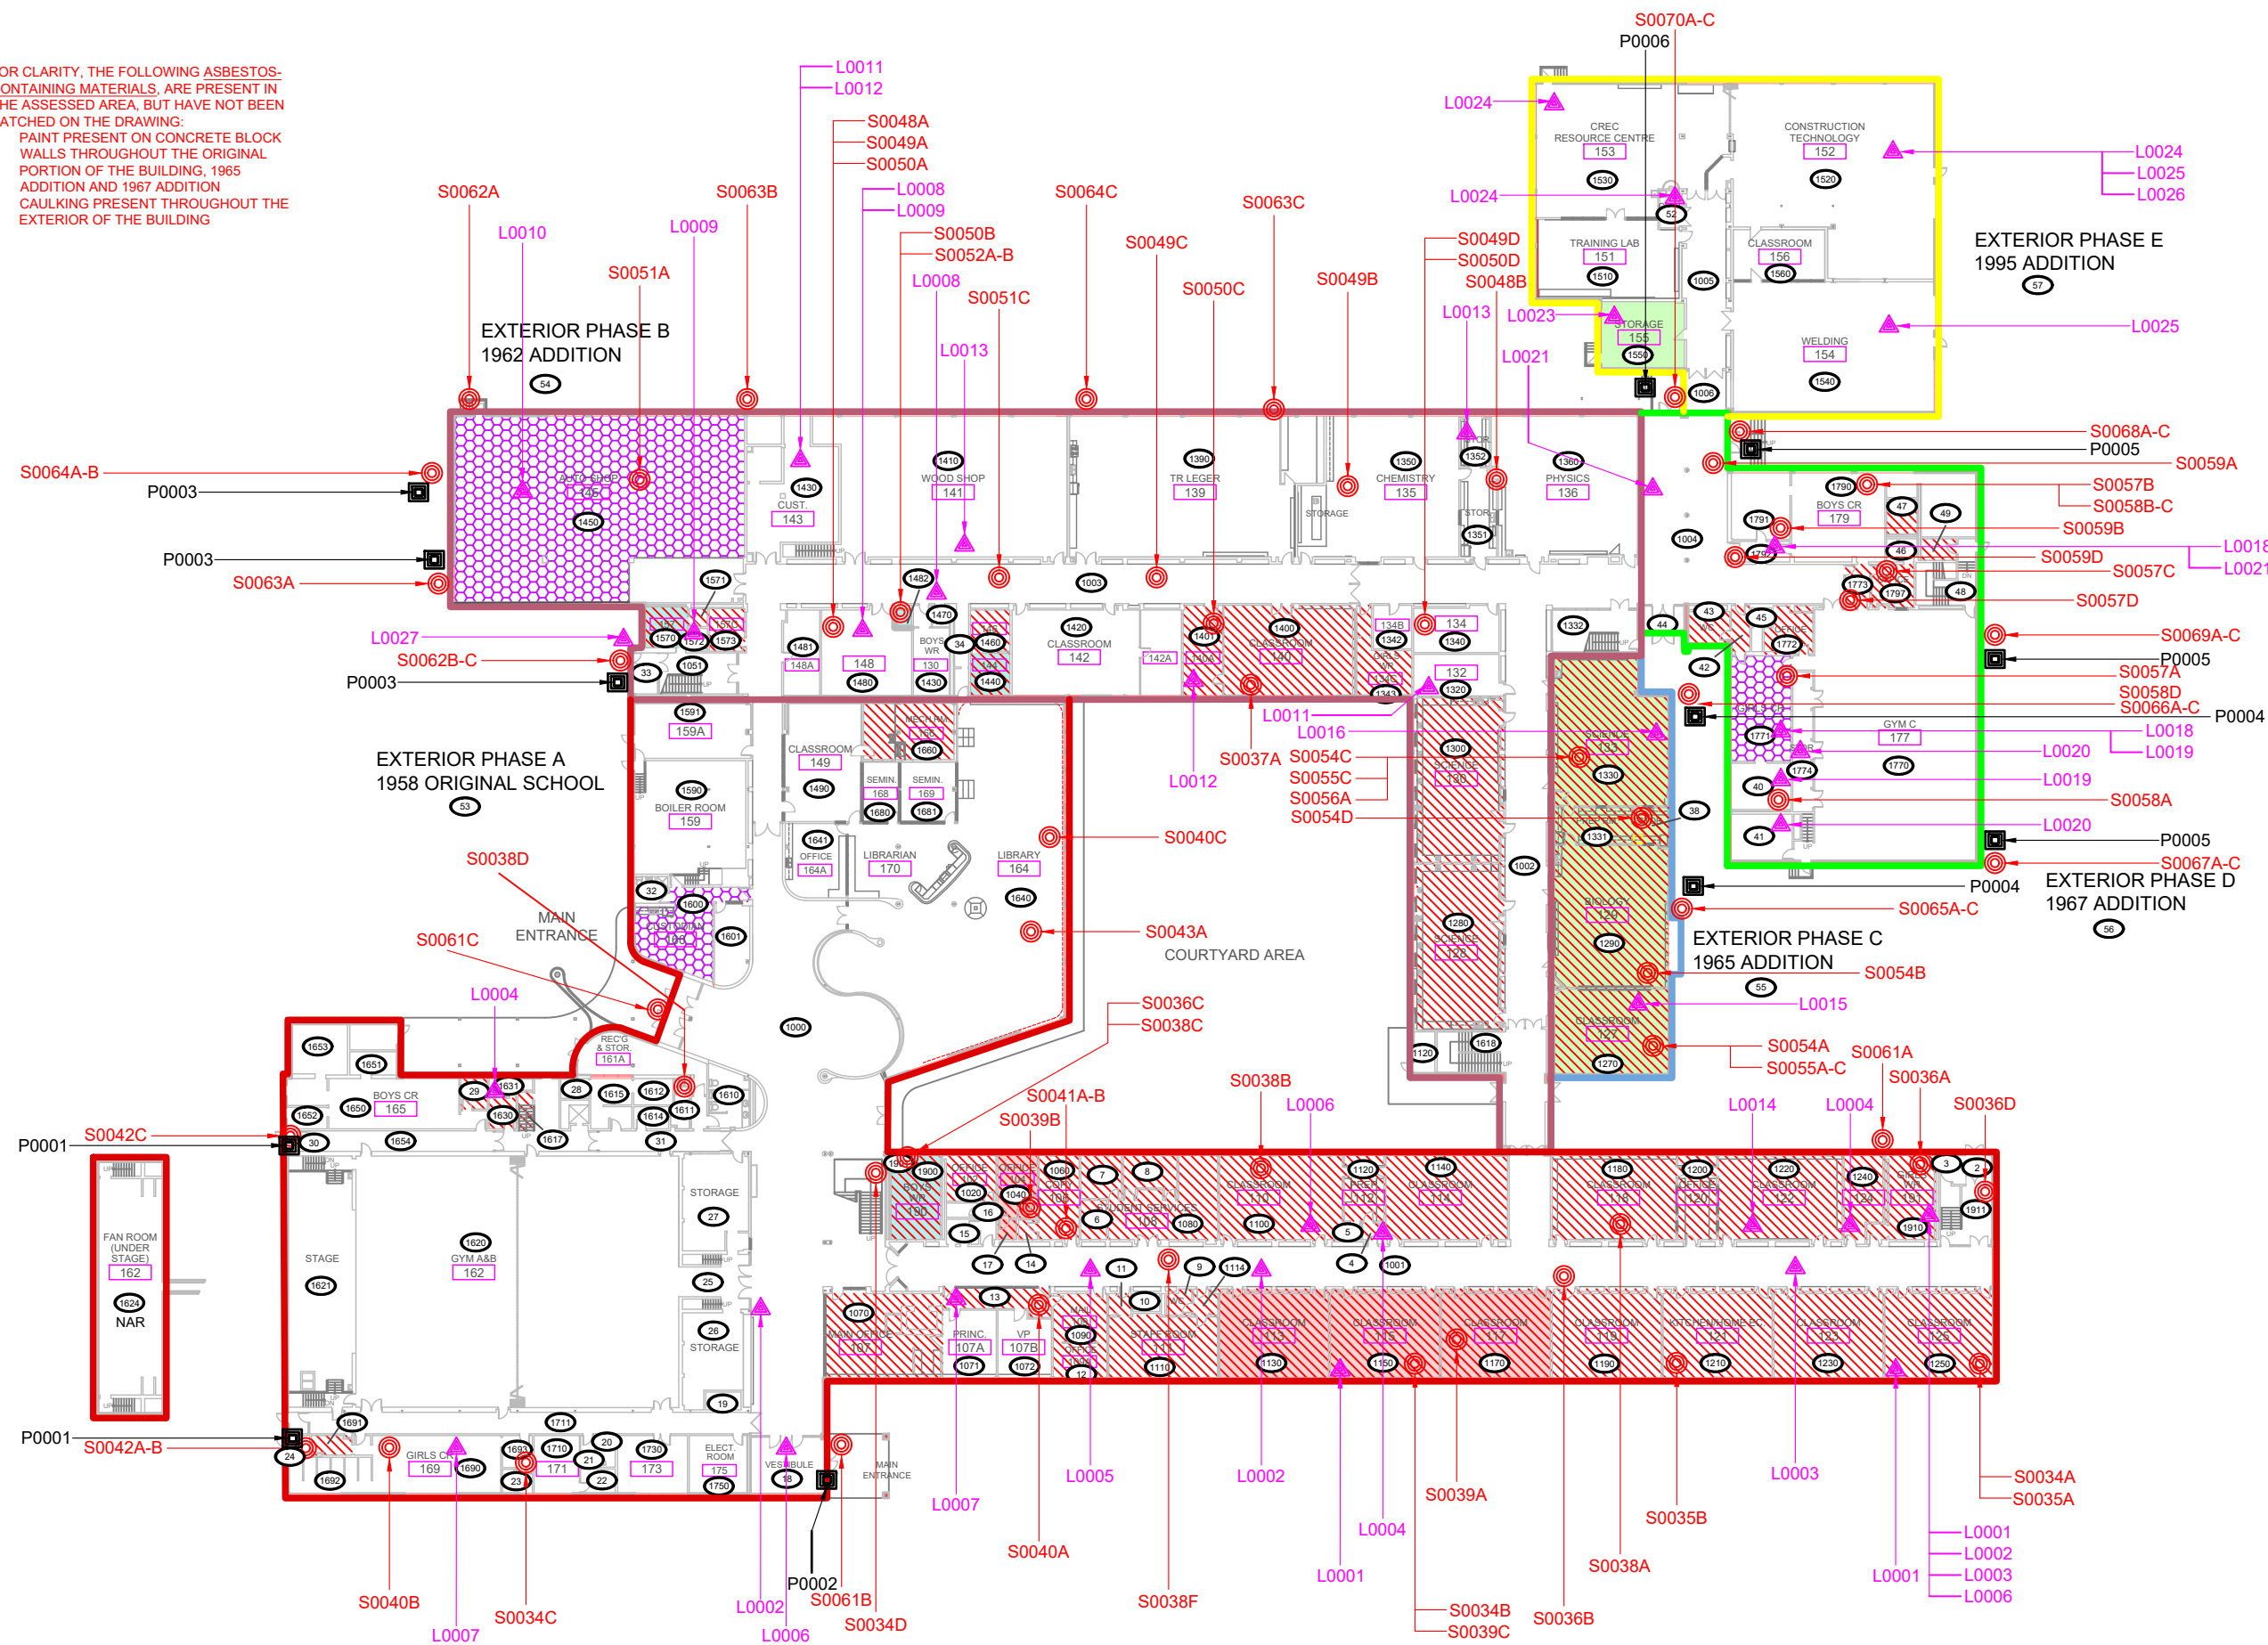
- PAINT PRESENT ON CONCRETE BLOCK WALLS THROUGHOUT THE ORIGINAL PORTION OF THE BUILDING, 1965 ADDITION AND 1967 ADDITION
- CAULKING PRESENT THROUGHOUT THE EXTERIOR OF THE BUILDING

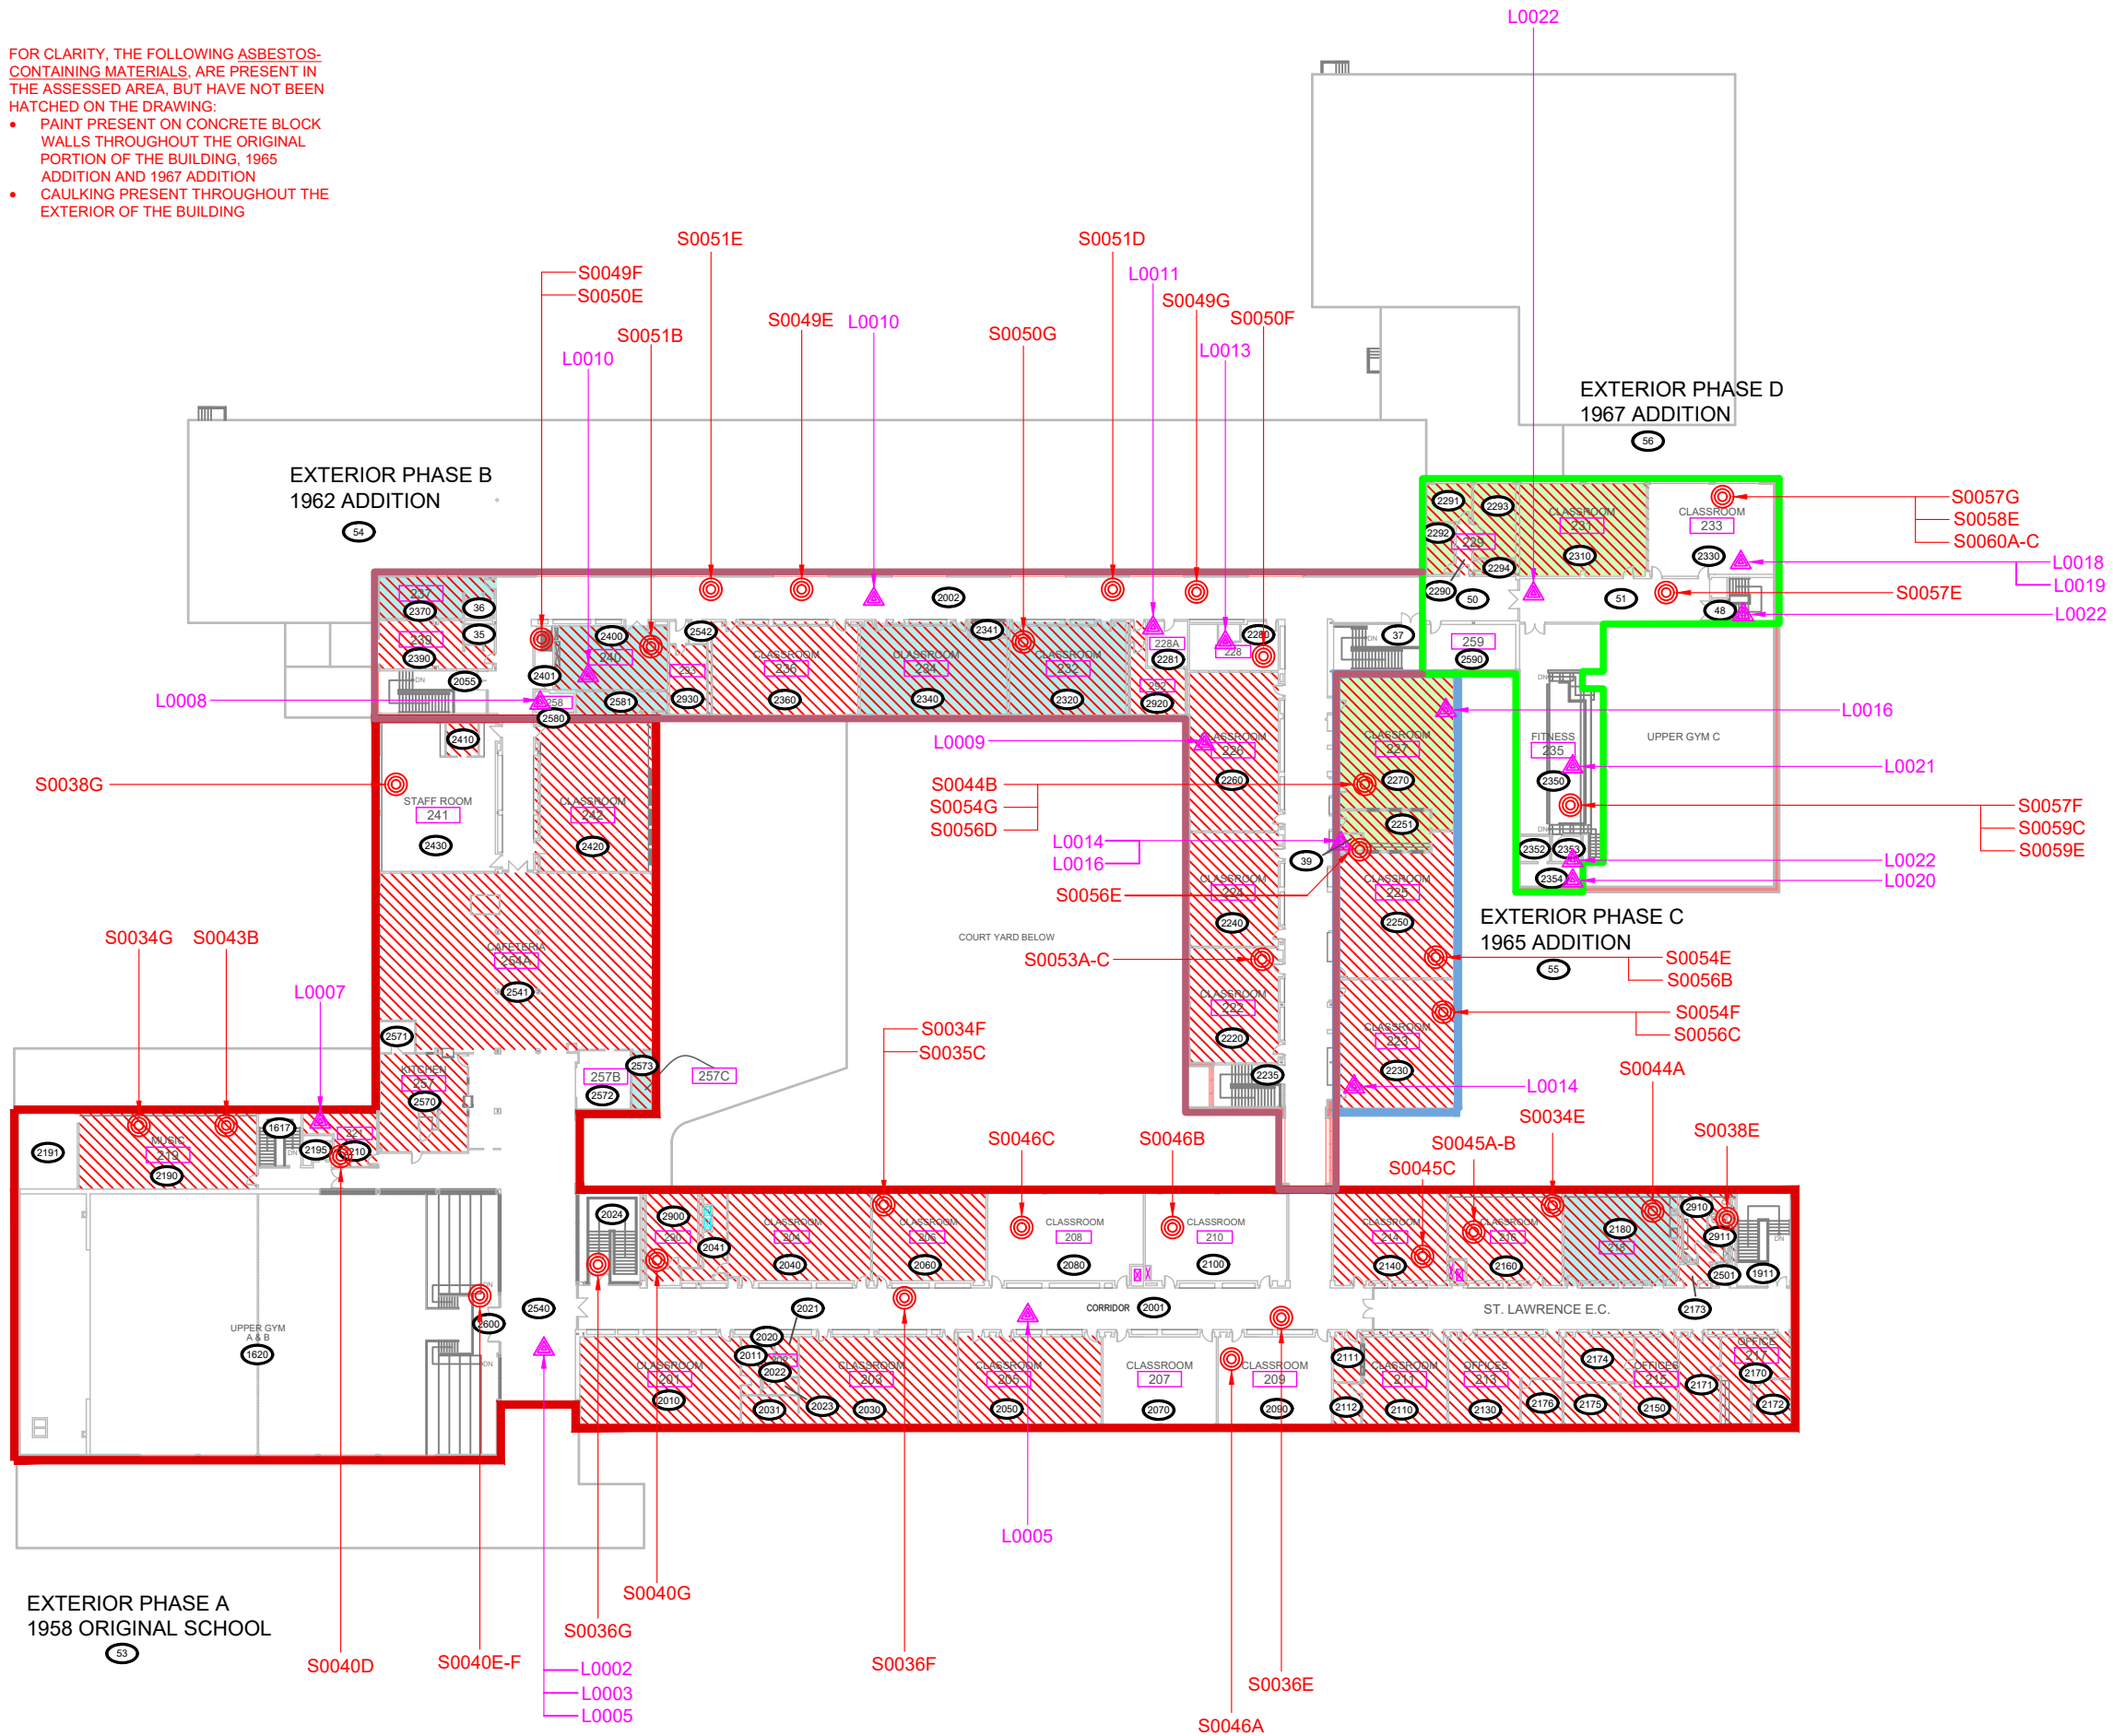
- PAINT PRESENT ON CONCRETE BLOCK WALLS THROUGHOUT THE ORIGINAL PORTION OF THE BUILDING, 1965 ADDITION AND 1967 ADDITION
- CAULKING PRESENT THROUGHOUT THE EXTERIOR OF THE BUILDING
