**FINAL**  
**Hazardous Building**  
**Materials Assessment**  
**(Management)**

Thousand Islands Secondary  
School  
2510 Parkedale Avenue,  
Brockville, Ontario

**Upper Canada District School  
Board**

September 15, 2023

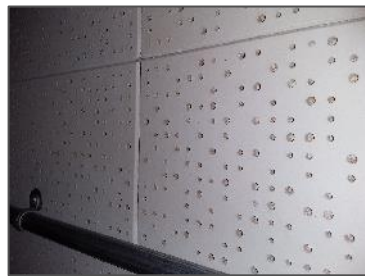
Description	Sample Location	Sample Number, Date Code or Material Composition	Asbestos	Photo
1'x1', mechanically fastened, large and medium uniform pinholes	Office (Location 1081) Workroom (Location 1530) Classroom (Location 2180)	Previous Pinchin Samples 0004A-C	No

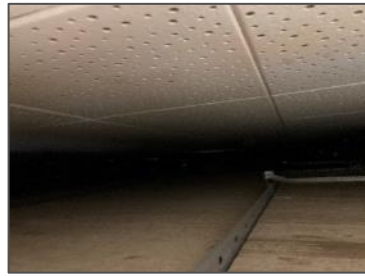
1'x1', glued-on, large and medium random pinholes	Staff Lounge (Location 1031)	Previous Pinchin Samples 0009A-C	No

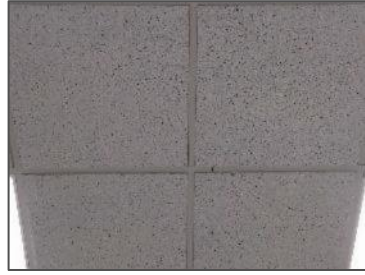
2'x4', lay-in, textured finish and pinholes	Library (Location 1511)	Previous Pinchin Samples 0011A-C	No

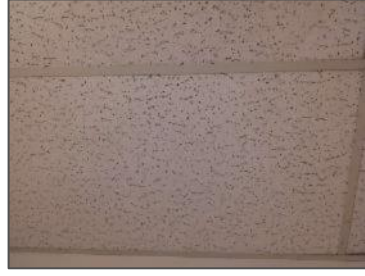
<i>2'x4', lay-in, fine textured surface</i>	<i>Corridor (Location 1091)</i>	<i>Previous Pinchin Samples 0012A-C</i>	<i>No (No Longer Present)</i>	
2'x4', lay-in, lengthwise deep wide fissures and pinholes	Corridor (Location 1091)	Previous Pinchin Samples 0013A-C	No

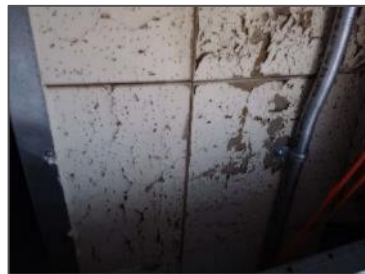
Description	Sample Location	Sample Number, Date Code or Material Composition	Asbestos	Photo
1'x1', splined, fissures and pinholes	Conference Room (Location 1010)	Previous Pinchin Samples 0016A-C	No

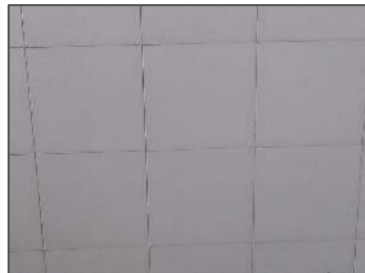
1'x1', splined, smooth textured finish	Vestibule (Location 1982)	Previous Pinchin Samples 0017A-C	No

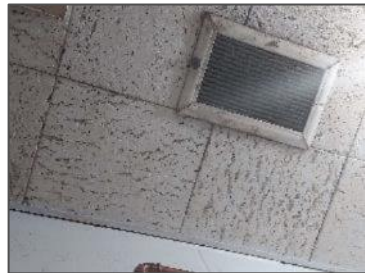
1'x1', mechanically fastened, coarse texture and fissures	Office (Location 1111) Washroom (Location 1970)	Previous Pinchin Samples 0020A-C	No

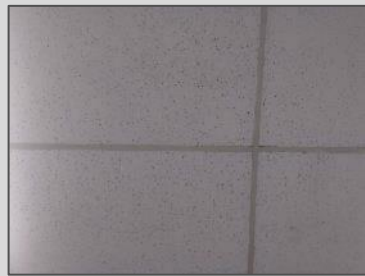
Description	Sample Location	Sample Number, Date Code or Material Composition	Asbestos	Photo
2'x4', lay-in, textured finish and pinholes	Classroom (Location 2250)	Previous Pinchin Samples 0036A-C	Yes

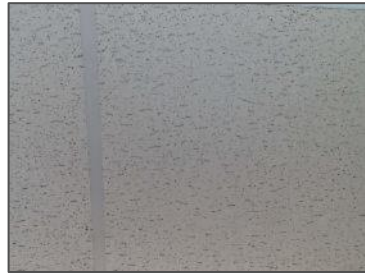
2'x4', lay-in, dense pinholes and short and medium widthwise fissures	Washroom (Location 1012) Storage (Location 1013)	Samples S0050A-C	No

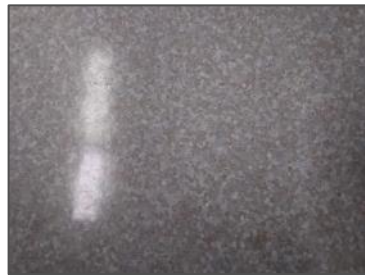
Description	Sample Location (Loc #)	Sample Number	Asbestos (Backing / Adhesive)	Photo
Grey, stone pattern	Music Room (Location 1170)	Previous Pinchin Samples S0023A-C	No / No

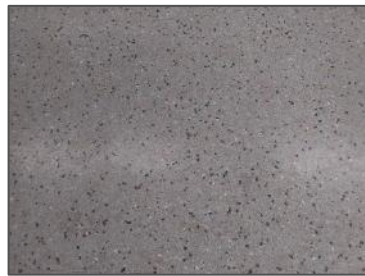
Description	Sample Location (Loc #)	Sample Number	Asbestos (Backing / Adhesive)	Photo
Beige, large cubes pattern	Elevator (Location 1) Storage (Location 1261)	Previous Pinchin Samples 0024A-C	Yes	 
Grey, blue and red, small stone pattern	Transportation Technology (Location 1250)	Previous Pinchin Samples 0025A-C	No / No

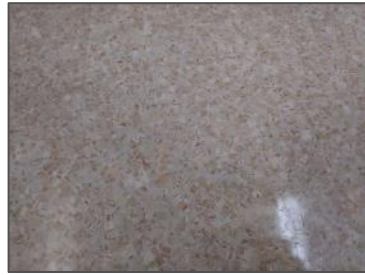
Beige, large cubes pattern	Classroom (Location 2020)	Previous Pinchin Samples 0031A-C	No / No

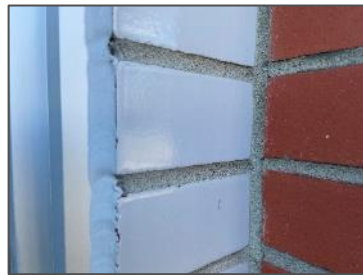
Material, Description and Application	Sample Location (Location #)	Sample Number	Asbestos	Photo
Caulking, grey, door frames	Exterior Phase E (Location 3007) Exterior Phase C (Location 3008) Exterior Phase D (Location 3009)	S0077A-C	No

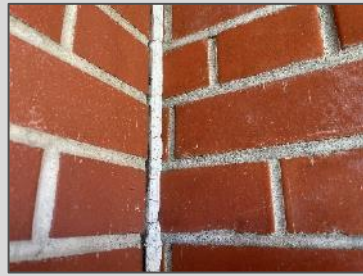
Caulking, hard grey, expansion joints	Exterior Phase E (Location 3007) Exterior Phase D (Location 3009)	S0083A-C	Yes
