# FINAL **Asbestos Reassessment**

Ernestown Secondary School  
50 Main Street, Odessa, Ontario

December 16, 2025

Pinchin File: 201262.363

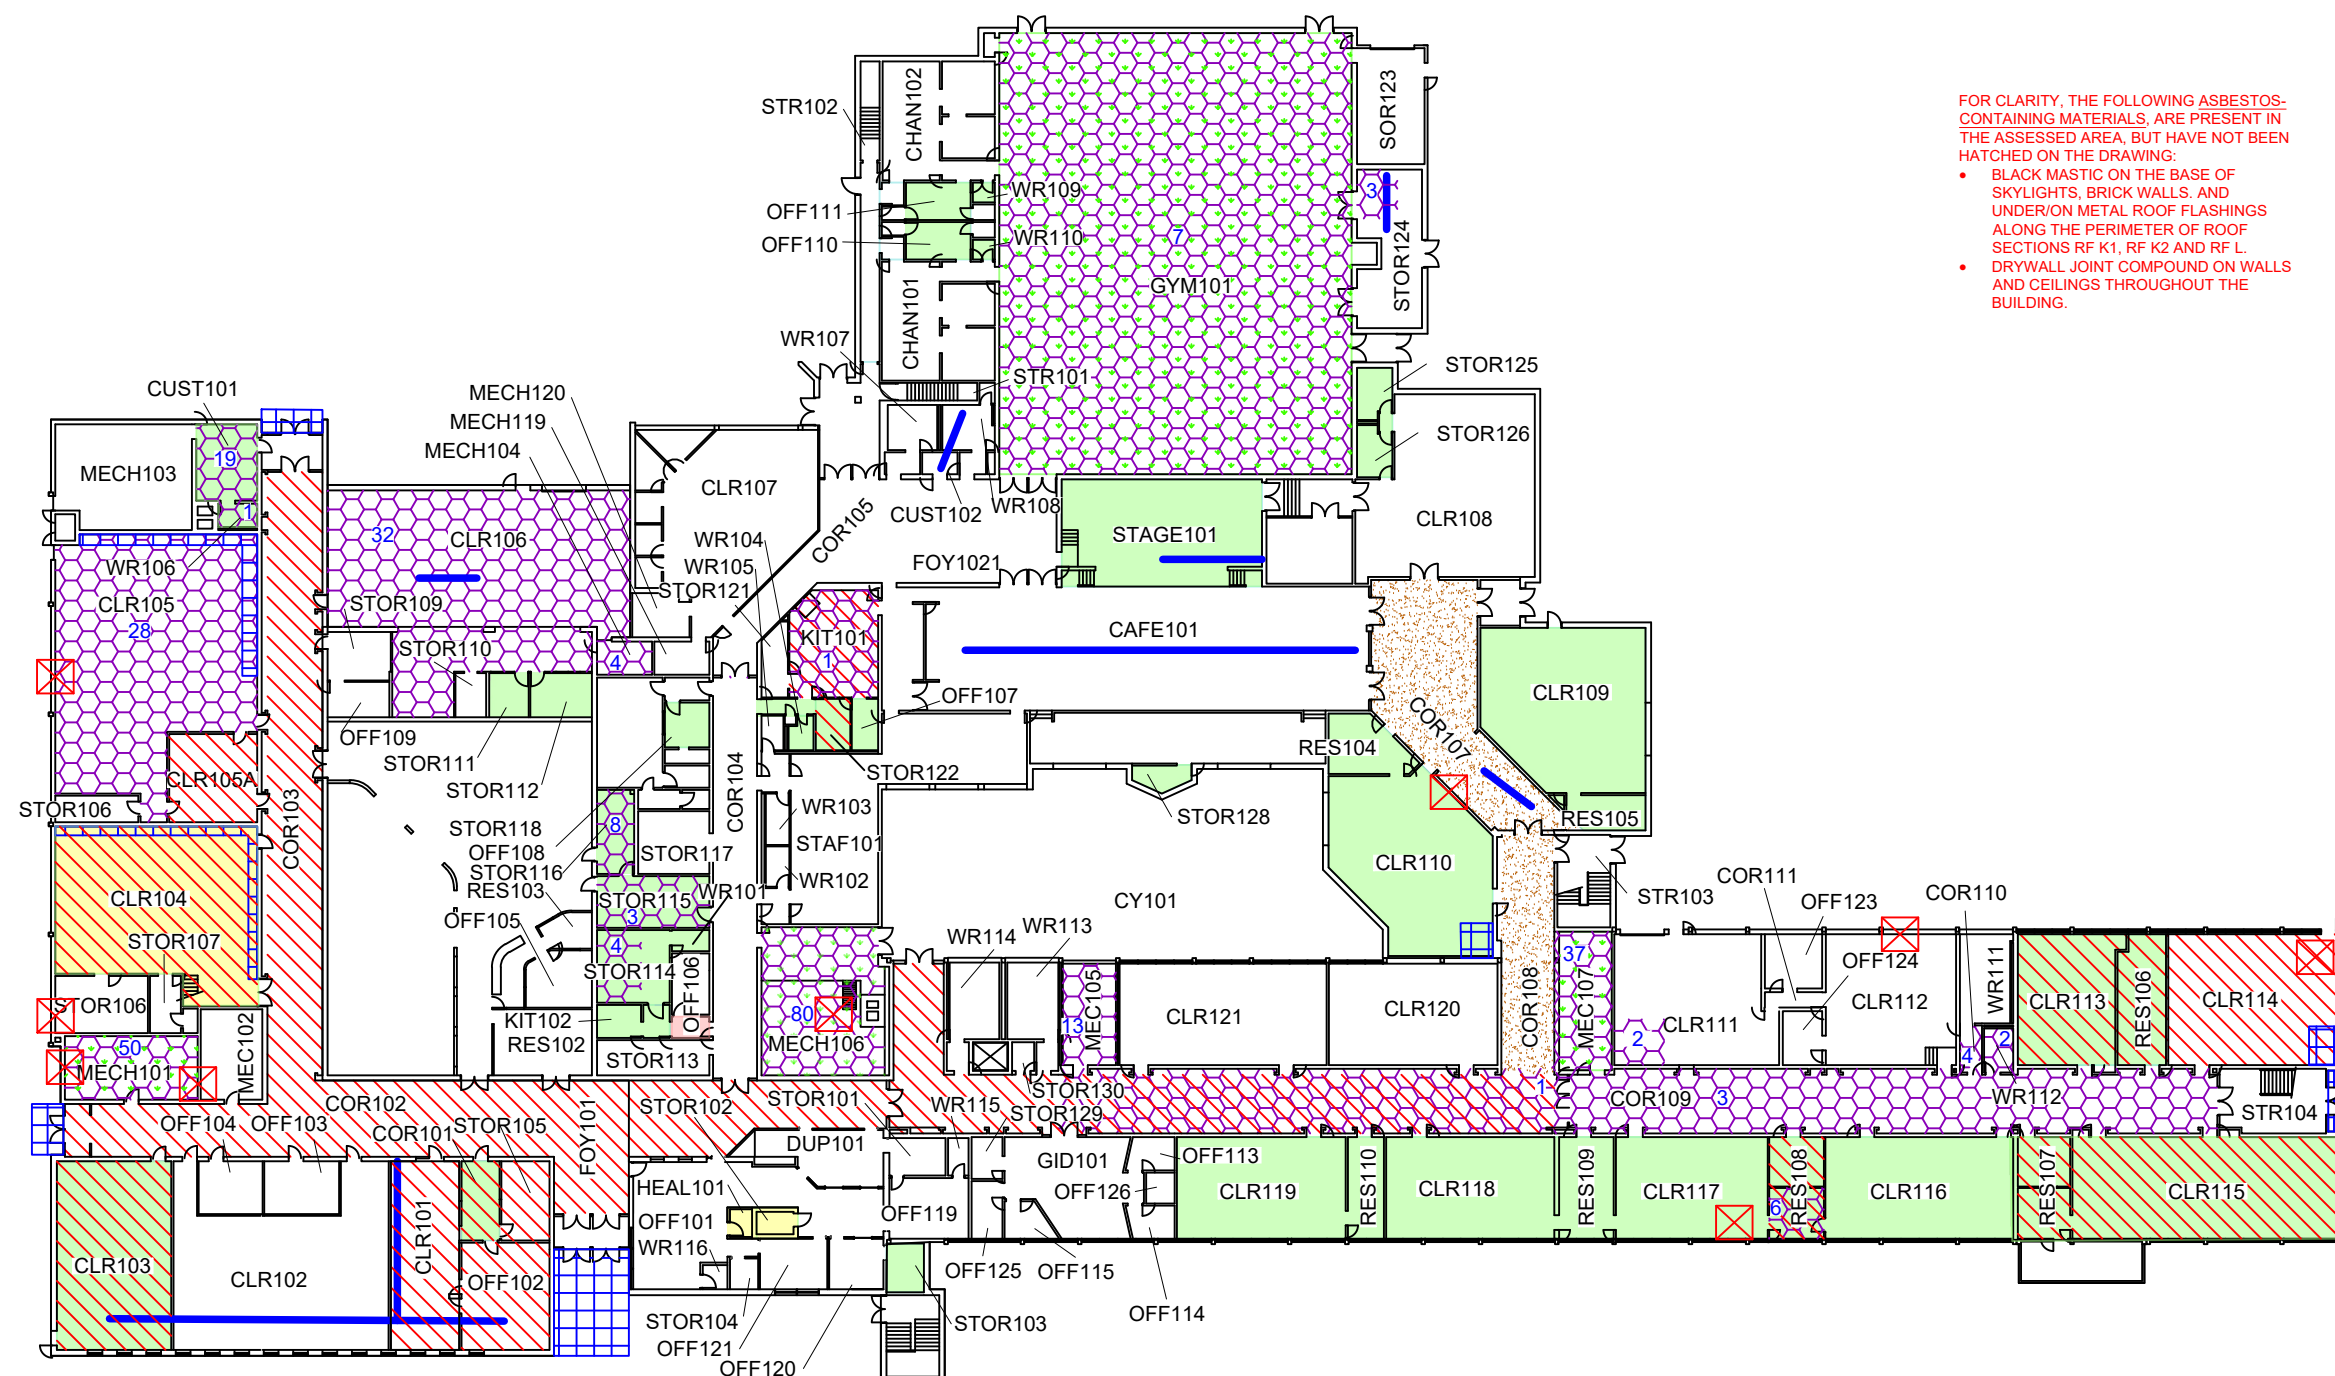
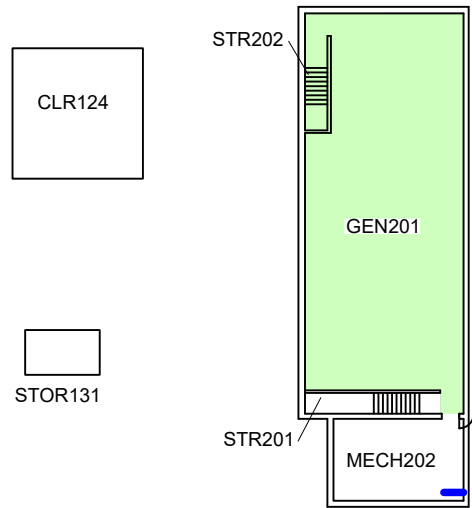
1 OF 3

FOR CLARITY, THE FOLLOWING ASBESTOS-CONTAINING MATERIALS, ARE PRESENT IN THE ASSESSED AREA, BUT HAVE NOT BEEN HATCHED ON THE DRAWING:

- BLACK MASTIC ON THE BASE OF SKYLIGHTS, BRICK WALLS, AND UNDER/ON METAL ROOF FLASHINGS ALONG THE PERIMETER OF ROOF SECTIONS RF K1, RF K2 AND RF L.
- DRYWALL JOINT COMPOUND ON WALLS AND CEILINGS THROUGHOUT THE BUILDING.

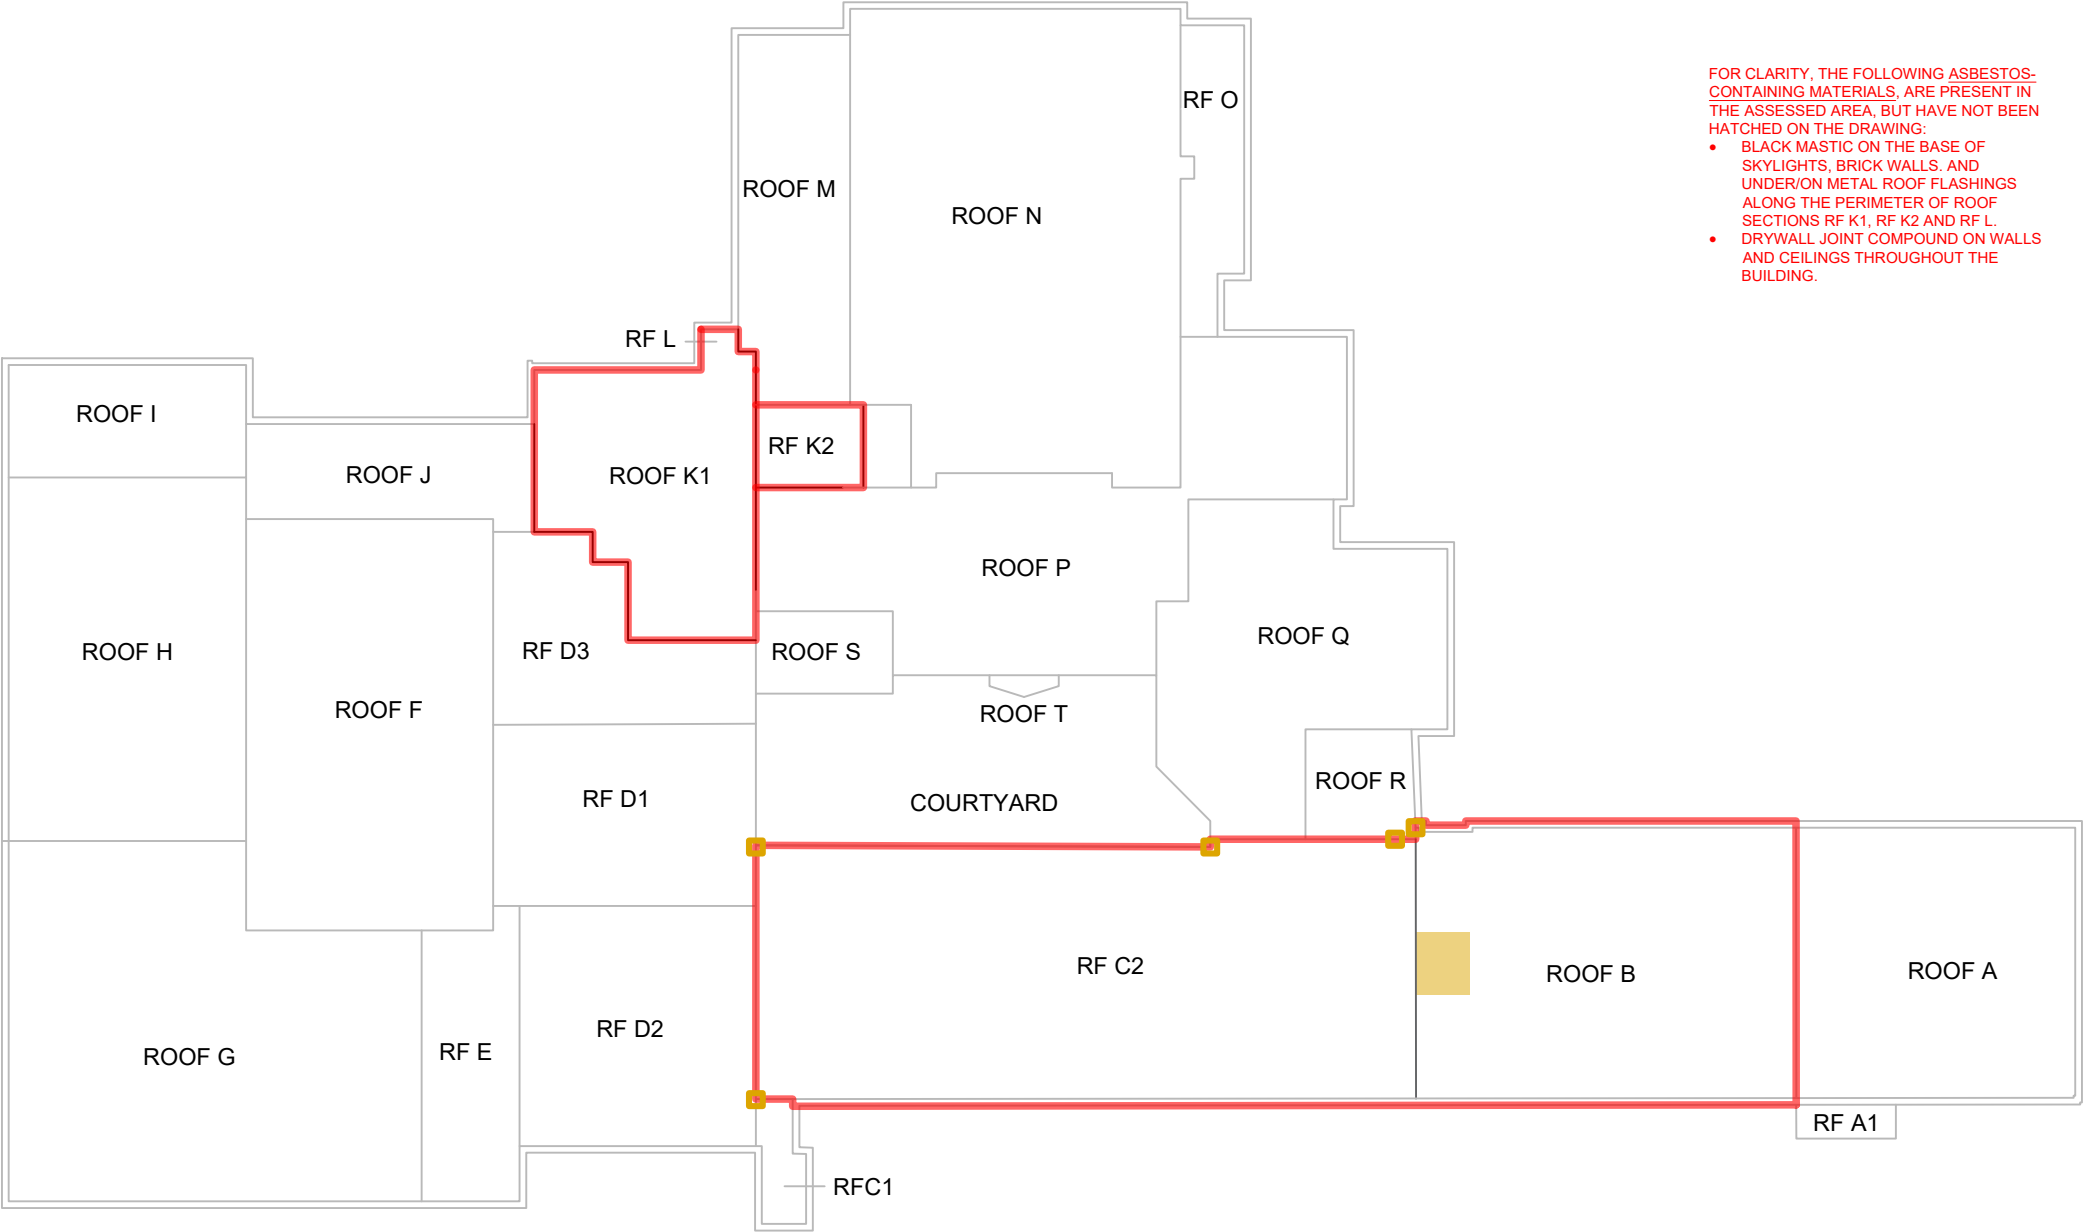
DATE: DEC 2025  
FIGURE NUMBER: 2 OF 3

FOR CLARITY, THE FOLLOWING ASBESTOS-CONTAINING MATERIALS, ARE PRESENT IN THE ASSESSED AREA, BUT HAVE NOT BEEN HATCHED ON THE DRAWING.

- BLACK MASTIC ON THE BASE OF SKYLIGHTS, BRICK WALLS, AND UNDER/ON METAL ROOF FLASHINGS ALONG THE PERIMETER OF ROOF SECTIONS RF K1, RF K2 AND RF L.
- DRYWALL JOINT COMPOUND ON WALLS AND CEILINGS THROUGHOUT THE BUILDING.
