FINAL **Hazardous Building** **Materials Assessment**

Pineview Public School
8 George Street, Athens,
Ontario

**Upper Canada District School
Board**

April 20, 2023

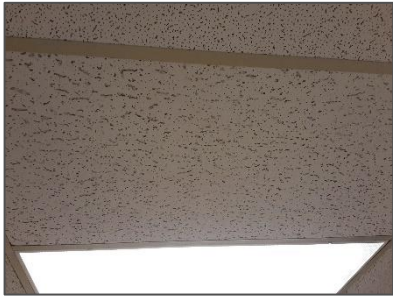
| Description | Sample Location | Sample Number, Date Code or Material Composition | Asbestos | Photo |
|---|---|--|---|---|
| 2'x4', lay-in, deep wide lengthwise fissures and pinholes with pink backing | Locations 18 and 60 | Previous Pinchin Samples 0008A-C | None Detected | |

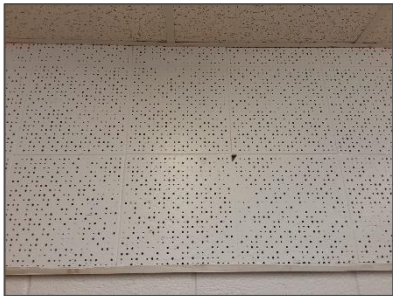
| Description | Sample Location | Sample Number, Date Code or Material Composition | Asbestos | Photo |
|---|---|--|---|---|
| 1'x1', mechanically fastened, large and medium pinholes | Locations 7, 8 and 9 | Previous Pinchin Samples 0009A-C | None Detected | |

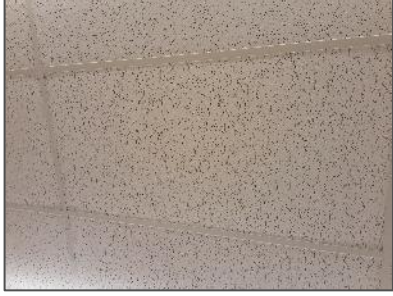
| Description | Sample Location | Sample Number, Date Code or Material Composition | Asbestos | Photo |
|---|---|--|---|---|
| 2'x4', lay-in, deep wide fissures and random pinholes | Not Sampled | Dated 06/04/1997 | None | |

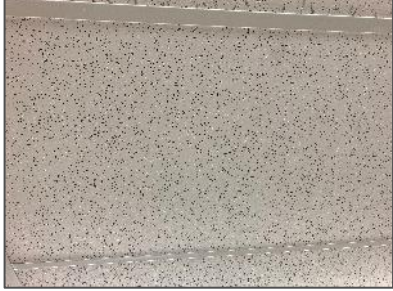
| Description | Sample Location | Sample Number, Date Code or Material Composition | Asbestos | Photo |
|---|---|--|---|---|
| 2'x4', lay-in, fleck and pinholes | Not Sampled | Dated 02/08/2021 | None | |

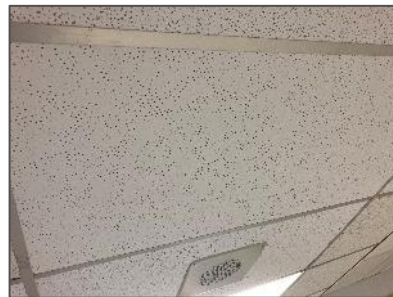
| Description | Sample Location | Sample Number, Date Code or Material Composition | Asbestos | Photo |
|--|---|--|---|---|
| 2'x4', lay-in, random pinholes | Not Sampled | Dated 11/02/1998 | None | |

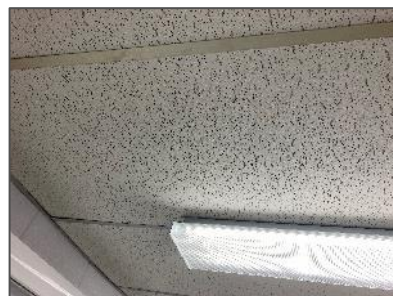
| Description | Sample Location | Sample Number, Date Code or Material Composition | Asbestos | Photo |
|--|---|--|---|---|
| 2'x4', lay-in, small fissures and pinholes | Not sampled | Dated 07/03/1997 | None | |

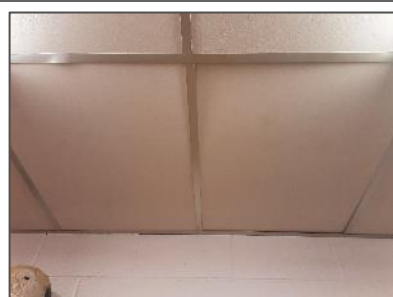
| Description | Sample Location | Sample Number, Date Code or Material Composition | Asbestos | Photo |
|--|---|--|---|---|
| 2'x4', lay-in, gypsum | Not Sampled | None | None* | |

*Ceiling tiles are presumed to be non-asbestos based on the composition of the tiles (e.g., gypsum).

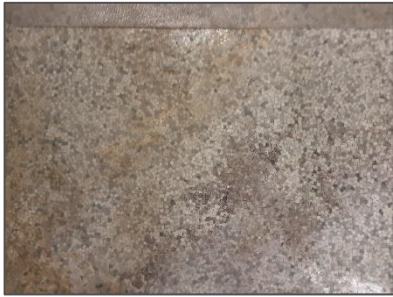
| Description | Sample Location (Loc #) | Sample Number | Asbestos (Backing / Adhesive) | Photo |
|---|---|---|---|---|
| Grey cubes | Location 49 | Previous Pinchin Samples 0003A-C | None Detected | |

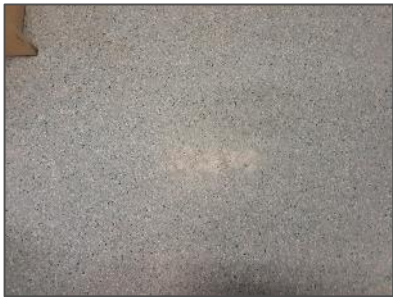
| Description | Sample Location (Loc #) | Sample Number | Asbestos (Backing / Adhesive) | Photo |
|---|---|---|---|---|
| Blue speckle | Not Sampled | Installed Post 1992 | None** | |

**Vinyl sheet flooring is presumed to be non-asbestos based on historical knowledge of the type of flooring (foam) or based on the lack of a paper backing layer (underpad) and date of installation (i.e. post 1992).

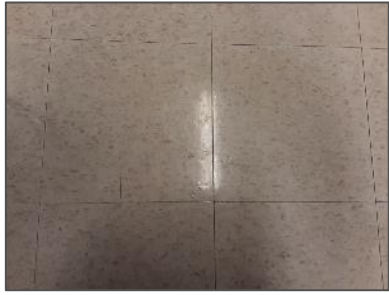
| Description | Sample Location (Location #) | Sample Number | Asbestos (Tile / Adhesive) | Photo |
|--|---|---|---|---|
| 12"x12", beige fleck | Not Sampled | Installed Post 1992 | None* | |

*Vinyl floor tiles were presumed to be non-asbestos based on historical knowledge of the date of installation (1992).

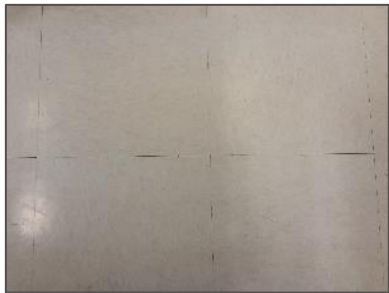
| Description | Sample Location (Location #) | Sample Number | Asbestos (Tile / Adhesive) | Photo |
|---|---|---|---|---|
| 12"x12", white with purple fleck | Not Sampled | Installed Post 1992 | None* | |

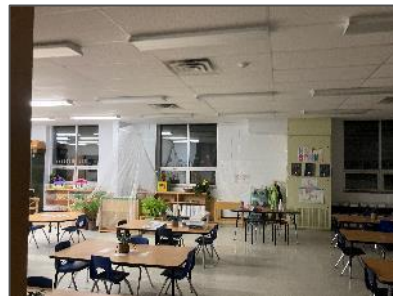
| Material, Description and Application | Sample Location (Location #) | Sample Number | Asbestos | Photo |
|---|---|---|---|---|
| Caulking, light grey, window frames | Locations 1 and 2 | S0033A-C | None Detected | |

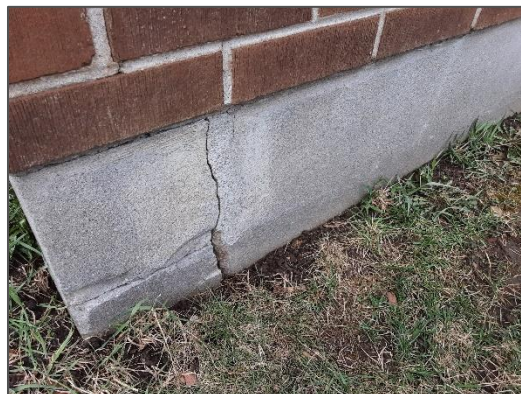
Non-asbestos wall parging.

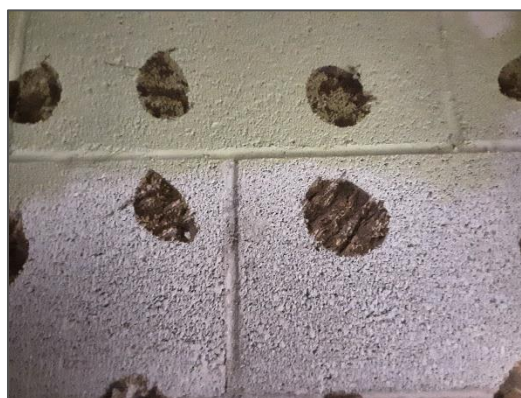
Non-asbestos brown wall mastic.

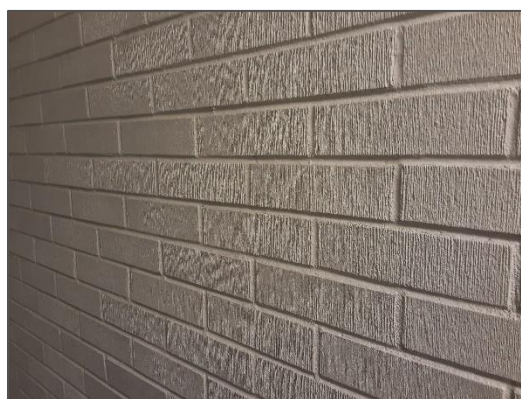
Non-asbestos paint present on the brick wall.
