# Designated Substances and Hazardous Materials Survey

*DCC Project No. HQ1562DC, 52 North Star Drive, CFB Trenton, ON  
Building 52 - Hanger 10*

20442331

August 2021

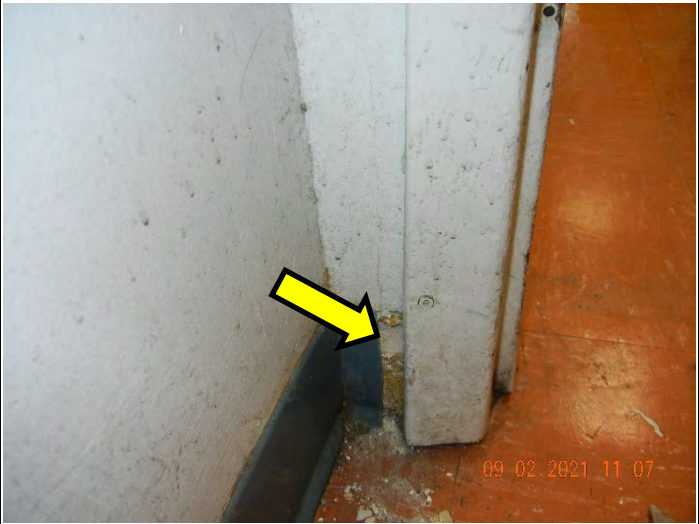
| Material <sup>(1)</sup><br>Description | Material<br>Location | Observed<br>Estimated<br>Quantity <sup>(2)</sup> | Condition | Friable<br>(Yes / No) | Accessibility <sup>(3)</sup> | Sample Number | Asbestos<br>Concentration (%)<br>and Type | Photograph |
|---|---|---|---|---|---|---|---|---|
| Tan mastic | Associated with<br>navy vinyl<br>baseboard<br>(Room 1007) | N/A <sup>(4)</sup> | N/A | N/A | N/A | A-002A<br>to<br>A-002C | None Detected | |

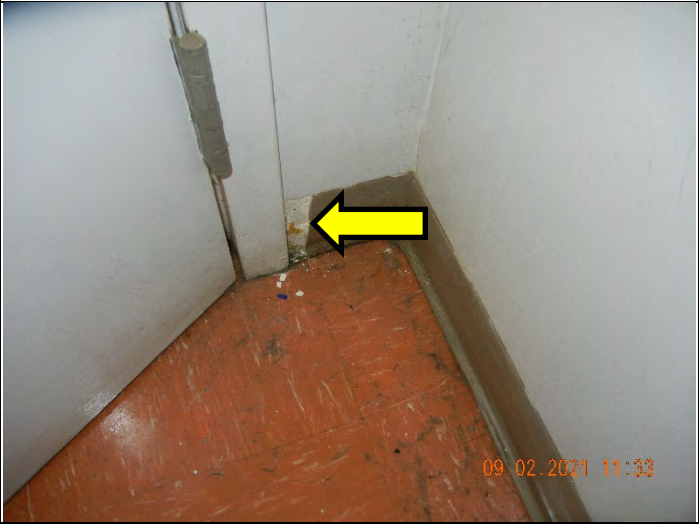
| Material <sup>(1)</sup><br>Description | Material<br>Location | Observed<br>Estimated<br>Quantity <sup>(2)</sup> | Condition | Friable<br>(Yes / No) | Accessibility <sup>(3)</sup> | Sample Number | Asbestos<br>Concentration (%)<br>and Type | Photograph |
|---|---|---|---|---|---|---|---|---|
| Yellow/tan mastic | Associated with<br>grey vinyl<br>baseboard<br>(Rooms 1015 -<br>1018) | N/A | N/A | N/A | N/A | A-005A<br>to<br>A-005C | None Detected | |

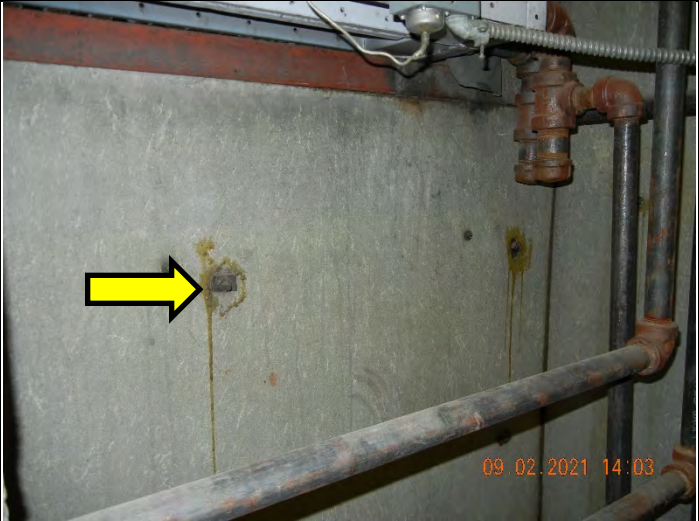
| Material <sup>(1)</sup><br>Description | Material<br>Location | Observed<br>Estimated<br>Quantity <sup>(2)</sup> | Condition | Friable<br>(Yes / No) | Accessibility <sup>(3)</sup> | Sample Number | Asbestos<br>Concentration (%)<br>and Type | Photograph |
|---|---|---|---|---|---|---|---|---|
| Yellow mastic | Present on wall<br>penetration<br>openings in<br>utility spaces<br>throughout Site | N/A | N/A | N/A | N/A | A-010A<br>to<br>A-010C | None Detected | |

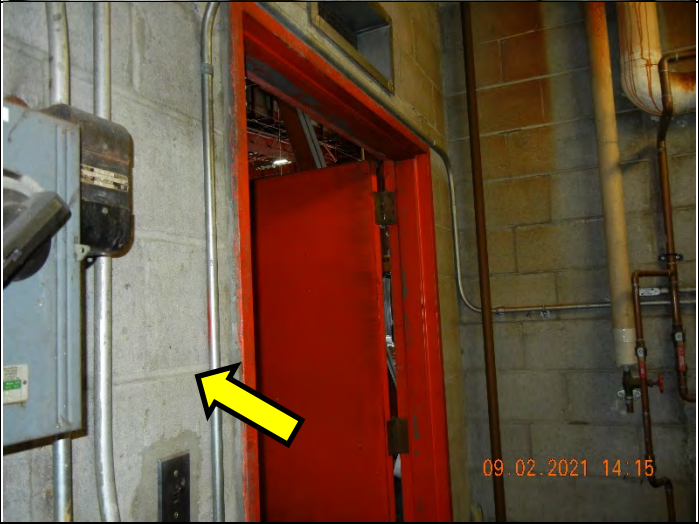
| Material <sup>(1)</sup><br>Description | Material<br>Location | Observed<br>Estimated<br>Quantity <sup>(2)</sup> | Condition | Friable<br>(Yes / No) | Accessibility <sup>(3)</sup> | Sample Number | Asbestos<br>Concentration (%)<br>and Type | Photograph |
|---|---|---|---|---|---|---|---|---|
| Grey cinderblock<br>mortar | Present in<br>cinderblock and<br>mortar walls<br>throughout Site | N/A | N/A | N/A | N/A | A-011A<br>to<br>A-011G | None Detected | |

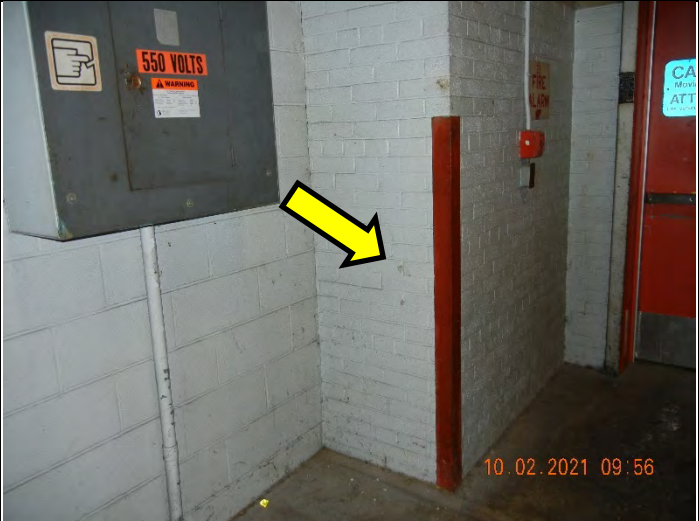
| Material <sup>(1)</sup><br>Description | Material<br>Location | Observed<br>Estimated<br>Quantity <sup>(2)</sup> | Condition | Friable<br>(Yes / No) | Accessibility <sup>(3)</sup> | Sample Number | Asbestos<br>Concentration (%)<br>and Type | Photograph |
|---|---|---|---|---|---|---|---|---|
| Grey brick mortar | Present in brick walls throughout Site | N/A | N/A | N/A | N/A | A-012A to A-012G | None Detected | |

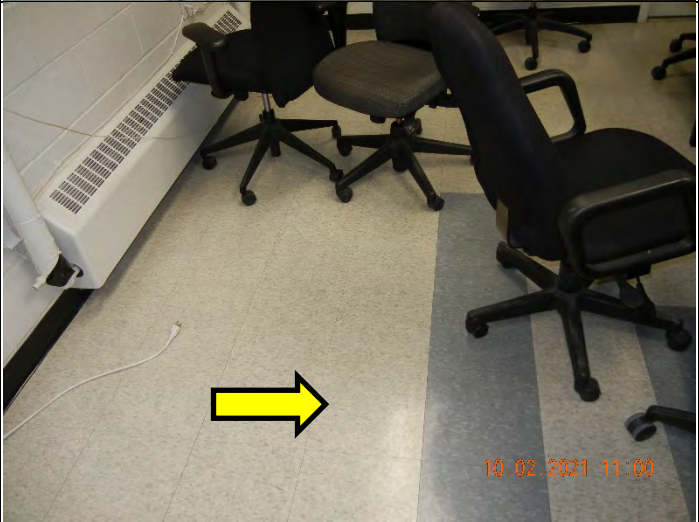
| Material <sup>(1)</sup><br>Description | Material<br>Location | Observed<br>Estimated<br>Quantity <sup>(2)</sup> | Condition | Friable<br>(Yes / No) | Accessibility <sup>(3)</sup> | Sample Number | Asbestos<br>Concentration (%)<br>and Type | Photograph |
|---|---|---|---|---|---|---|---|---|
| 1' x 1' white with grey streaks vinyl floor tiles (VFTs) | Present on floor of Room 1118 | N/A | N/A | N/A | N/A | A-013A to A-013C | None Detected | |

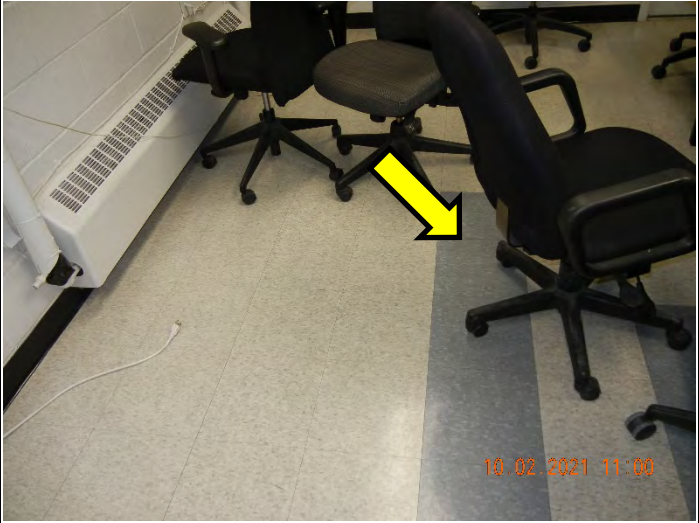
| Material <sup>(1)</sup><br>Description | Material<br>Location | Observed<br>Estimated<br>Quantity <sup>(2)</sup> | Condition | Friable<br>(Yes / No) | Accessibility <sup>(3)</sup> | Sample Number | Asbestos<br>Concentration (%)<br>and Type | Photograph |
|---|---|---|---|---|---|---|---|---|
| 1' x 1' blue with<br>white streaks<br>VFTs | Present on floor<br>of Room 1118 | N/A | N/A | N/A | N/A | A-015A<br>to<br>A-015C | None Detected | |

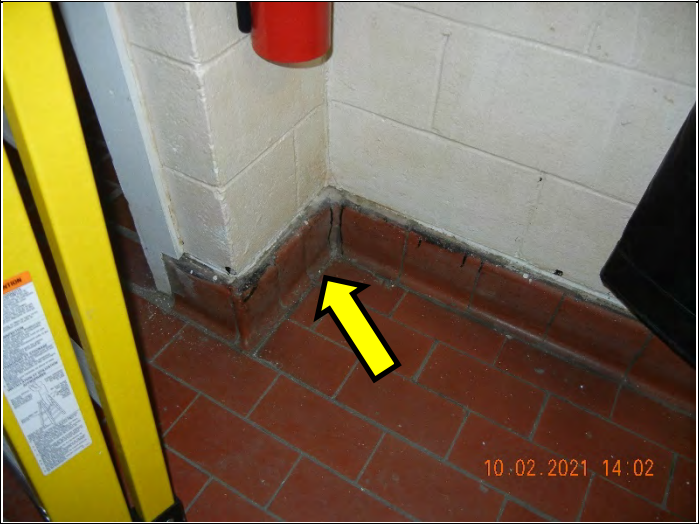
| Material <sup>(1)</sup><br>Description | Material<br>Location | Observed<br>Estimated<br>Quantity <sup>(2)</sup> | Condition | Friable<br>(Yes / No) | Accessibility <sup>(3)</sup> | Sample Number | Asbestos<br>Concentration (%)<br>and Type | Photograph |
|---|---|---|---|---|---|---|---|---|
| Dark grey mortar | Present under<br>red ceramic<br>flooring in<br>Rooms 1137,<br>1138 and 1139 | N/A | N/A | N/A | N/A | A-017A<br>to<br>A-017C | None Detected | |

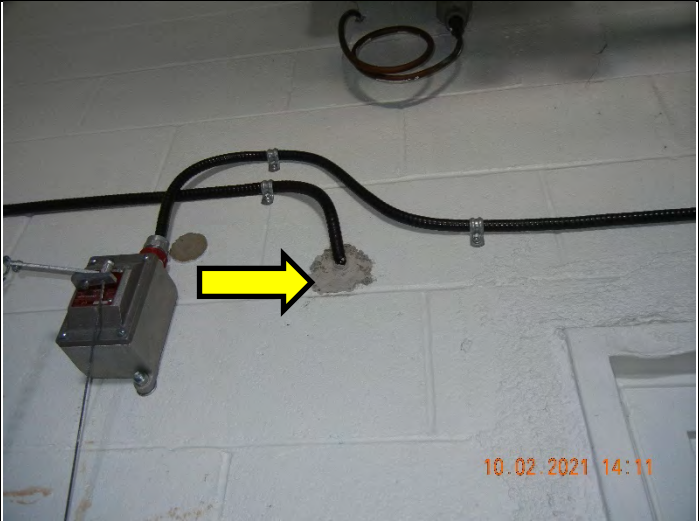
| Material <sup>(1)</sup><br>Description | Material<br>Location | Observed<br>Estimated<br>Quantity <sup>(2)</sup> | Condition | Friable<br>(Yes / No) | Accessibility <sup>(3)</sup> | Sample Number | Asbestos<br>Concentration (%)<br>and Type | Photograph |
|---|---|---|---|---|---|---|---|---|
| Light grey firestop<br>caulking | Present applied<br>to wall<br>penetration<br>openings in<br>Room 1137 | N/A | N/A | N/A | N/A | A-018A<br>to<br>A-018C | None Detected | |

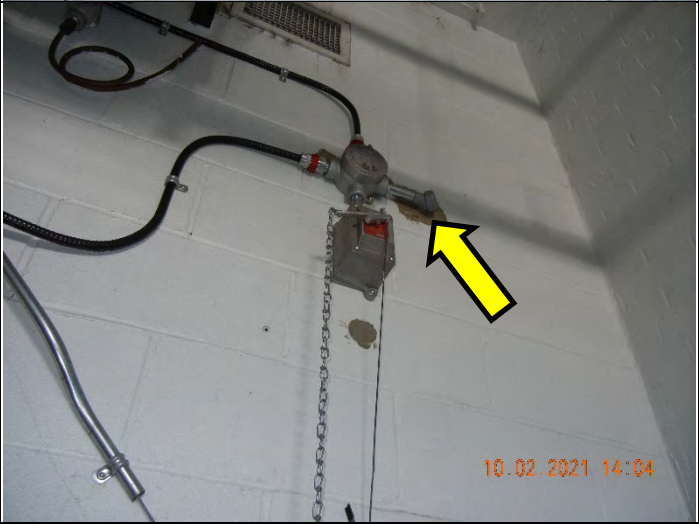
| Material <sup>(1)</sup><br>Description | Material<br>Location | Observed<br>Estimated<br>Quantity <sup>(2)</sup> | Condition | Friable<br>(Yes / No) | Accessibility <sup>(3)</sup> | Sample Number | Asbestos<br>Concentration (%)<br>and Type | Photograph |
|---|---|---|---|---|---|---|---|---|
| Grey parging<br>cement firestop | Present applied<br>to wall<br>penetration<br>openings in<br>Room 1137 | N/A | N/A | N/A | N/A | A-019A<br>to<br>A-019E | None Detected | |

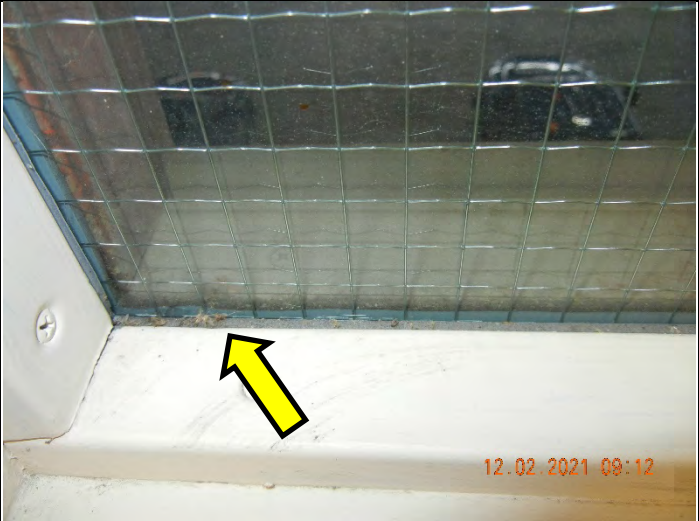
| Material <sup>(1)</sup><br>Description | Material<br>Location | Observed<br>Estimated<br>Quantity <sup>(2)</sup> | Condition | Friable<br>(Yes / No) | Accessibility <sup>(3)</sup> | Sample Number | Asbestos<br>Concentration (%)<br>and Type | Photograph |
|---|---|---|---|---|---|---|---|---|
| Grey caulking<br>(interior windows) | Present on<br>second floor<br>interior office<br>windows | N/A | N/A | N/A | N/A | A-023A<br>to<br>A-023C | None Detected | |

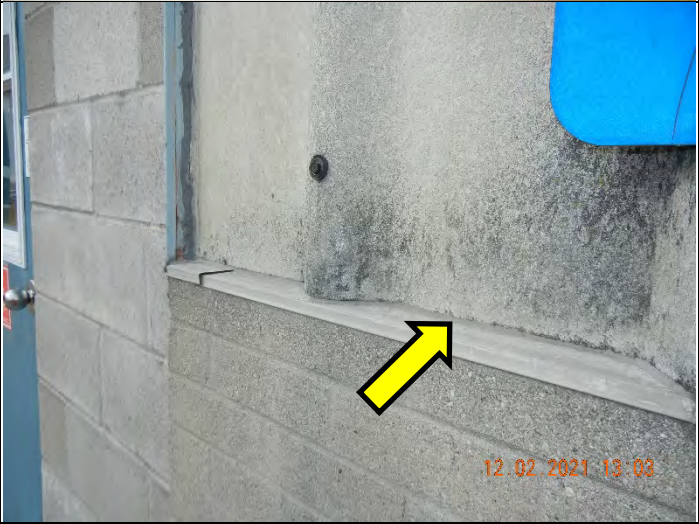
| Material <sup>(1)</sup><br>Description | Material<br>Location | Observed<br>Estimated<br>Quantity <sup>(2)</sup> | Condition | Friable<br>(Yes / No) | Accessibility <sup>(3)</sup> | Sample Number | Asbestos<br>Concentration (%)<br>and Type | Photograph |
|---|---|---|---|---|---|---|---|---|
| Light grey caulking | Present applied<br>to construction<br>seams in<br>exterior<br>corrugate<br>Transite<br>Paneling (A-030) | N/A | N/A | N/A | N/A | A-026A<br>to<br>A-026C | None Detected | |

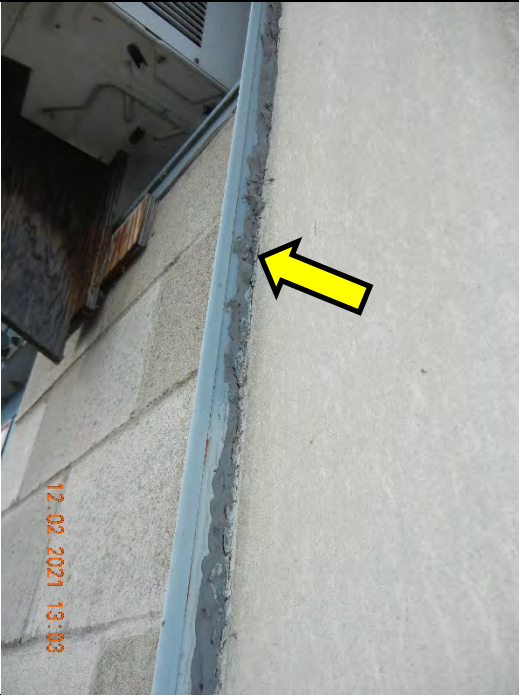
| Material <sup>(1)</sup><br>Description | Material<br>Location | Observed<br>Estimated<br>Quantity <sup>(2)</sup> | Condition | Friable<br>(Yes / No) | Accessibility <sup>(3)</sup> | Sample Number | Asbestos<br>Concentration (%)<br>and Type | Photograph |
|---|---|---|---|---|---|---|---|---|
| Blue/grey caulking | Present applied<br>to exterior<br>construction<br>seams around<br>select doors | N/A | N/A | N/A | N/A | A-027A<br>to<br>A-027C | None Detected | |

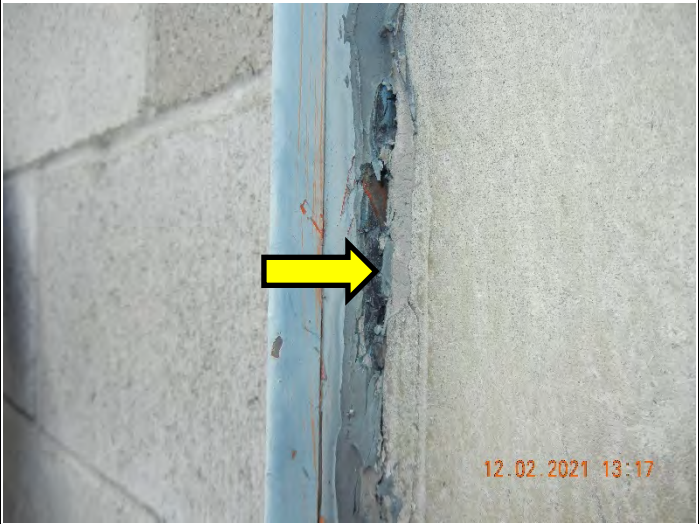
| Material <sup>(1)</sup><br>Description | Material<br>Location | Observed<br>Estimated<br>Quantity <sup>(2)</sup> | Condition | Friable<br>(Yes / No) | Accessibility <sup>(3)</sup> | Sample Number | Asbestos<br>Concentration (%)<br>and Type | Photograph |
|---|---|---|---|---|---|---|---|---|
| Black caulking | Present applied under blue/grey caulking (A-027) around select exterior doors | N/A | N/A | N/A | N/A | A-028A to A-028C | None Detected | |

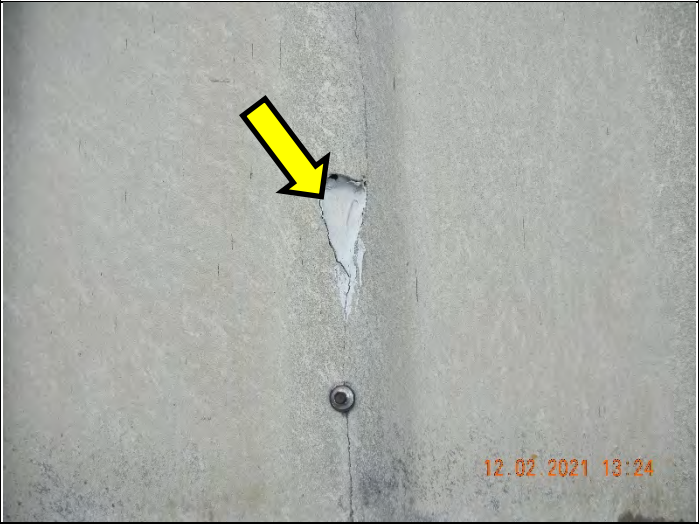
| Material <sup>(1)</sup><br>Description | Material<br>Location | Observed<br>Estimated<br>Quantity <sup>(2)</sup> | Condition | Friable<br>(Yes / No) | Accessibility <sup>(3)</sup> | Sample Number | Asbestos<br>Concentration (%)<br>and Type | Photograph |
|---|---|---|---|---|---|---|---|---|
| White/grey caulking | Present applied to select exterior wall construction seams | N/A | N/A | N/A | N/A | A-029A to A-029C | None Detected | |

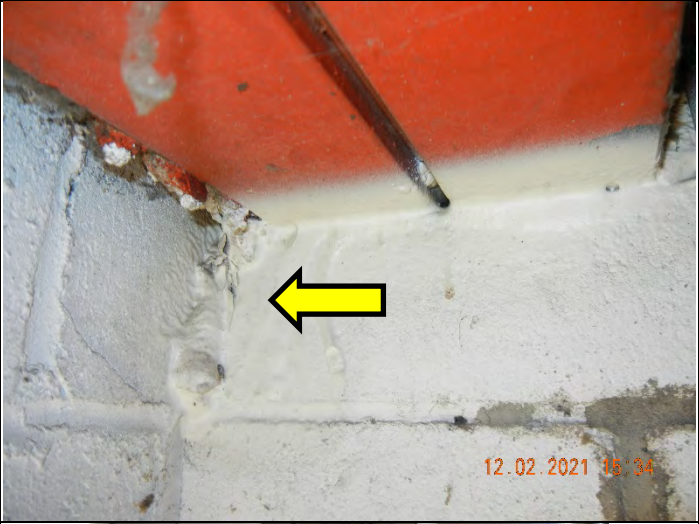
| Material <sup>(1)</sup><br>Description | Material<br>Location | Observed<br>Estimated<br>Quantity <sup>(2)</sup> | Condition | Friable<br>(Yes / No) | Accessibility <sup>(3)</sup> | Sample Number | Asbestos<br>Concentration (%)<br>and Type | Photograph |
|---|---|---|---|---|---|---|---|---|
| White firestop<br>caulking | Present applied<br>to interior<br>construction<br>seams<br>throughout the<br>Site | N/A | N/A | N/A | N/A | A-034A<br>to<br>A-034C | None Detected | |

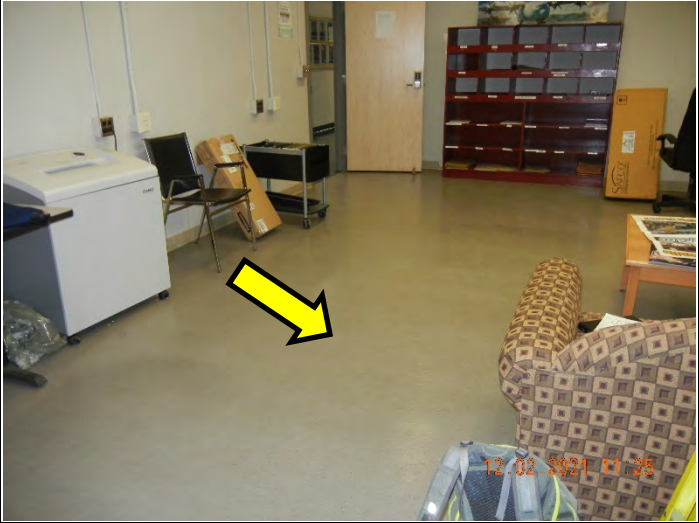
| Material <sup>(1)</sup><br>Description | Material<br>Location | Observed<br>Estimated<br>Quantity <sup>(2)</sup> | Condition | Friable<br>(Yes / No) | Accessibility <sup>(3)</sup> | Sample Number | Asbestos<br>Concentration (%)<br>and Type | Photograph |
|---|---|---|---|---|---|---|---|---|
| Grey vinyl floor tile | Present in<br>second floor<br>office area<br>(Room 2088) | N/A | N/A | N/A | N/A | A-036A<br>to<br>A-036C | None Detected | |

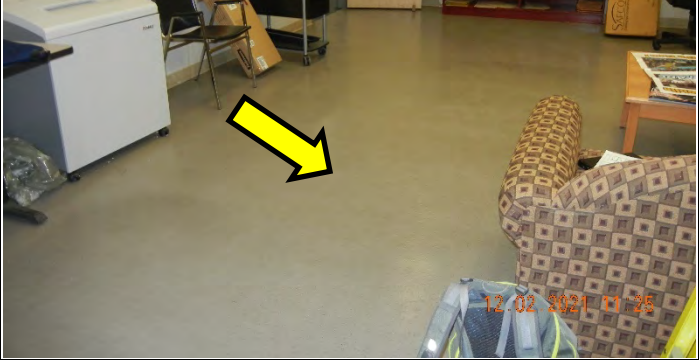
| Material <sup>(1)</sup><br>Description | Material<br>Location | Observed<br>Estimated<br>Quantity <sup>(2)</sup> | Condition | Friable<br>(Yes / No) | Accessibility <sup>(3)</sup> | Sample Number | Asbestos<br>Concentration (%)<br>and Type | Photograph |
|---|---|---|---|---|---|---|---|---|
| Brown/tan mastic | Associated with<br>installed Grey<br>vinyl floor tiles<br>(A-036) | N/A | N/A | N/A | N/A | A-037A<br>to<br>A-037C | None Detected | |

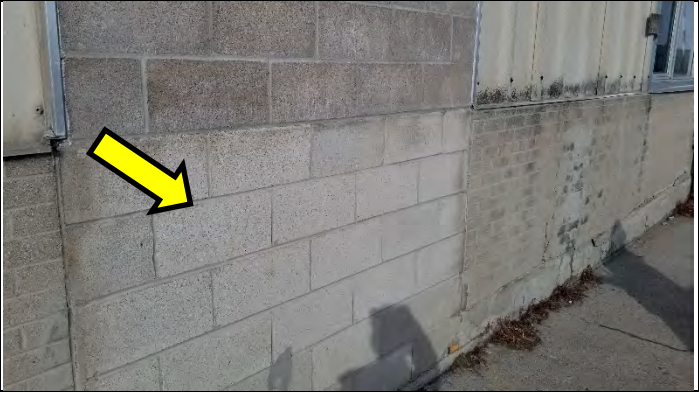
| Material <sup>(1)</sup><br>Description | Material<br>Location | Observed<br>Estimated<br>Quantity <sup>(2)</sup> | Condition | Friable<br>(Yes / No) | Accessibility <sup>(3)</sup> | Sample Number | Asbestos<br>Concentration (%)<br>and Type | Photograph |
|---|---|---|---|---|---|---|---|---|
| Grey cinderblock<br>mortar | Present applied<br>to visually<br>distinct patch in<br>exterior<br>cinderblock wall<br>(S façade) | N/A | N/A | N/A | N/A | A-038A<br>to<br>A-038C | None Detected | |

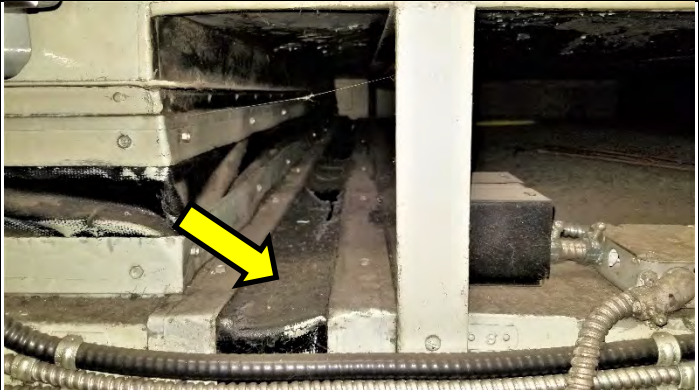
| Material <sup>(1)</sup><br>Description | Material<br>Location | Observed<br>Estimated<br>Quantity <sup>(2)</sup> | Condition | Friable<br>(Yes / No) | Accessibility <sup>(3)</sup> | Sample Number | Asbestos<br>Concentration (%)<br>and Type | Photograph |
|---|---|---|---|---|---|---|---|---|
| Black duct<br>expansion flex<br>joint | Present on<br>HVAC ductwork<br>installed within<br>second floor<br>mechanical<br>rooms and fan<br>rooms | N/A | N/A | N/A | N/A | A-039A<br>to<br>A-039C | None Detected | |

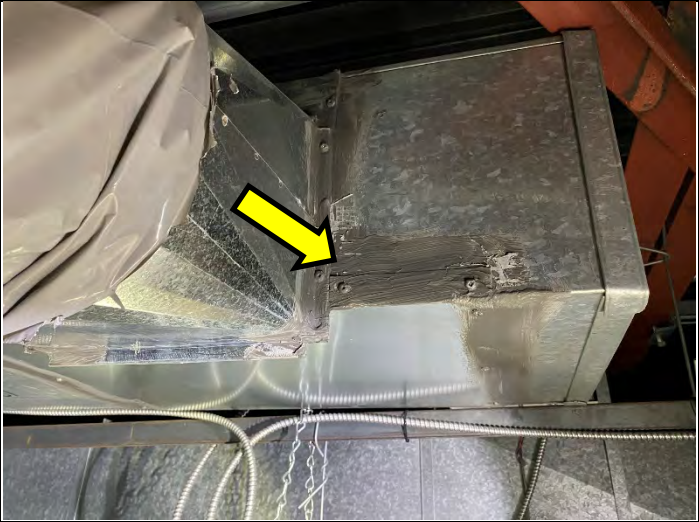
| Material <sup>(1)</sup><br>Description | Material<br>Location | Observed<br>Estimated<br>Quantity <sup>(2)</sup> | Condition | Friable<br>(Yes / No) | Accessibility <sup>(3)</sup> | Sample Number | Asbestos<br>Concentration (%)<br>and Type | Photograph |
|---|---|---|---|---|---|---|---|---|
| Dark grey duct<br>joint caulking | Present on<br>ductwork<br>encountered<br>above second<br>floor drop<br>ceilings | N/A | N/A | N/A | N/A | A-043A<br>to<br>A-043C | None Detected | |

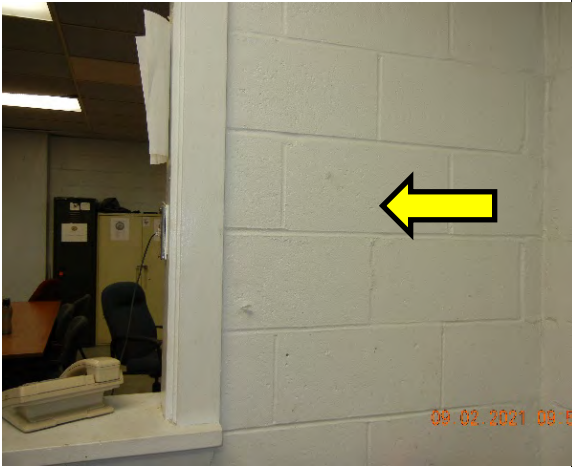
| Description <sup>(1)</sup> / Location of Material | Condition | Observed<br>Estimated<br>Quantity to<br>Be Impacted | Lead<br>(Pb)<br>Conc.<br>(ug/g) | Arsenic<br>(As)<br>Conc.<br>(ug/g) | Mercury<br>(Hg)<br>Conc.<br>(ug/g) | Sample<br>Number | Pb, As, or Hg Containing<br>Material<br>(Yes/No) | Photograph |
|---|---|---|---|---|---|---|---|---|
| Glossy white paint –<br><br>Present on interior walls<br>within Room 1001 and<br>throughout Site | Good | N/A | 15 | <50 <sup>(2)</sup> | <2 | L-001 | No | |

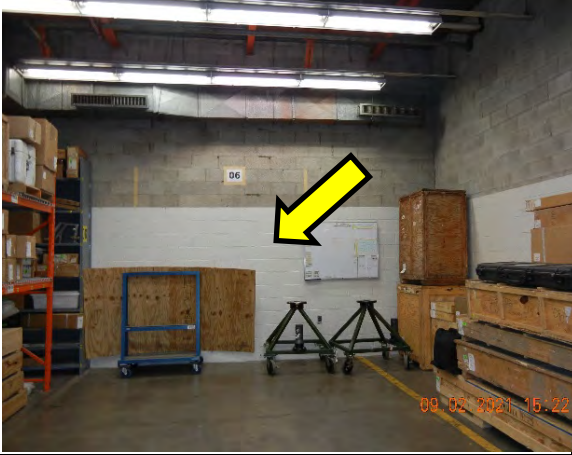
| Description <sup>(1)</sup> / Location of Material | Condition | Observed<br>Estimated<br>Quantity to<br>Be Impacted | Lead<br>(Pb)<br>Conc.<br>(ug/g) | Arsenic<br>(As)<br>Conc.<br>(ug/g) | Mercury<br>(Hg)<br>Conc.<br>(ug/g) | Sample<br>Number | Pb, As, or Hg Containing<br>Material<br>(Yes/No) | Photograph |
|---|---|---|---|---|---|---|---|---|
| Matte white paint –<br><br>Present on walls within<br>Room 1030 and<br>throughout Site | Good | N/A | 11 | <50 | <2 | L-002 | No | |

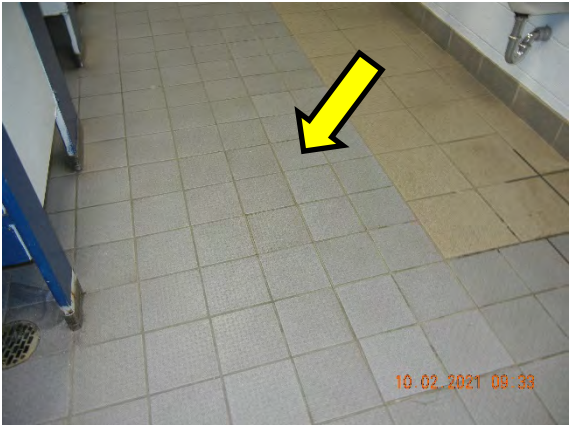
| Description <sup>(1)</sup> / Location of Material | Condition | Observed<br>Estimated<br>Quantity to<br>Be Impacted | Lead<br>(Pb)<br>Conc.<br>(ug/g) | Arsenic<br>(As)<br>Conc.<br>(ug/g) | Mercury<br>(Hg)<br>Conc.<br>(ug/g) | Sample<br>Number | Pb, As, or Hg Containing<br>Material<br>(Yes/No) | Photograph |
|---|---|---|---|---|---|---|---|---|
| Blue/grey textured<br>ceramic tile glazing –<br><br>Present installed on floor<br>of washroom 1123 and<br>select washrooms | Good | N/A | 2 | <1 | <0.1 | L-005 | No | |

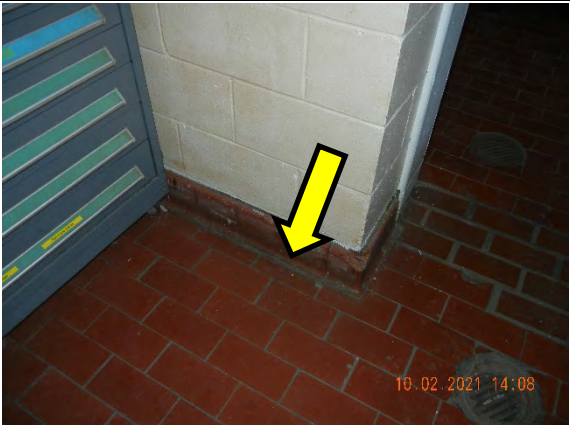
| Description <sup>(1)</sup> / Location of Material | Condition | Observed<br>Estimated<br>Quantity to<br>Be Impacted | Lead<br>(Pb)<br>Conc.<br>(ug/g) | Arsenic<br>(As)<br>Conc.<br>(ug/g) | Mercury<br>(Hg)<br>Conc.<br>(ug/g) | Sample<br>Number | Pb, As, or Hg Containing<br>Material<br>(Yes/No) | Photograph |
|---|---|---|---|---|---|---|---|---|
| Red ceramic tile glazing –<br><br>Present installed on floor<br>of Rooms 1137, 1138 and<br>1139 | Good to fair | N/A | 41 | 8 | <0.1 | L-006 | No | |

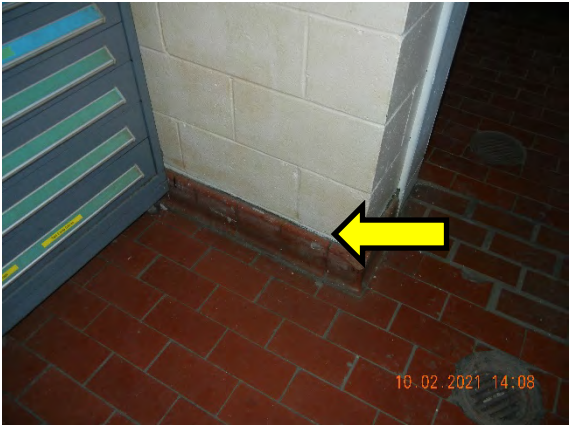
| Description <sup>(1)</sup> / Location of Material | Condition | Observed<br>Estimated<br>Quantity to<br>Be Impacted | Lead<br>(Pb)<br>Conc.<br>(ug/g) | Arsenic<br>(As)<br>Conc.<br>(ug/g) | Mercury<br>(Hg)<br>Conc.<br>(ug/g) | Sample<br>Number | Pb, As, or Hg Containing<br>Material<br>(Yes/No) | Photograph |
|---|---|---|---|---|---|---|---|---|
| Red ceramic tile glazing –<br><br>Present installed as<br>baseboard trim within<br>Rooms 1137, 1138 and<br>1139 | Good to fair | N/A | 25 | 11 | <0.1 | L-007 | No | |

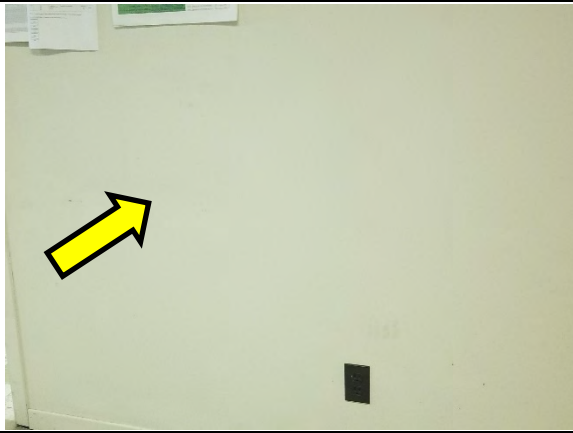
| Description <sup>(1)</sup> / Location of Material | Condition | Observed<br>Estimated<br>Quantity to<br>Be Impacted | Lead<br>(Pb)<br>Conc.<br>(ug/g) | Arsenic<br>(As)<br>Conc.<br>(ug/g) | Mercury<br>(Hg)<br>Conc.<br>(ug/g) | Sample<br>Number | Pb, As, or Hg Containing<br>Material<br>(Yes/No) | Photograph |
|---|---|---|---|---|---|---|---|---|
| Pale beige paint –<br><br>Present on select second<br>floor office walls (Room<br>2050E) | Good | N/A | <5 | <50 | <2 | L-010 | No | |

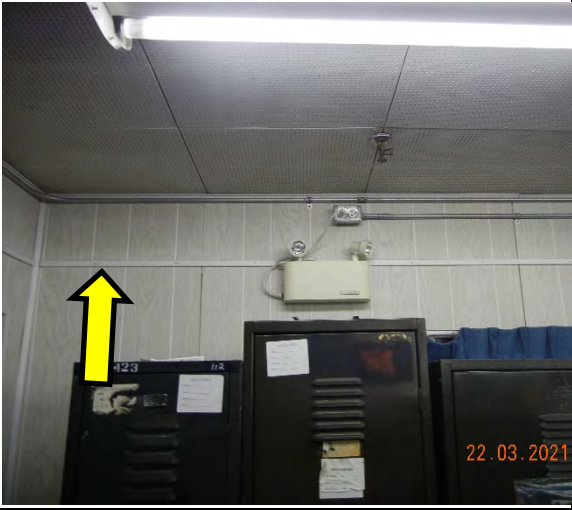
| Description <sup>(1)</sup> / Location of Material | Condition | Observed<br>Estimated<br>Quantity to<br>Be Impacted | Lead<br>(Pb)<br>Conc.<br>(ug/g) | Arsenic<br>(As)<br>Conc.<br>(ug/g) | Mercury<br>(Hg)<br>Conc.<br>(ug/g) | Sample<br>Number | Pb, As, or Hg Containing<br>Material<br>(Yes/No) | Photograph |
|---|---|---|---|---|---|---|---|---|
| Off-white paint –<br>Present on wood finishes<br>in second floor storage<br>room (2033) | Good | N/A | <5 | <50 | <2 | L-011 | No | |

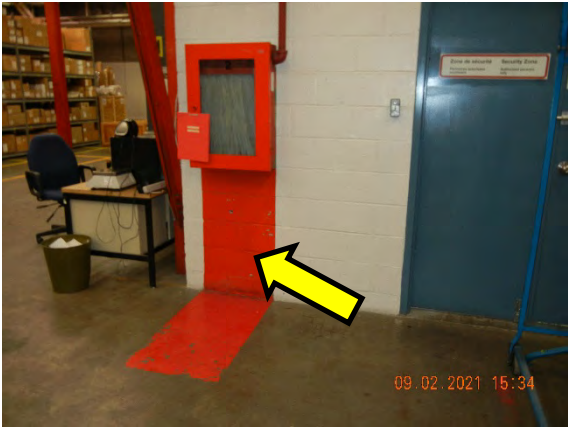
| Description / Location of Material | Condition | Lead (Pb) Leachate Conc (mg/L) | Arsenic (As) Leachate Conc (mg/L) | Mercury (Hg) Leachate Conc (mg/L) | Sample Number | Leachate Toxic Waste (Yes/No <sup>(2)</sup> ) | Photograph |
|---|---|---|---|---|---|---|---|
| Orange-red paint – Present on fire safety highlights within Room 1030 and throughout Site | Good | <0.05 <sup>(3)</sup> | N/A <sup>(4)</sup> | N/A | L-003 | No | |

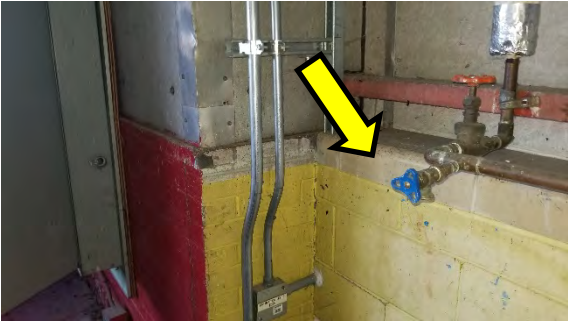
| Description / Location of Material | Condition | Lead (Pb) Leachate Conc (mg/L) | Arsenic (As) Leachate Conc (mg/L) | Mercury (Hg) Leachate Conc (mg/L) | Sample Number | Leachate Toxic Waste (Yes/No <sup>(2)</sup> ) | Photograph |
|---|---|---|---|---|---|---|---|
| Yellow trim ceramic tile glazing – Present installed on top of perimeter cinderblock walls along north and south façade within hanger spaces | Good | 0.16 | N/A | N/A | L-004 | No | |

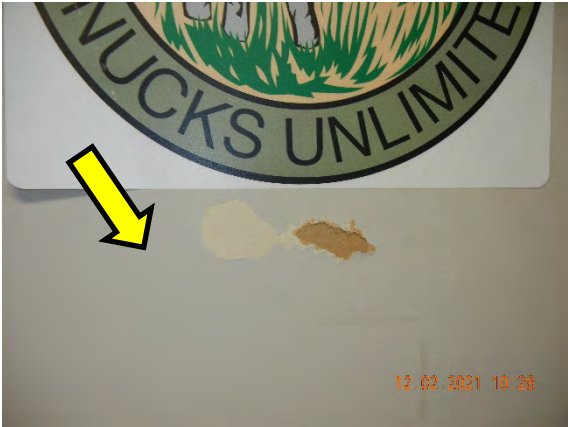
| Description / Location of Material | Condition | Lead (Pb) Leachate Conc (mg/L) | Arsenic (As) Leachate Conc (mg/L) | Mercury (Hg) Leachate Conc (mg/L) | Sample Number | Leachate Toxic Waste (Yes/No <sup>(2)</sup> ) | Photograph |
|---|---|---|---|---|---|---|---|
| Grey/beige paint – Present on select second floor office walls (Room 2087) | Good to fair | <0.20 | N/A | N/A | L-008 | No | |

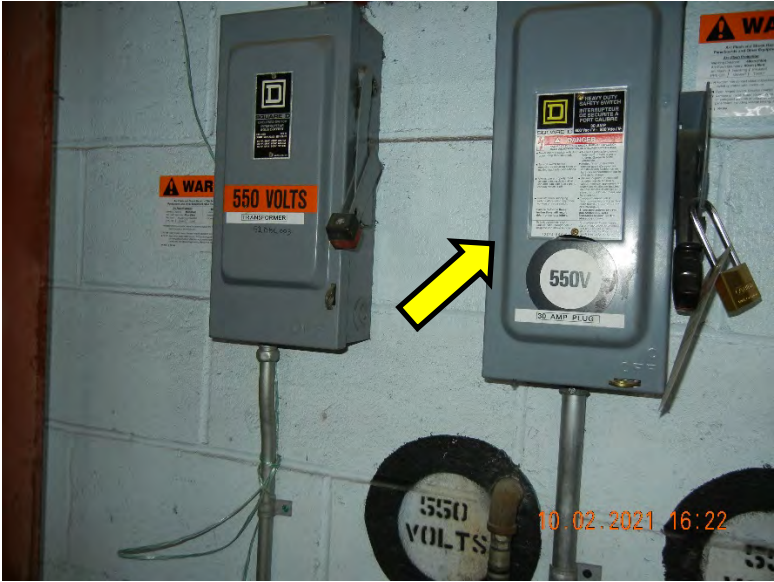
| Description / Location of Material | Photograph |
|---|---|
| <p>Electrical Switches –</p> <p>Present installed in select rooms throughout the Site</p> | |

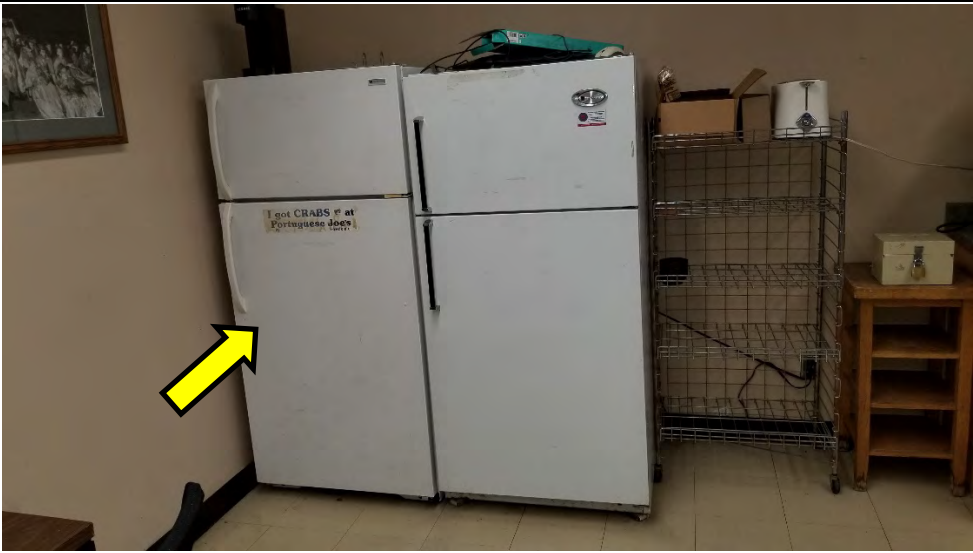
| Description / Location of Material | Photograph |
|---|---|
| <p>Refrigerator –</p> <p>Present in select office and dining spaces throughout the Site</p> | |

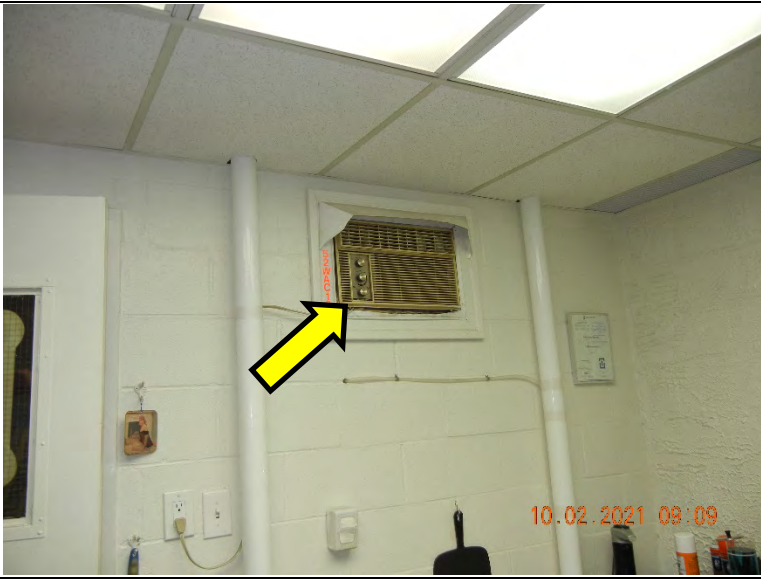
| Description / Location of Material | Photograph |
|---|---|
| <p>Air Conditioner Unit –</p> <p>Observed in barbershop and select perimeter office spaces</p> | |

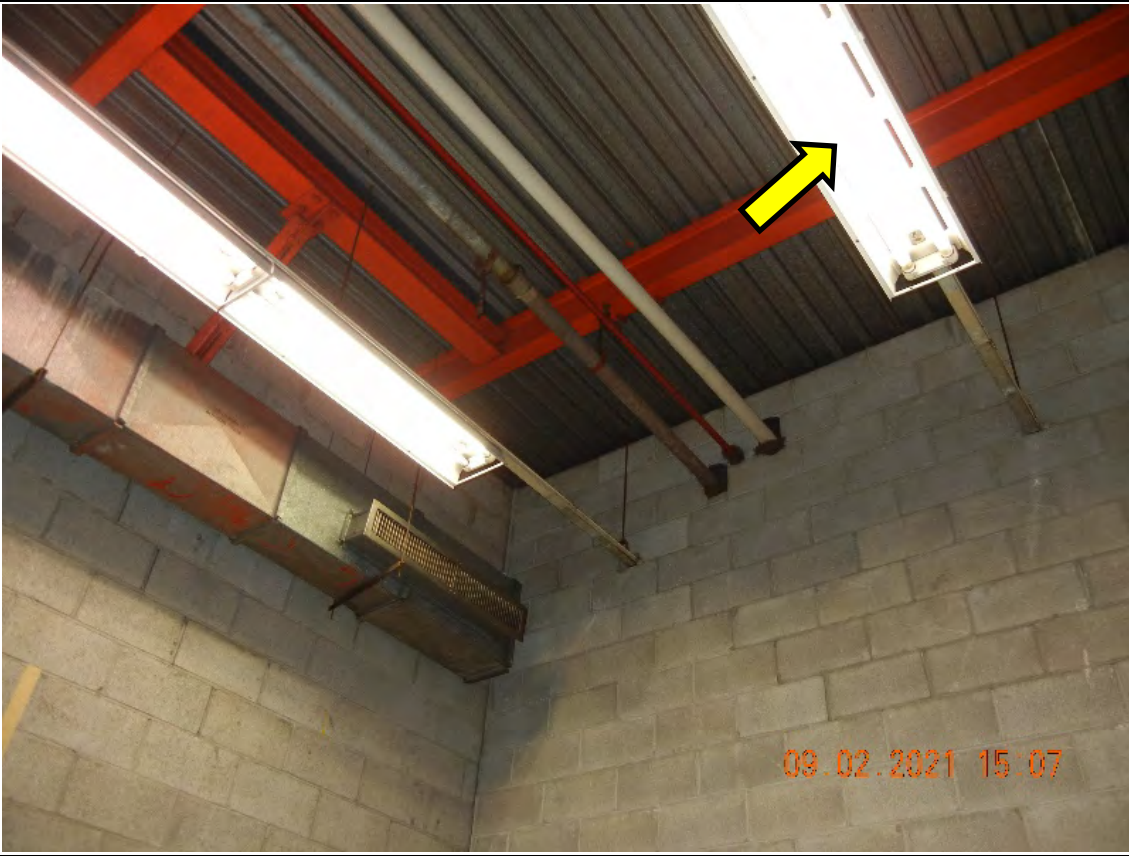
| Description / Location of Material | Photograph |
|---|---|
| <p>Light Fixture Ballasts –<br/><br/>Present installed throughout the Site</p> | |

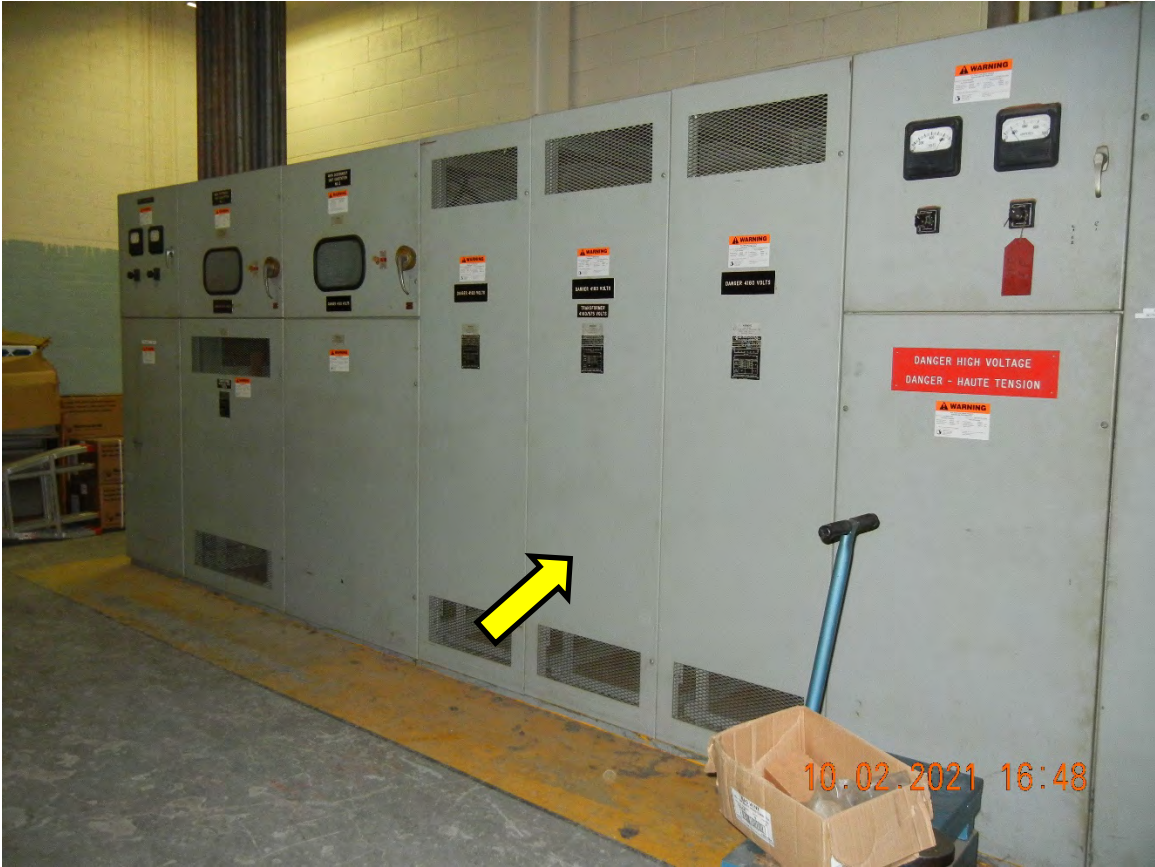
| Description / Location of Material | Photograph |
|---|---|
| <p>Electrical Transformers –</p> <p>Present installed in electrical rooms throughout the Site</p> | |

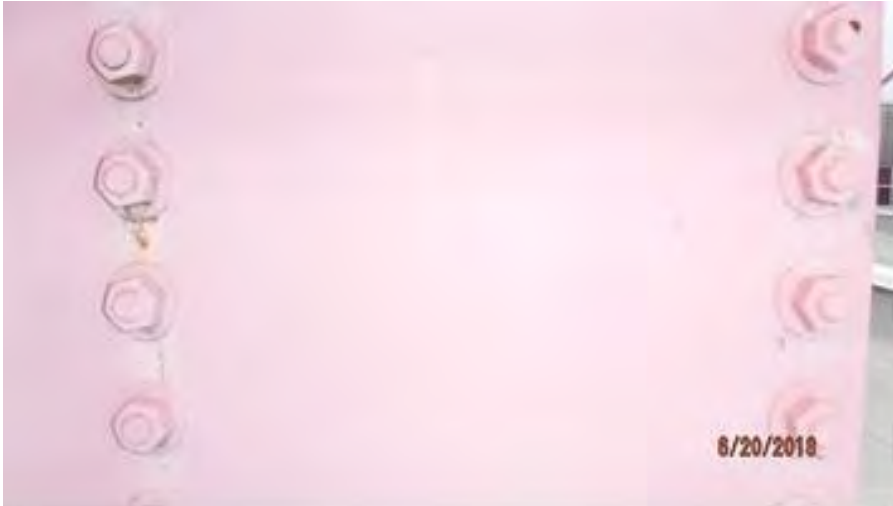
**Photo 3:**

Pink paint (Sample L1) was sampled from the structural beams on the roof and was found to contain 0.0267% chromium, 0.107% lead, and 0.0000491% mercury by dry weight.
