Reinforced Autoclaved Aerated Concrete Assessment (Siporex) Report

Pineview Public School

Report Prepared by:
Shoalts and Zaback Architects Ltd.
SZA Project #: 24028

Report Date: 2024-08-28

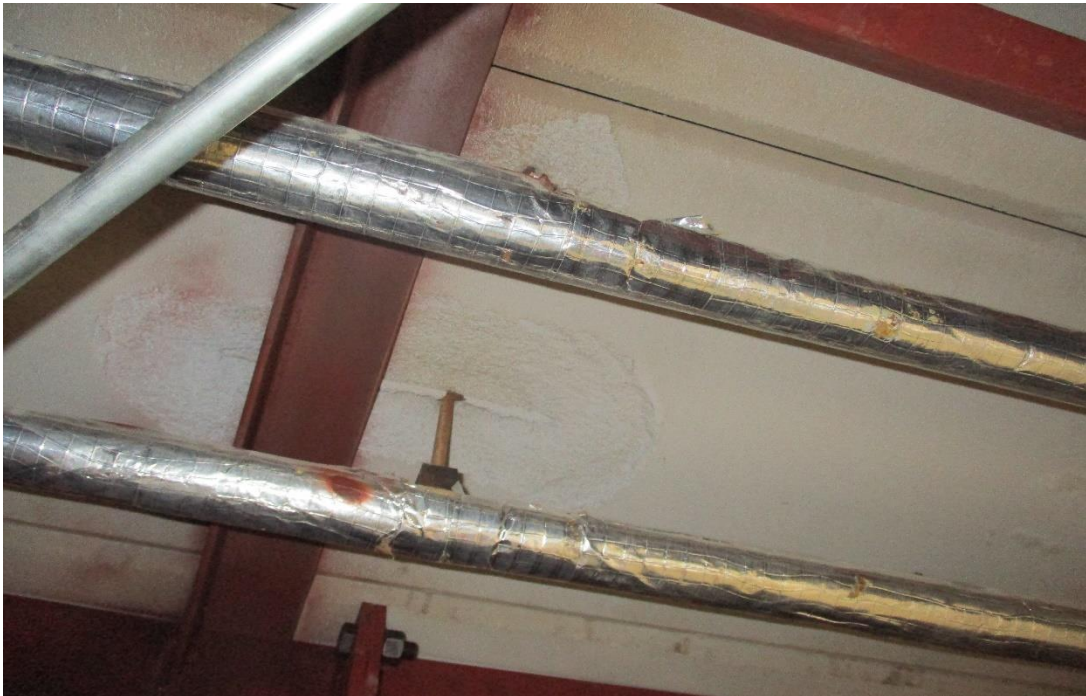
Delamination of Slab

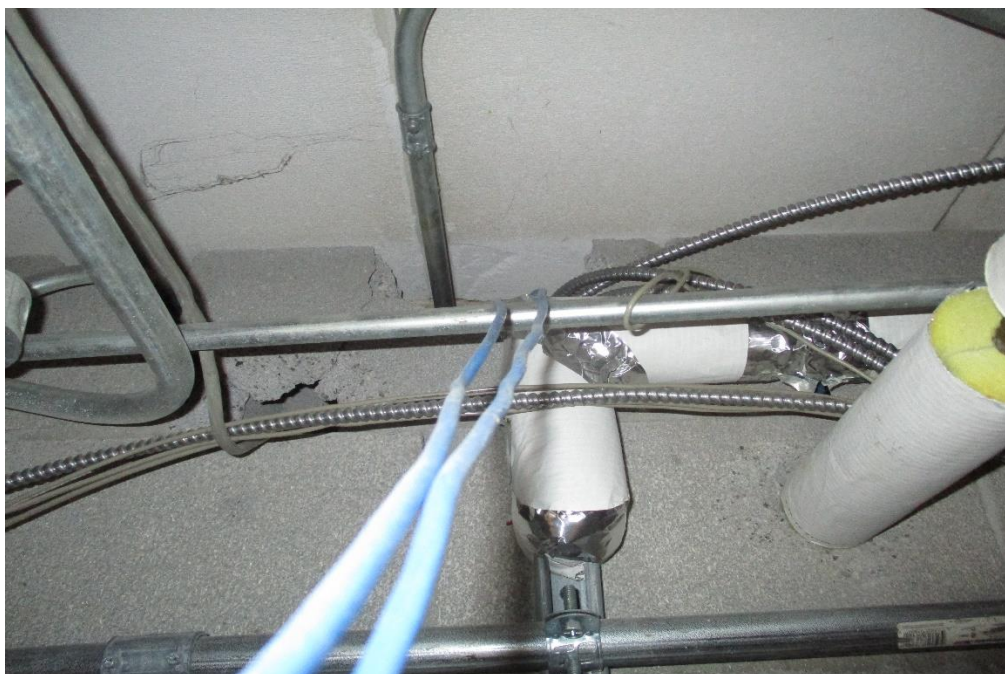
Gouging of Surface

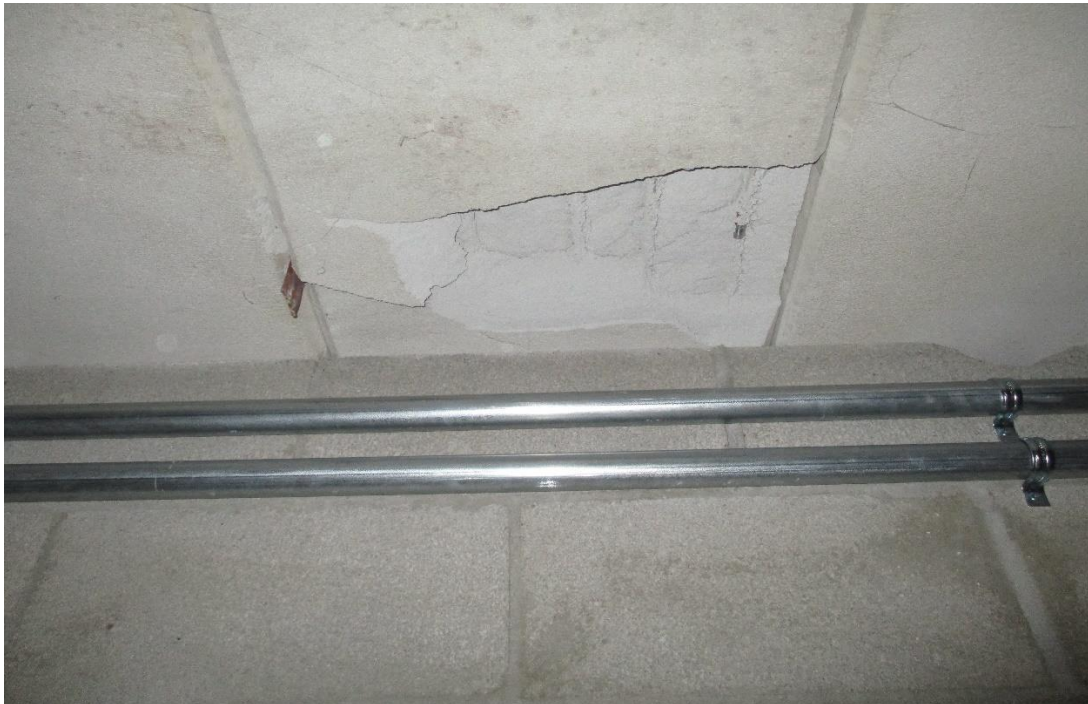
Large Surface Delamination

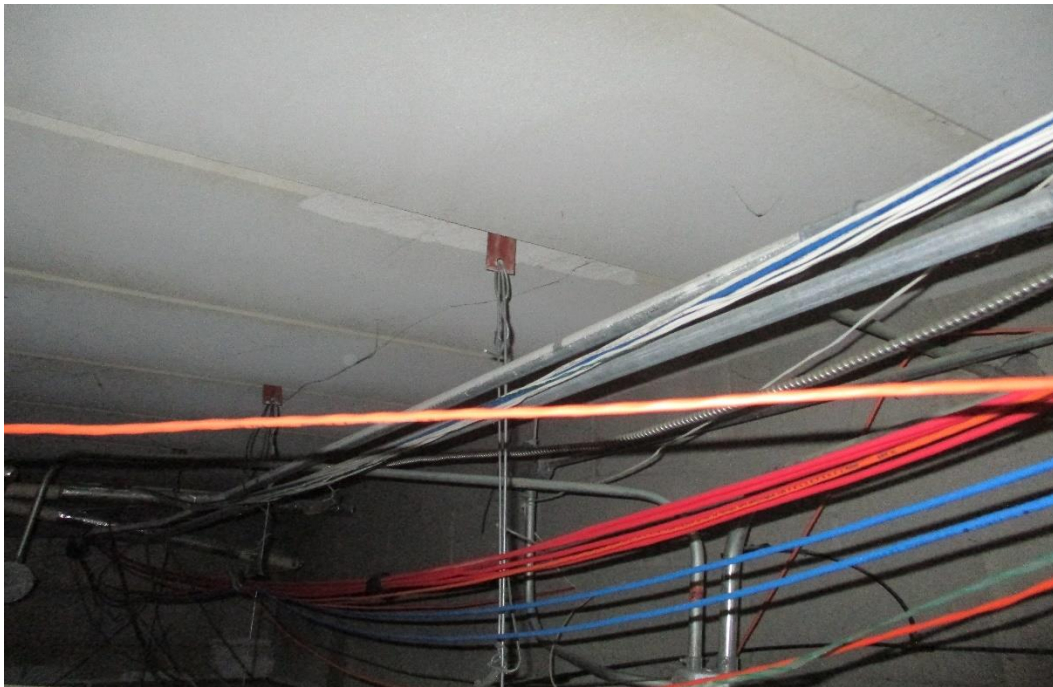
Large Surface Chipping

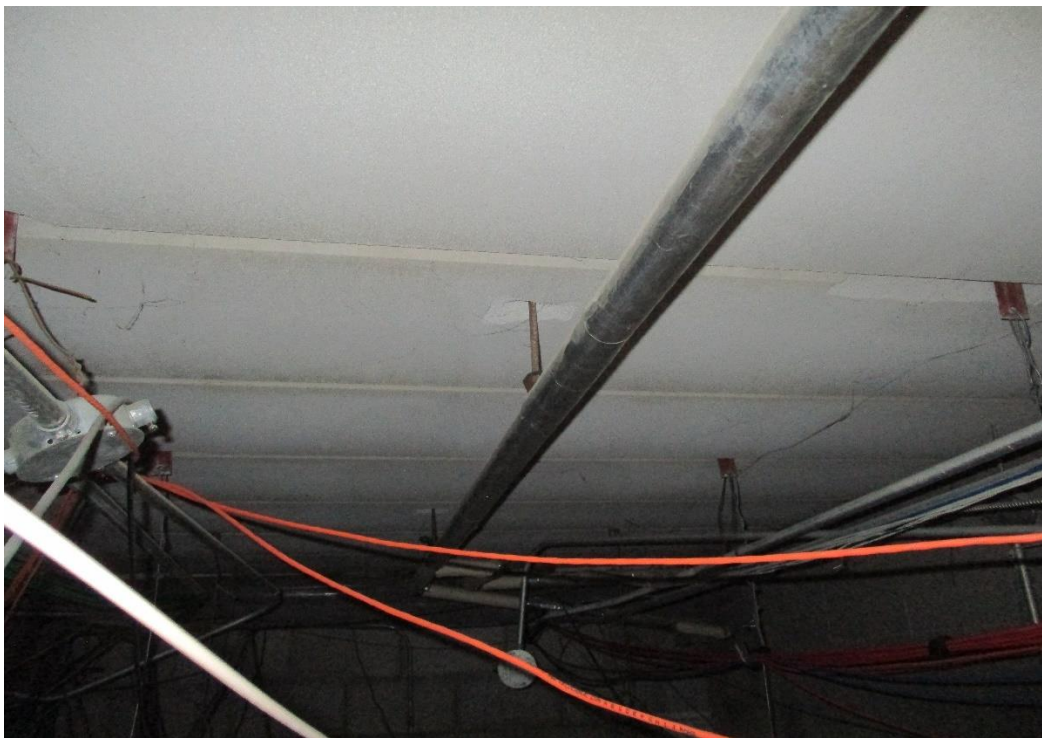
Chipping around Hanger

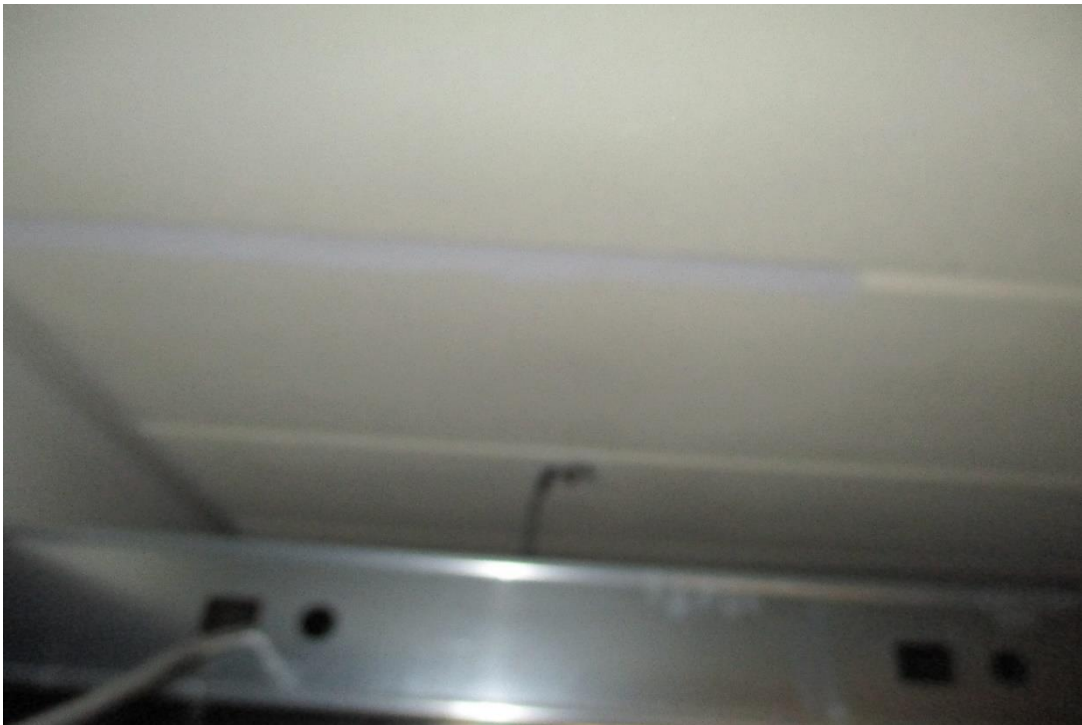
Delamination of Slabs

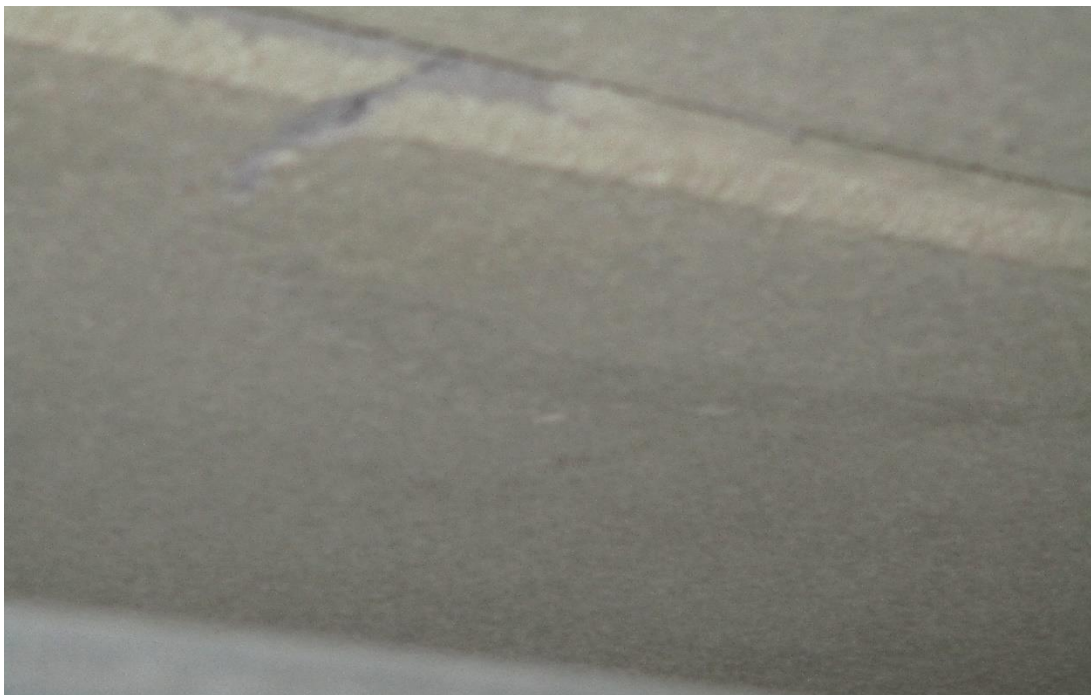
Delamination of Slabs

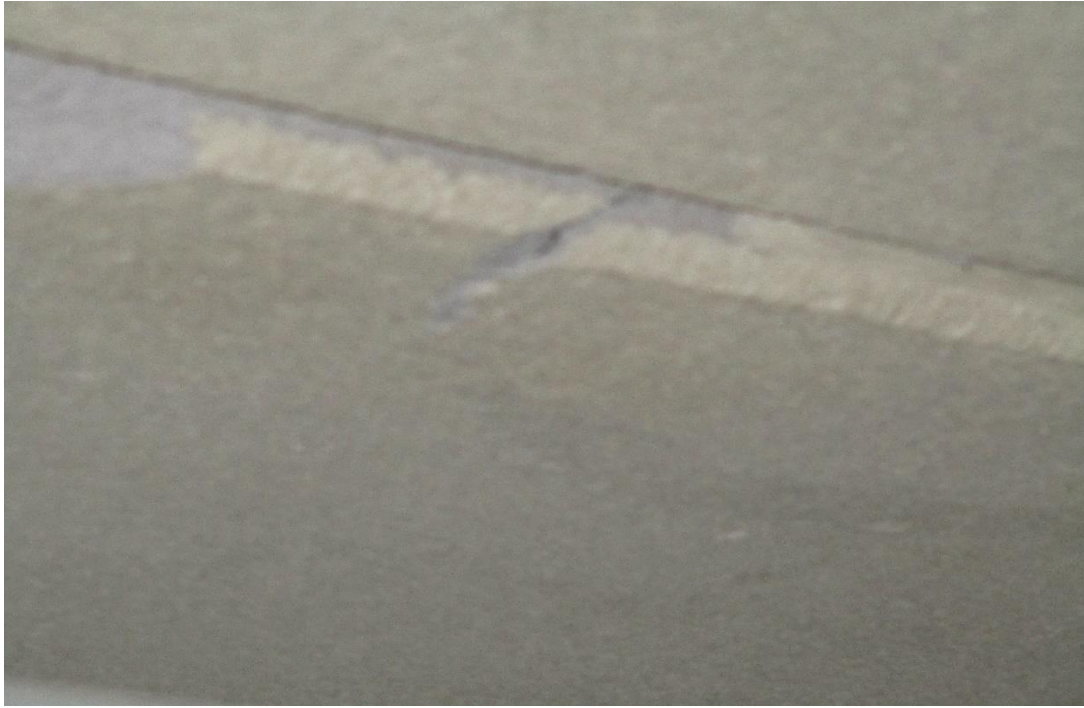
Delamination of Slabs

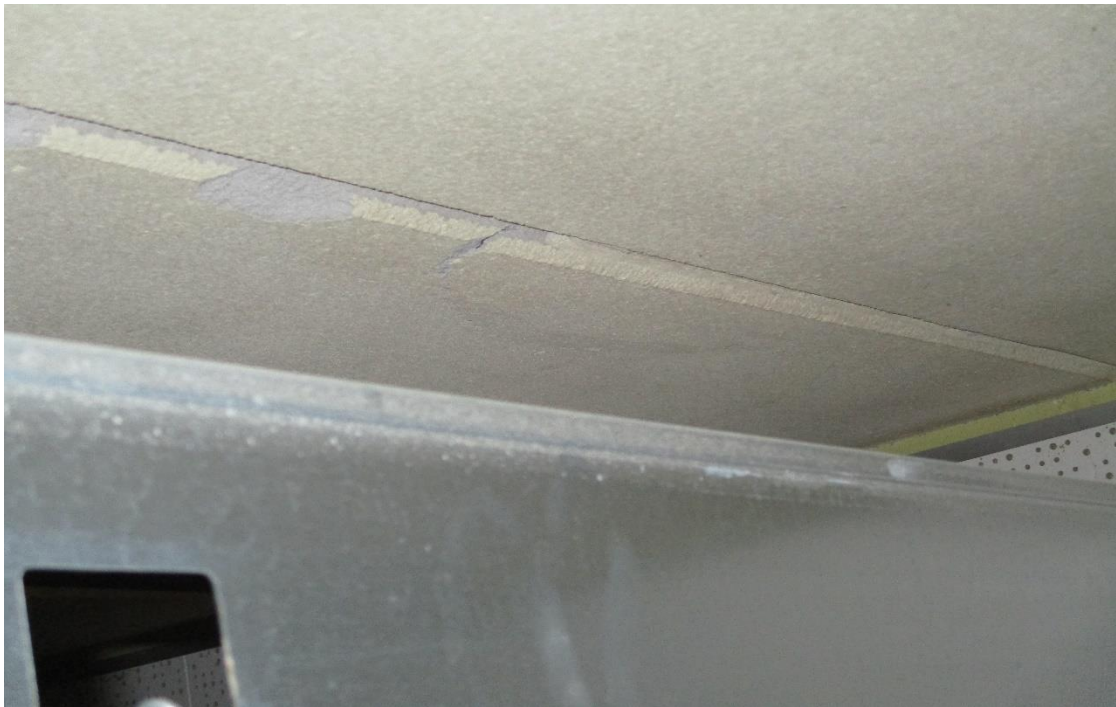
Delamination of Slabs

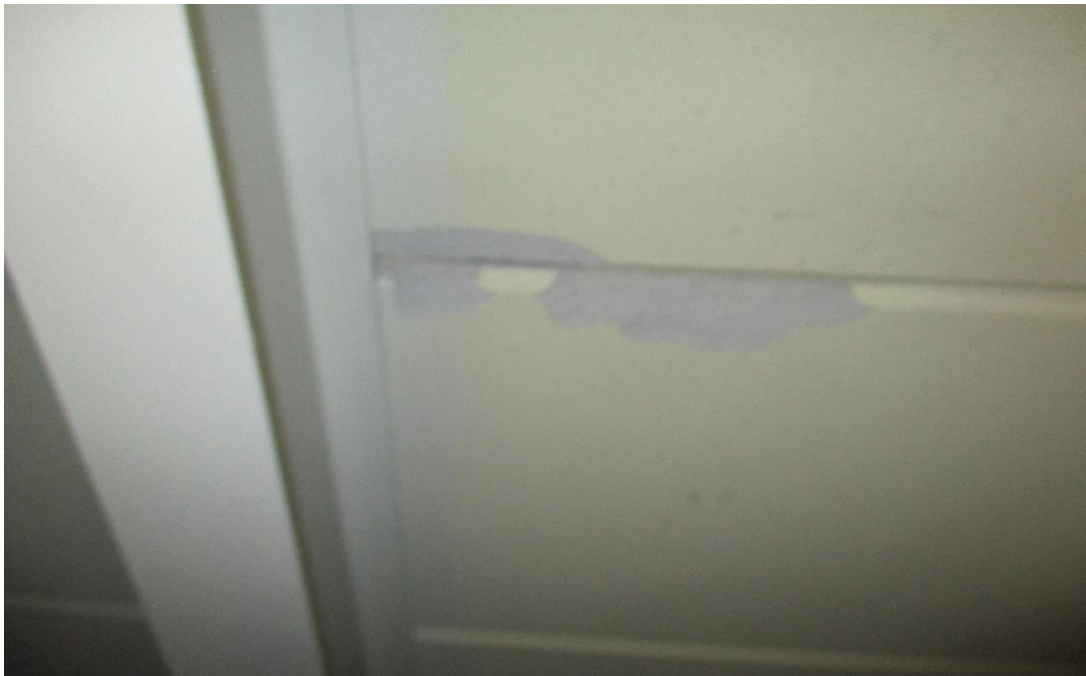
Delamination of Slabs

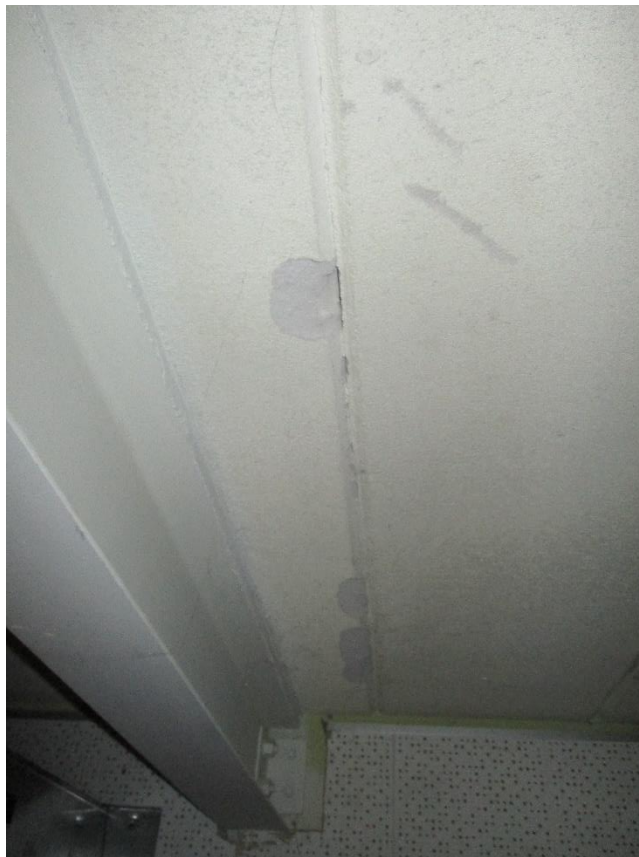
Delamination

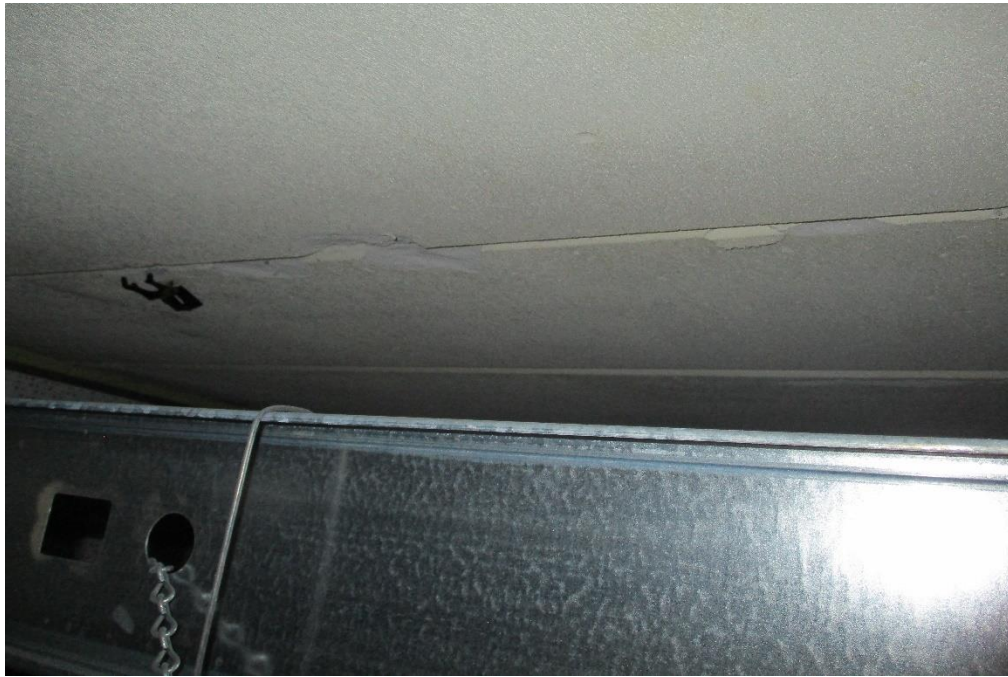
Chipping and Gouging

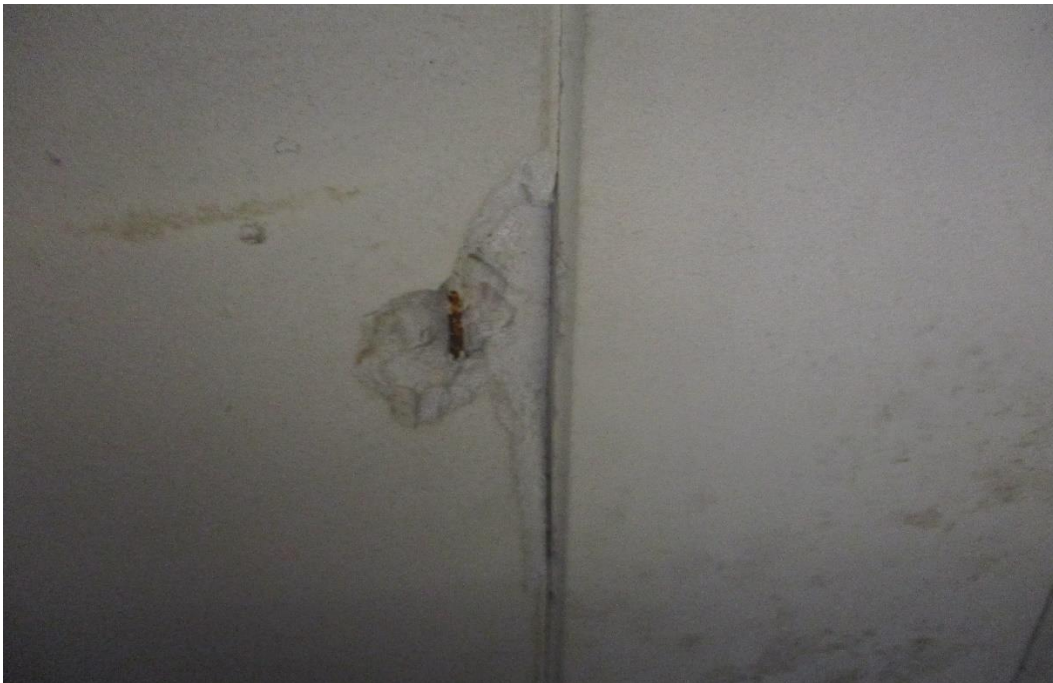
Chipping and Gouging

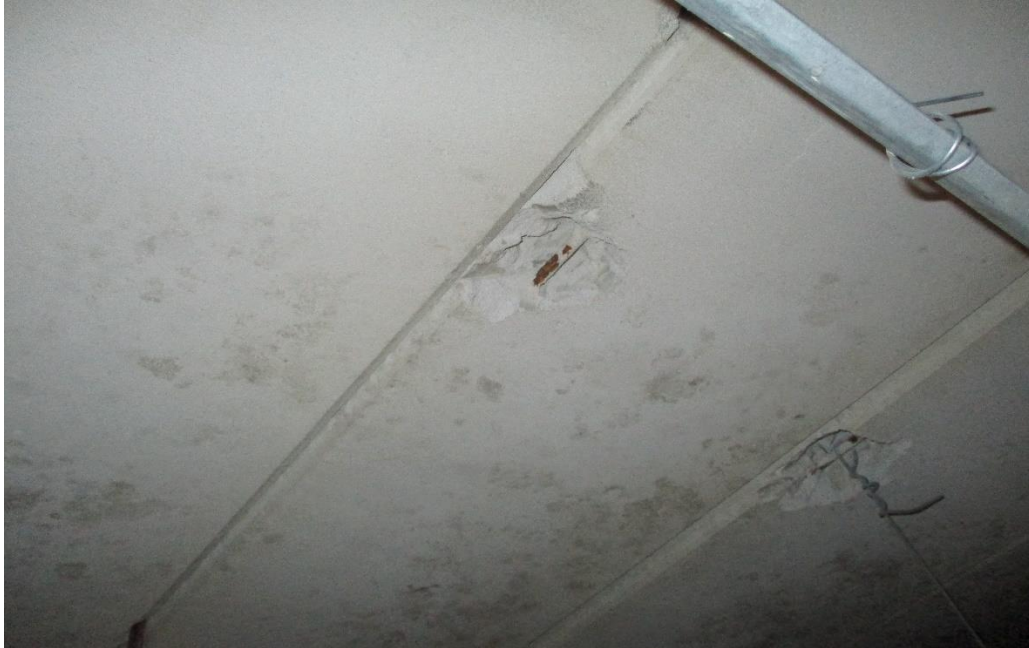
Chipping and Gouging

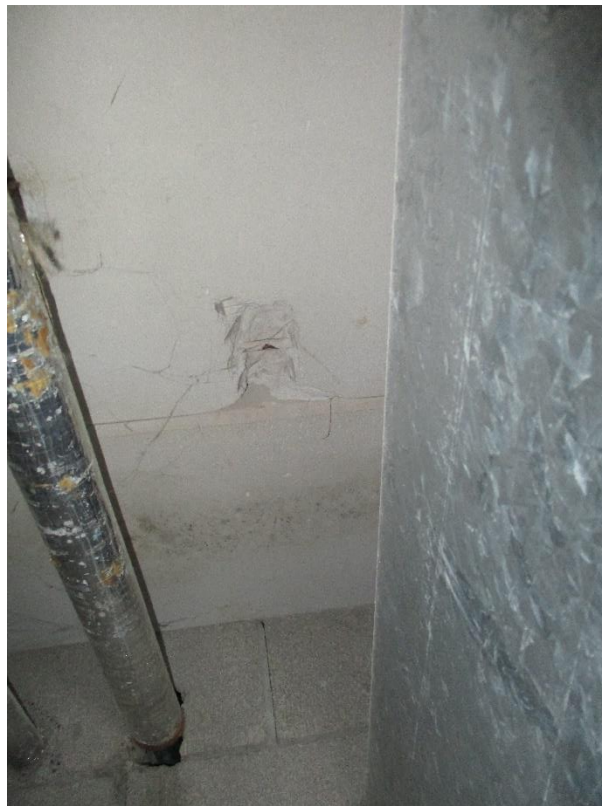
Chipping and Gouging

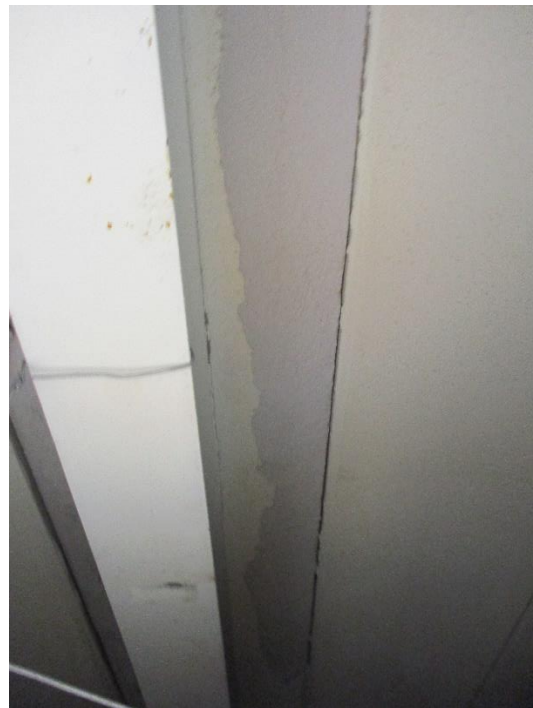
Large Surface Delamination

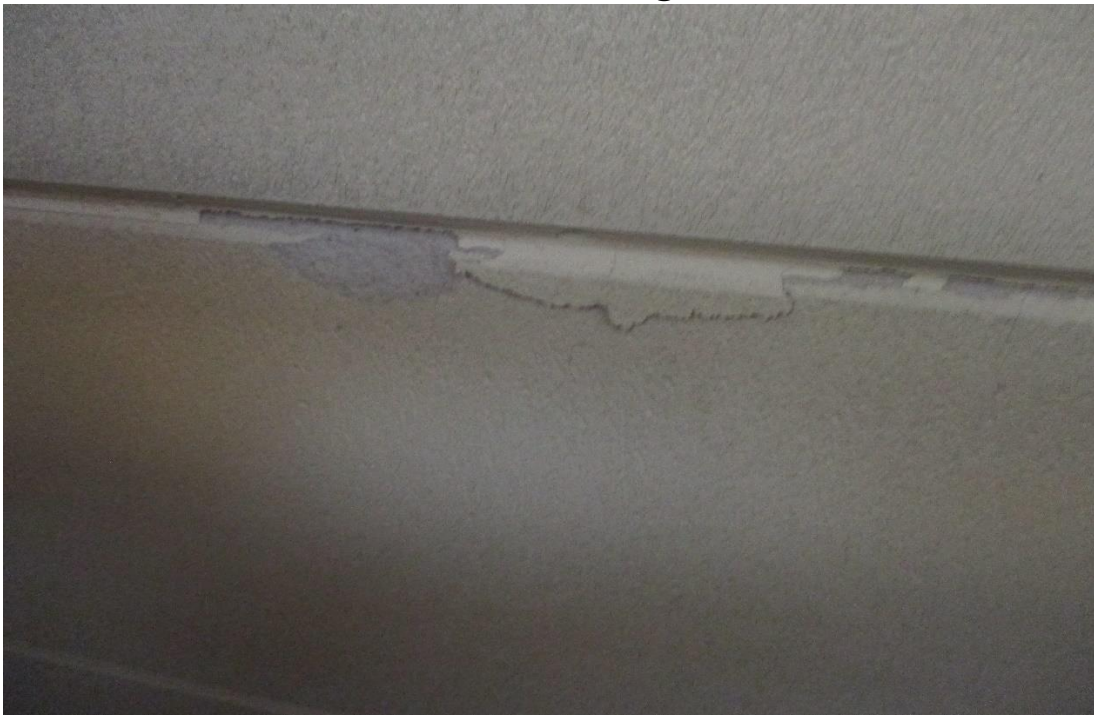
Delamination at Edges
